NOTICE IS GIVEN THAT A SERVICES, PROPERTY AND OUTDOOR SPACES COMMITTEE OF  
CULLOMPTON TOWN COUNCIL  
WILL BE HELD AT THE TOWN HALL, CULLOMPTON  
ON THURSDAY, 9<sup>th</sup> NOVEMBER 2023 AT 7PM

**MINUTES OF MEETING OF THE SERVICES, PROPERTY AND OUTDOOR SPACES COMMITTEE  
DATED TUESDAY 12 SEPTEMBER 2023 AT 7:00PM AT CULLOMPTON TOWN HALL**

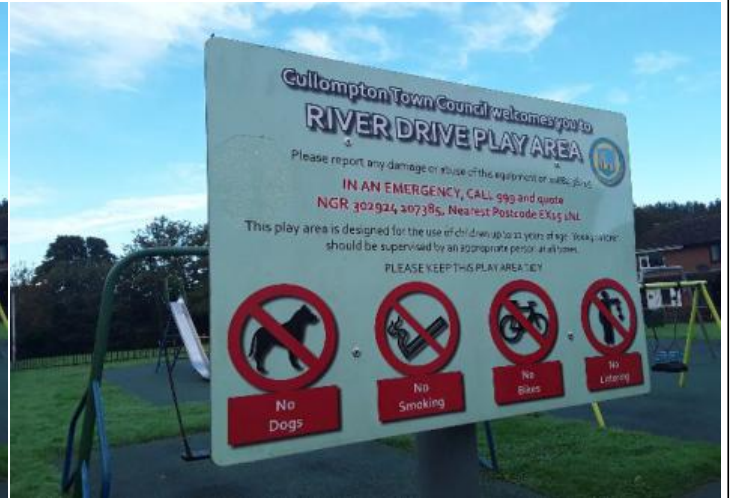
**Finding:** The site name (Culm Lea) does not match the name on the site sign, the report will be headed Culm Lea and may cause some confusion

**Action:** Consider amending the site name to match the sign and location

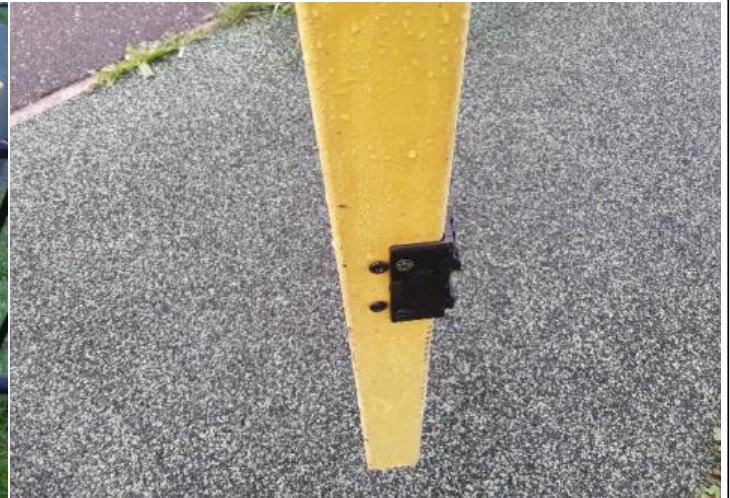
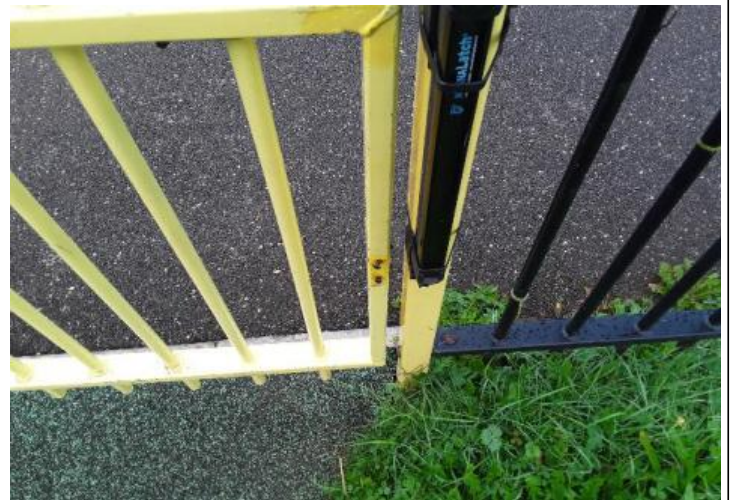
**Finding:** The gate latches are broken and the gates pass the slamming plates

**Action:** Replace the damaged latches

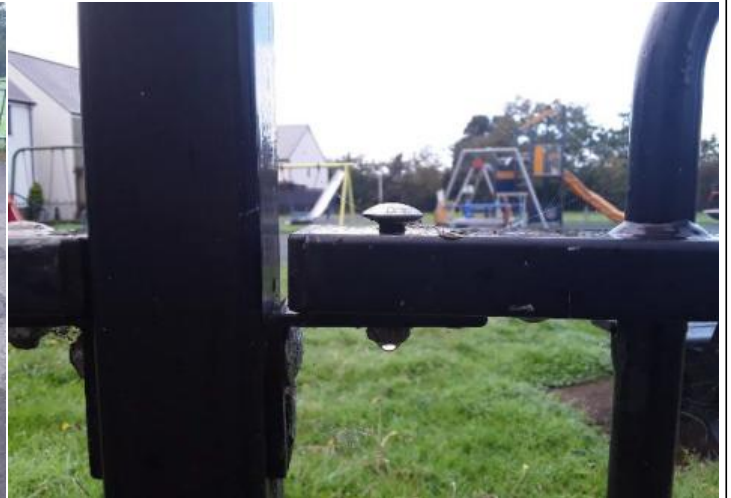
**Finding:** A number of fixings have worked loose around the fencing  
**Action:** Secure all loose fixings

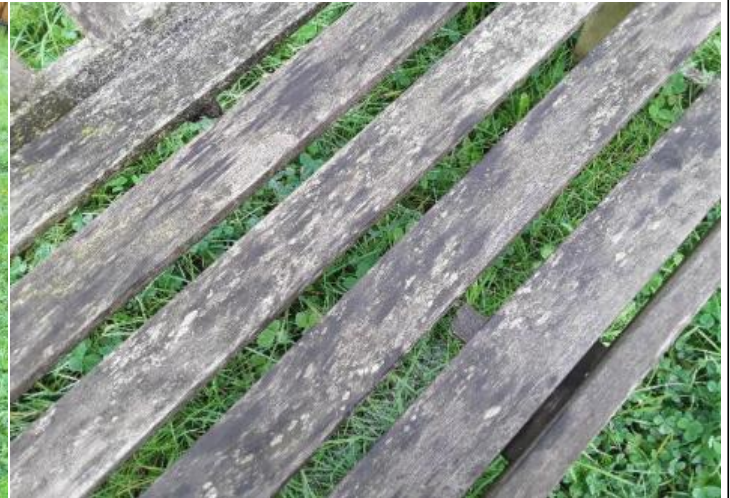
**Finding:** The middle timber seat brace has been damaged / removed  
**Action:** Replace the brace

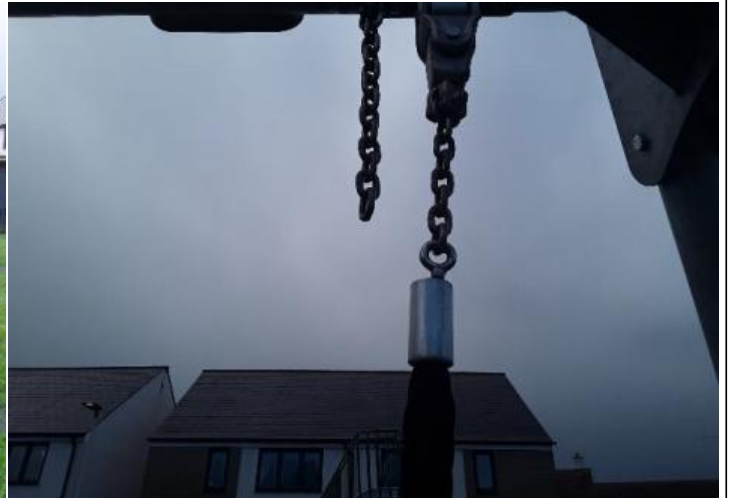
**Finding:** The shackle securing the safety chain to the suspension chain has been removed

**Action:** Replace the missing shackle

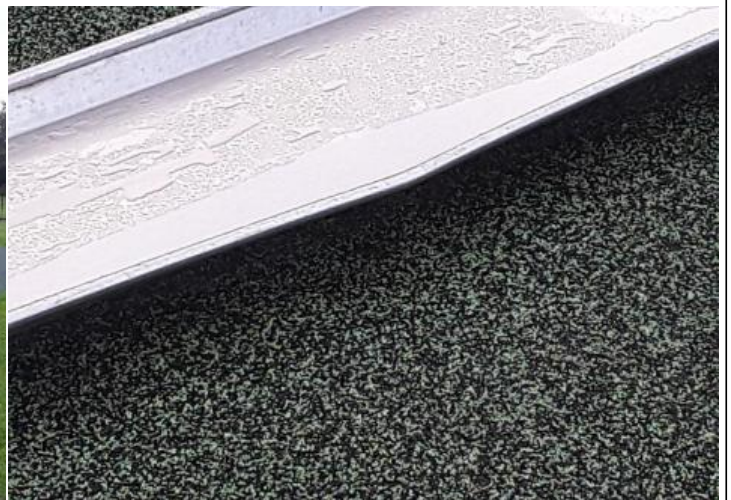
**Finding:** The side of the slide is damaged

**Action:** Monitor for any further deterioration and repair as required

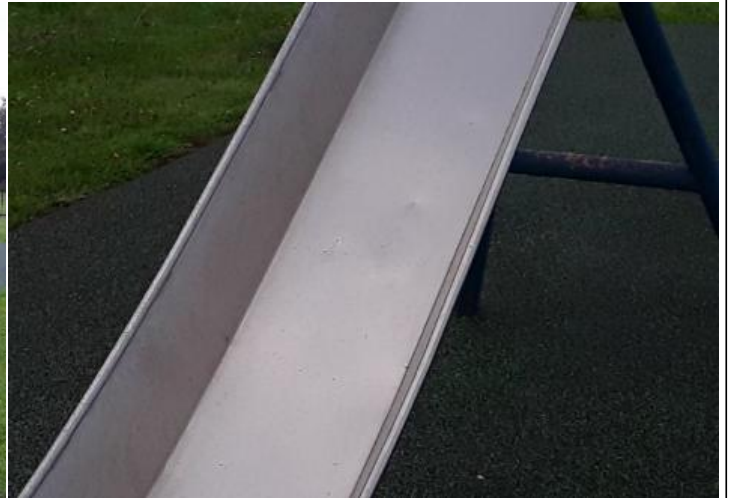
**Finding:** There are a number of dents in the slide surface

**Action:** Monitor for any further deterioration and repair as required

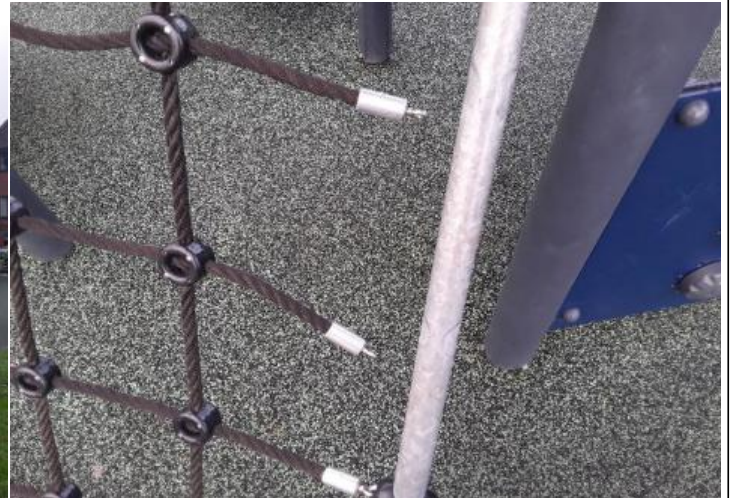
**Finding:** There is or are fixings missing on the cargo net

**Action:** Replace all missing fixings

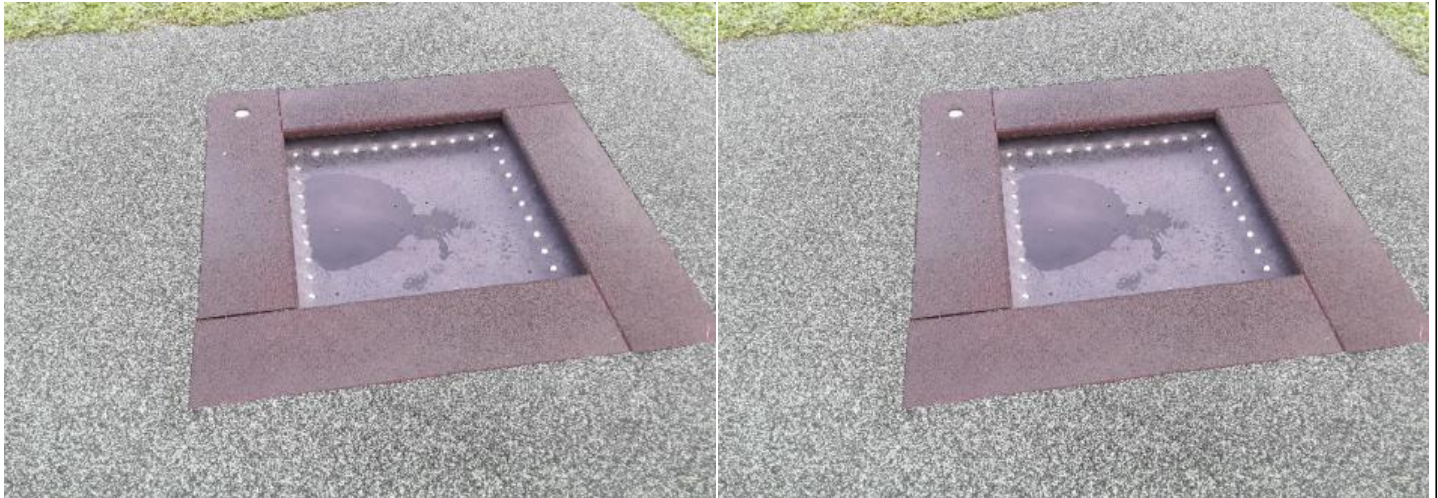
**Finding:** On site visits it is not possible to test the ground clearance of the Bouncing Facility bed as specified in BS EN 1176; ensure that the clearance between the Bouncing Facility Bed and the ground underneath is in accordance with the manufacturers recommendations (the bed is fully enclosed and we are unable to determine a nominal depth).

**Action:** Refer to the manufacturers recommendations

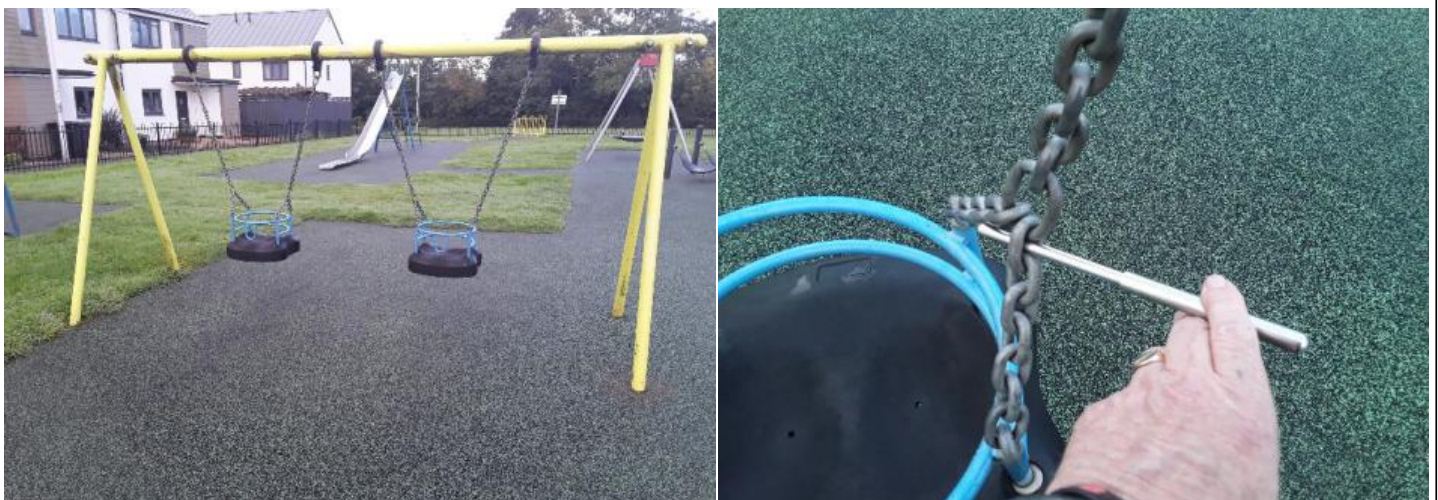
**Finding:** The chain openings are in excess of the 8.6mm as recommended by BS EN 1176

**Action:** Monitor - No remedial work recommended

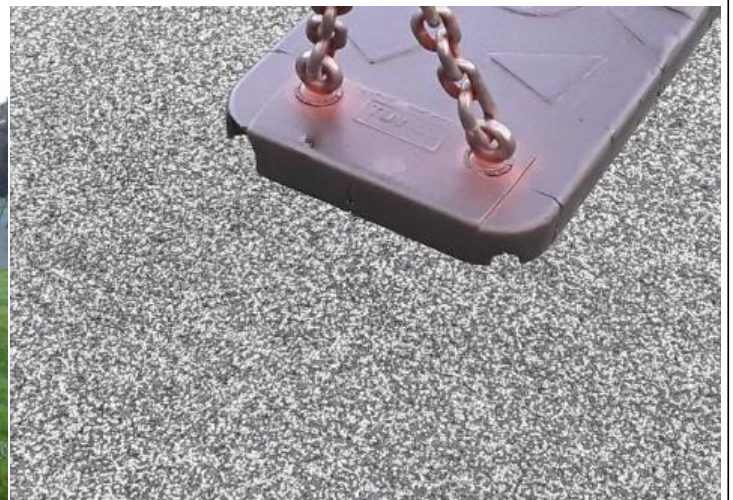
**Finding:** The seat has minor damage or wear

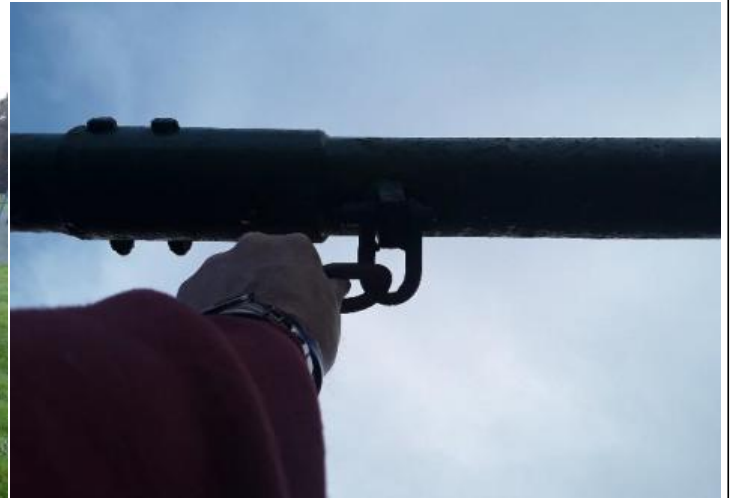
**Finding:** There is some wear to the shackles.

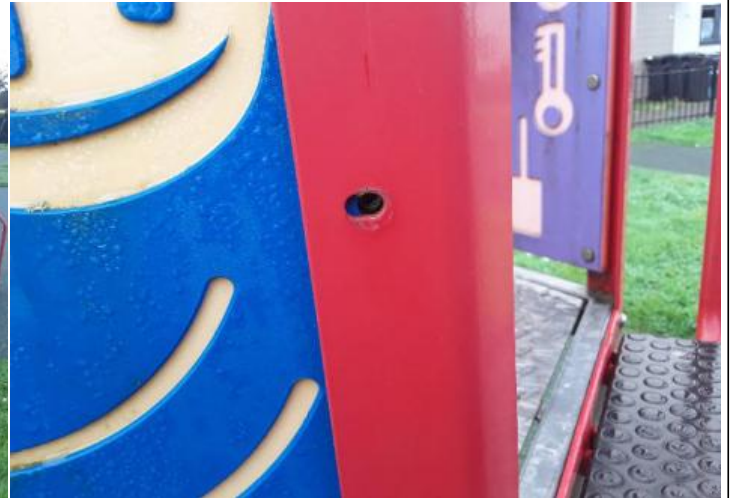
**Finding:** There is or are fixings missing on the item

**Action:** Replace all missing fixings

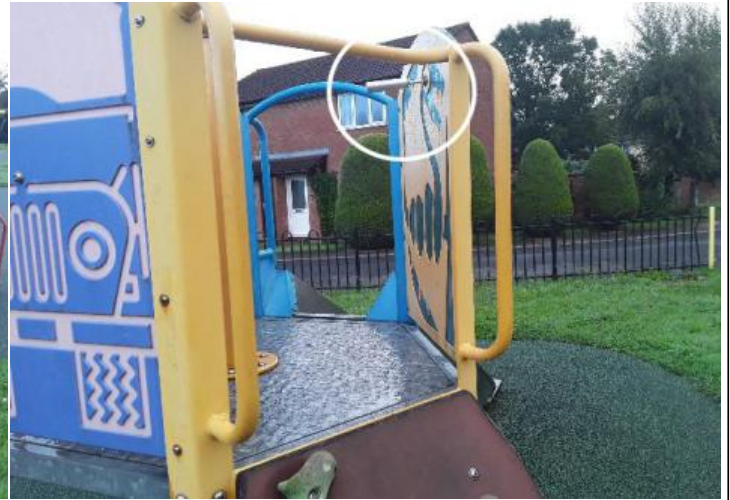
**Finding:** There is/are finger entrapment/s in the side panel due to missing components and the item fails to meet the requirements of BS EN 1176 Part 1 4.2.7.6 Entrapment of fingers

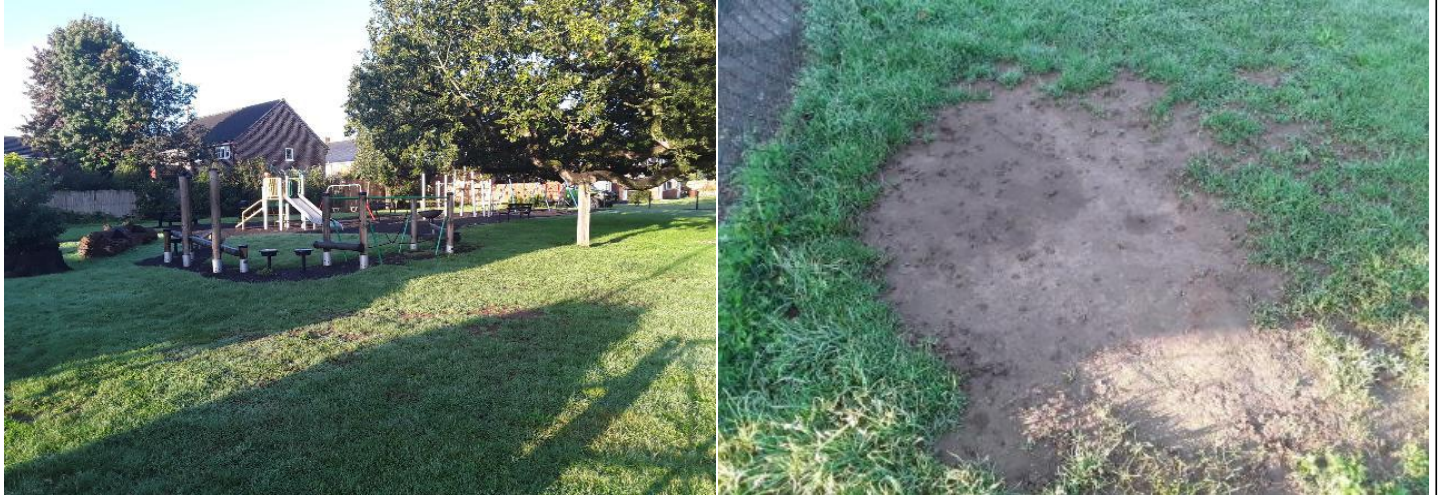
**Finding:** The surface has eroded in some areas and may be slippery in wet conditions  
**Action:** Reinstate the surface

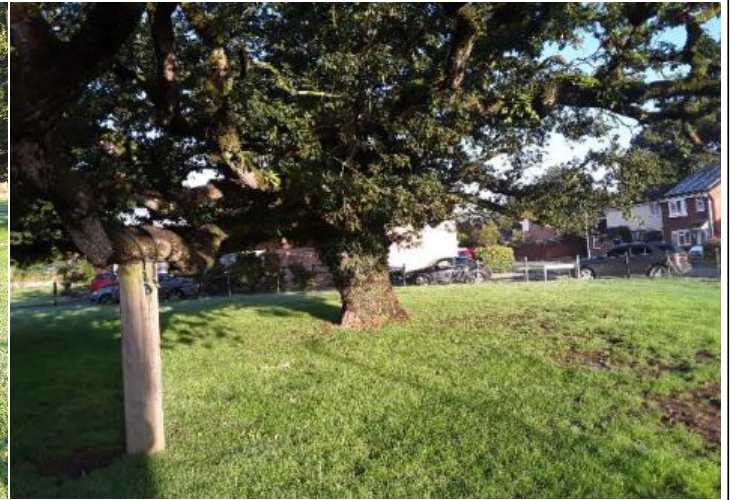
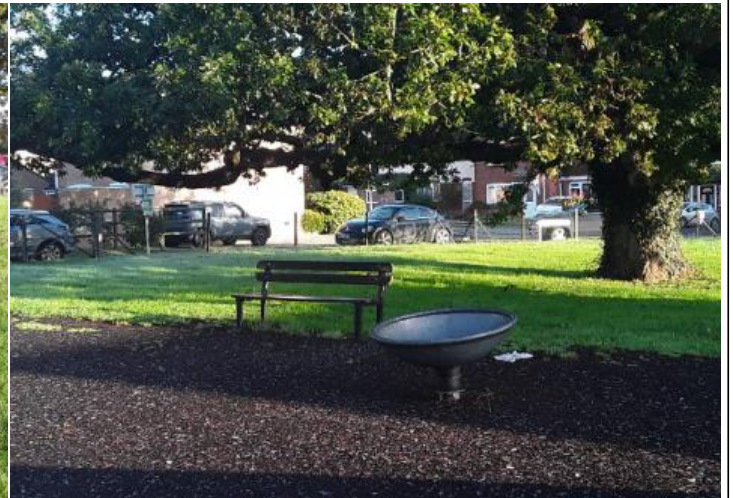
**Finding:** There is an oak tree within the play area with a span in excess of 10 metres. One branch has been supported to reduce the likelihood of failure due to the self weight of the branch. Other branch extremities extend over play equipment and seating

1. Town Council staff remove Ivy from the trunk of the Veteran Oak tree at Headweir Road play area.
2. That a detailed decay mapping survey is conducted on the Veteran Oak tree at Headweir Road play area.
3. That a detailed management plan is drawn up for the Veteran Oak tree at Headweir Road play area.

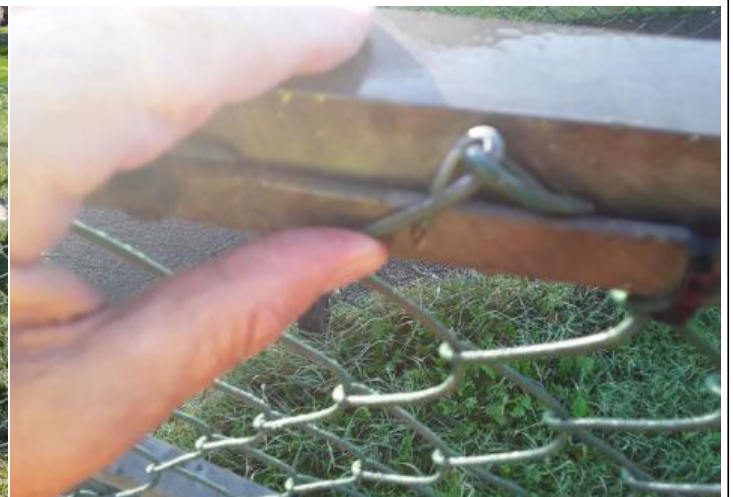
**Finding:** The cut off ends of the infill mesh are exposed and may cause puncture wounds

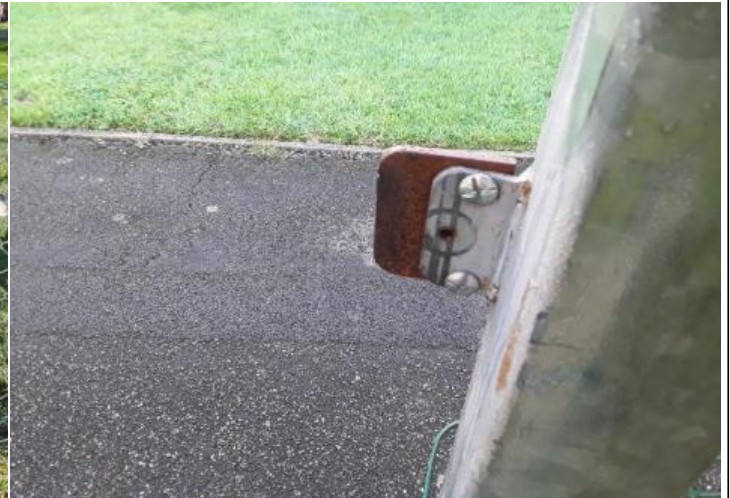
**Finding:** The rubber buffer is missing from the latch plate

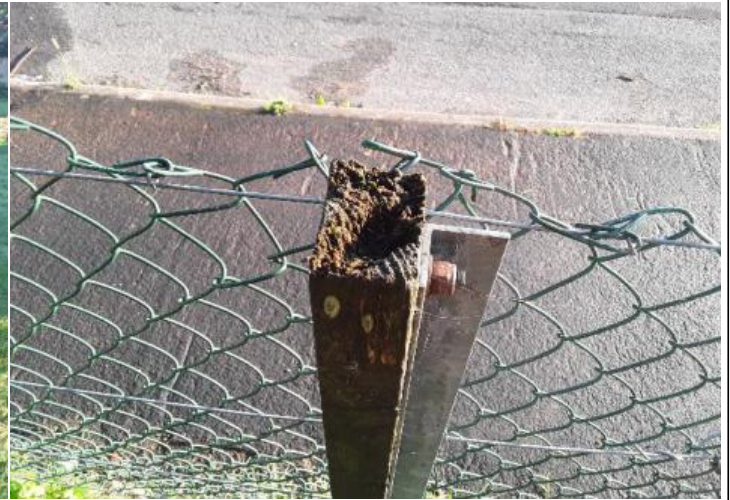
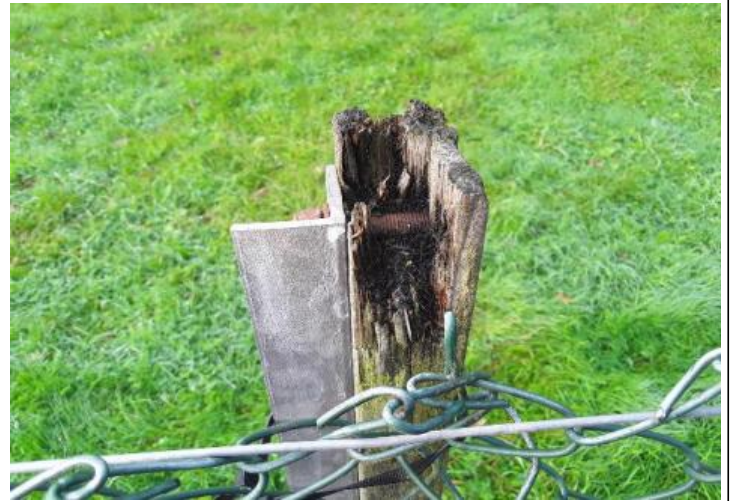
**Finding:** There is some evidence of rot in the timber

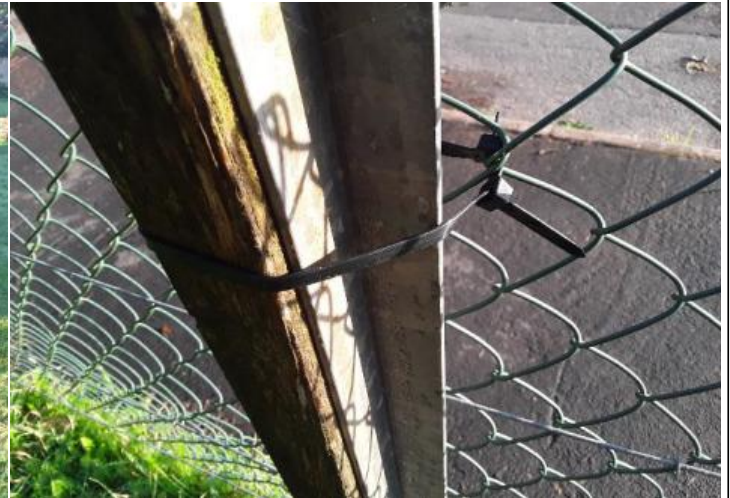
**Finding:** An incorrect fixing or fixing method has been used **Action:** Replace with appropriate fixings to the manufacturer's specification

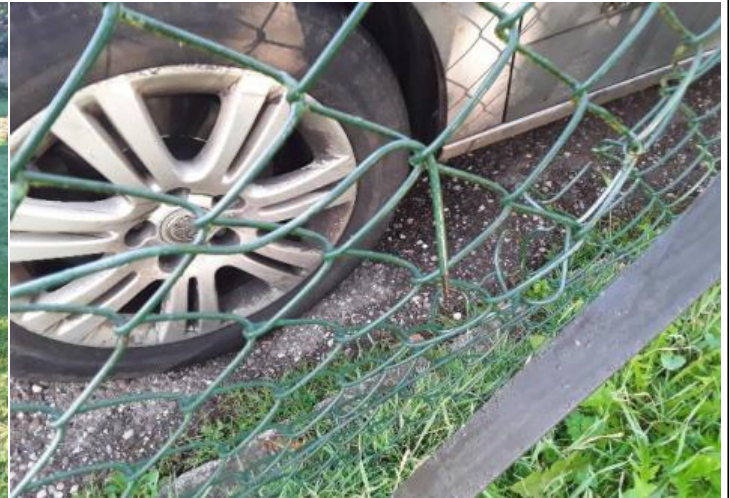
**Finding:** Line wires are broken

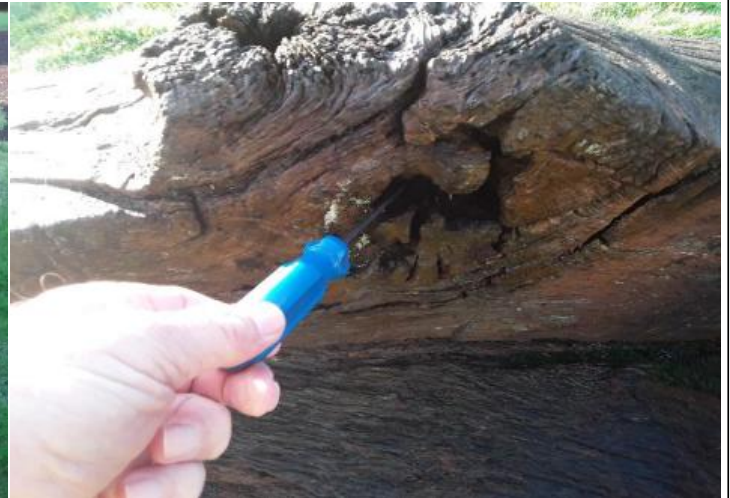
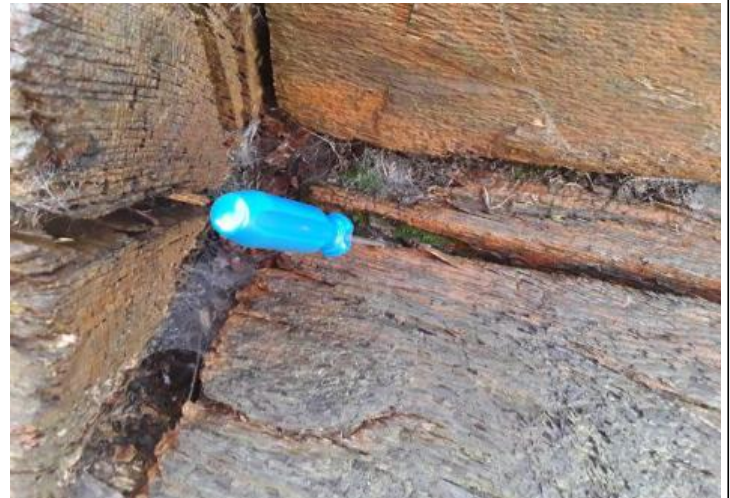
**Finding:** There is some evidence of rot in the timber

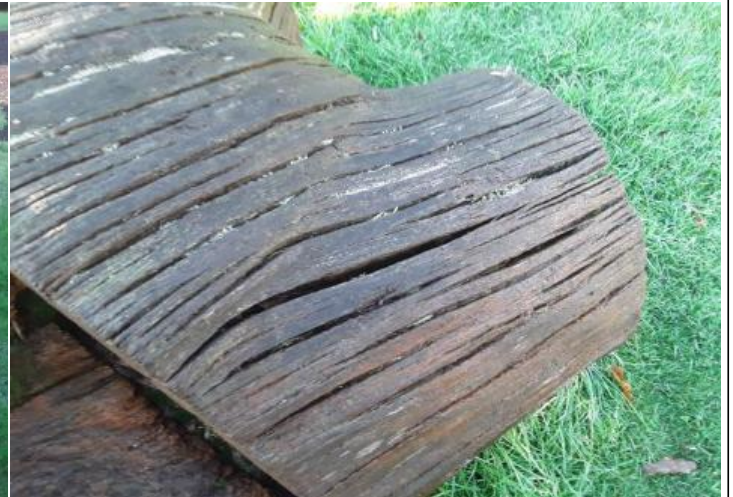
**Finding:** The timber has a number of splits/shakes or air cracks and this may affect the stability or allow water ingress which will accelerate the rotting process

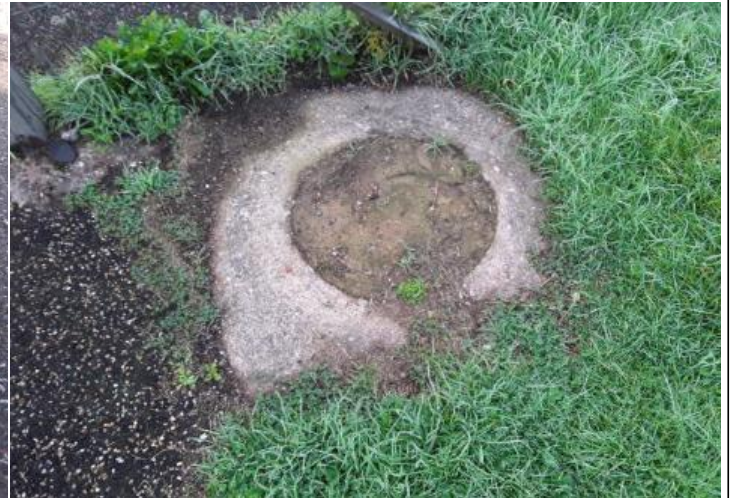
**Finding:** There are redundant concrete litter bin bases within the play area causing trip hazards

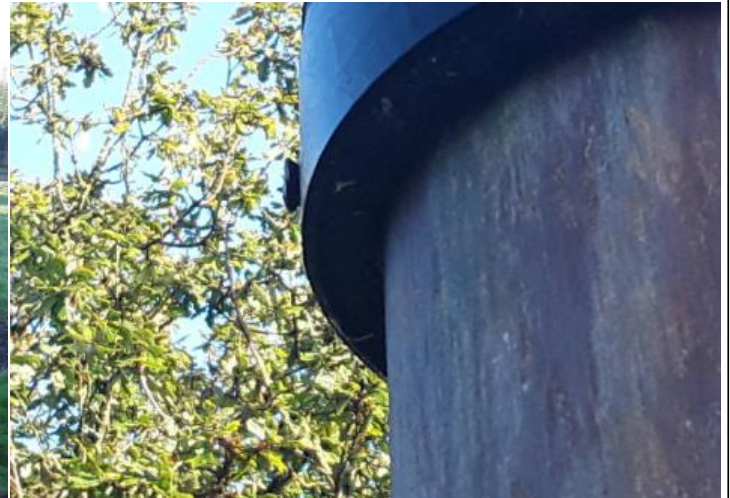
**Finding:** A number of cap fixing(s) have worked loose

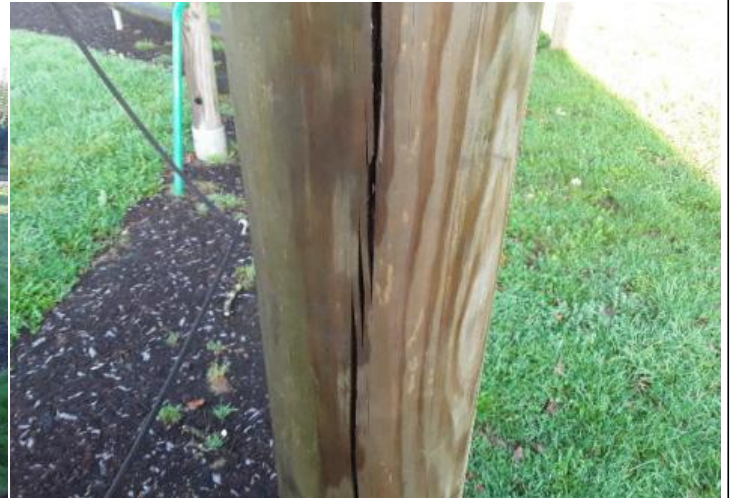
**Finding:** The timber has a number of splits/shakes or air cracks and this may affect the stability or allow water ingress which will accelerate the rotting process

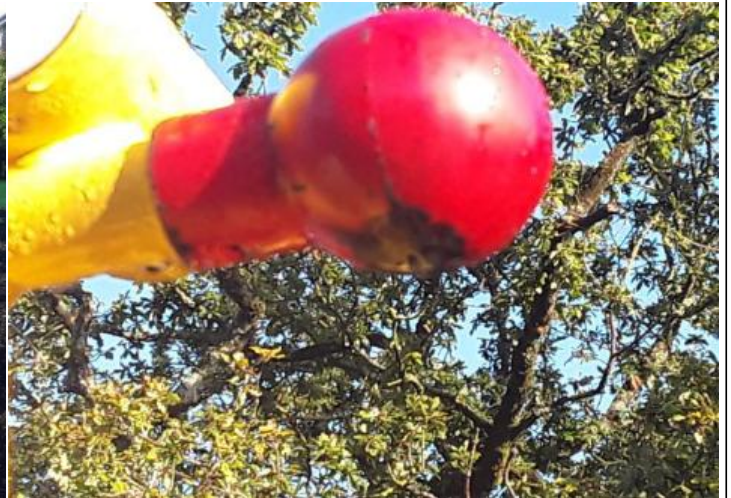
**Finding:** There is minor damage to the handgrips

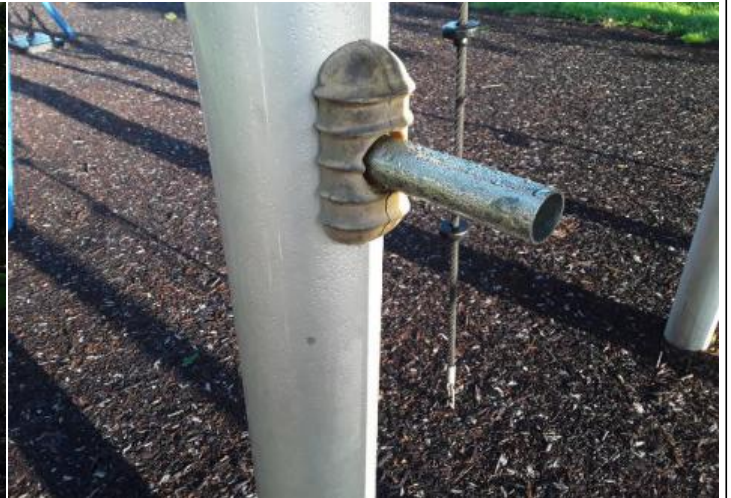
**Finding:** One foot peg cover has been removed

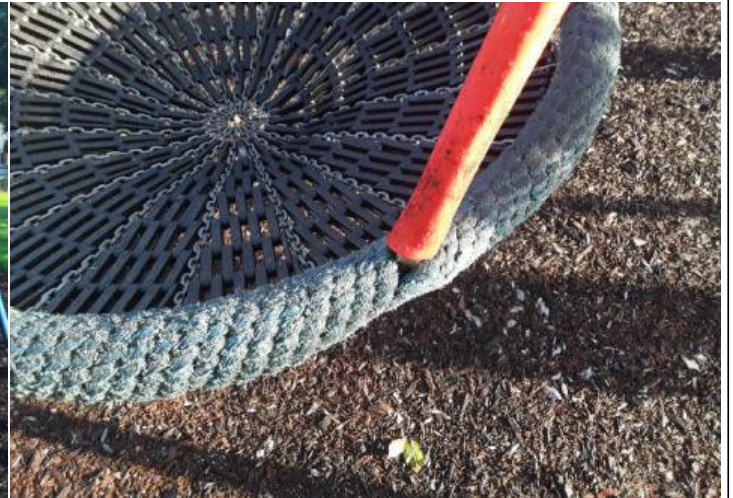
**Finding:** The seat connection cannot be inspected fully as the chain cover cannot be lifted

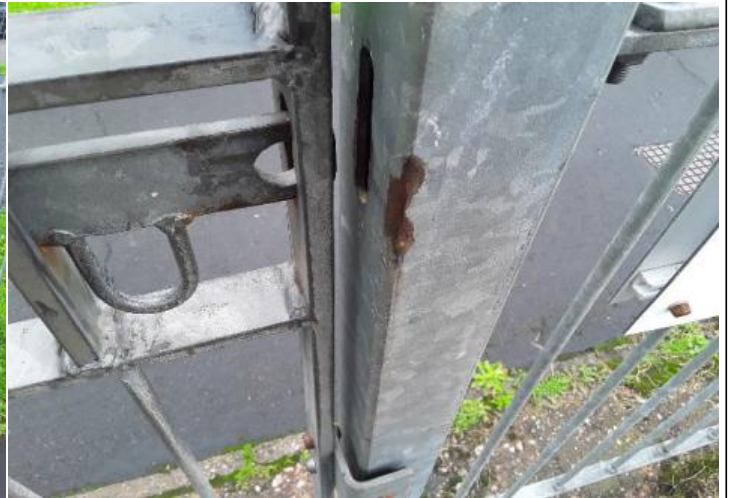
**Finding:** There is surface corrosion / rust present on the item

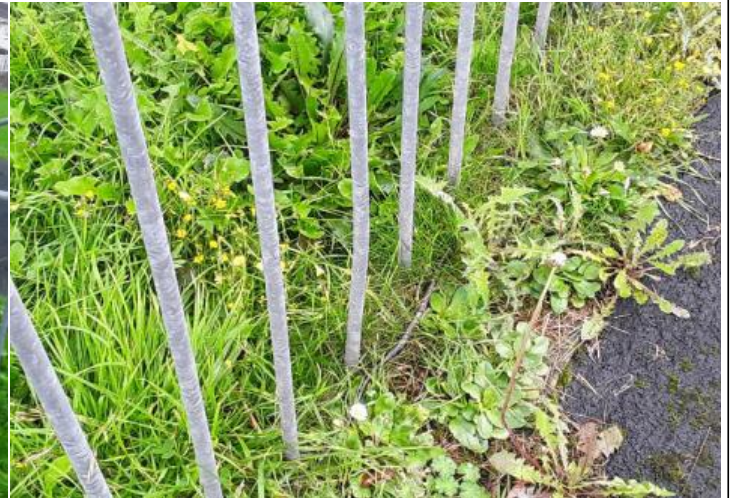
**Finding:** There is some damage to the fence sections

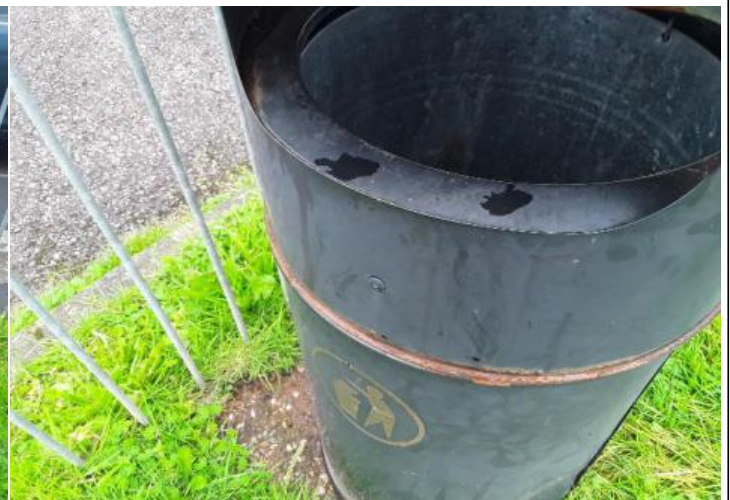
**Finding:** The paintwork on this item has been damaged or worn exposing the metal underneath which is rusting / corroding

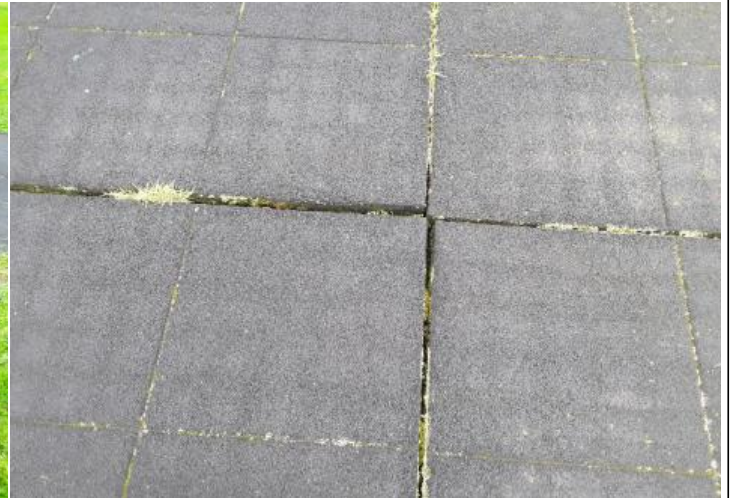
**Finding:** There are gaps opening in between the tiles  
**Action:** Monitor for any further deterioration and repair as required

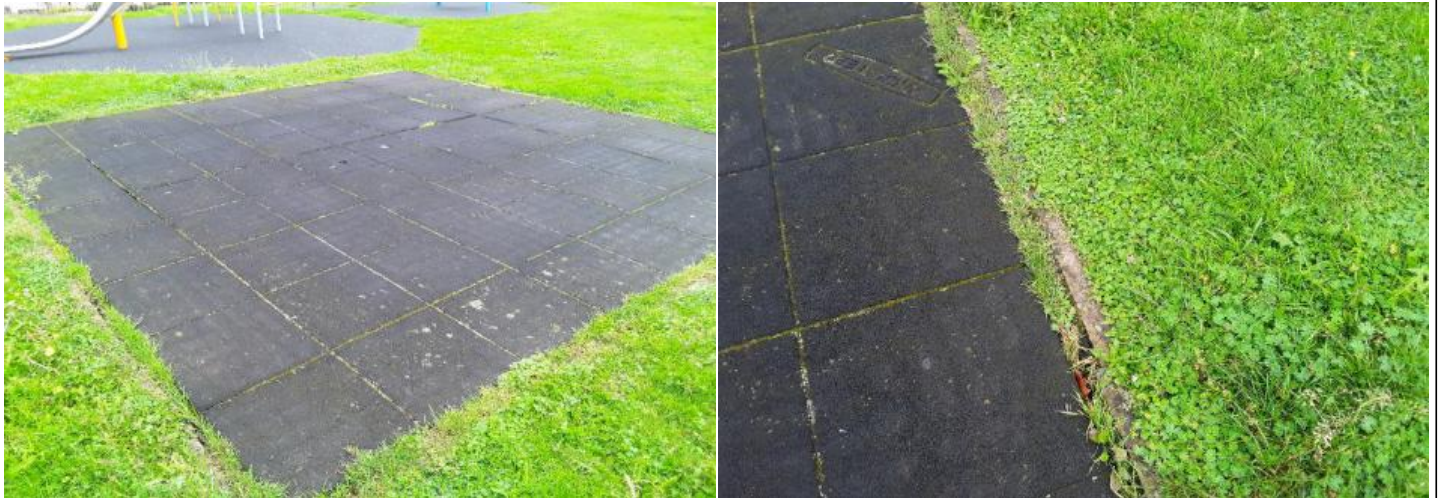
**Finding:** There are significant gaps (over 30mm) between the tiled surface and the edging or between the joints in the tiled surface; these are large enough for a small foot to enter  
**Action:** Repair the surfacing

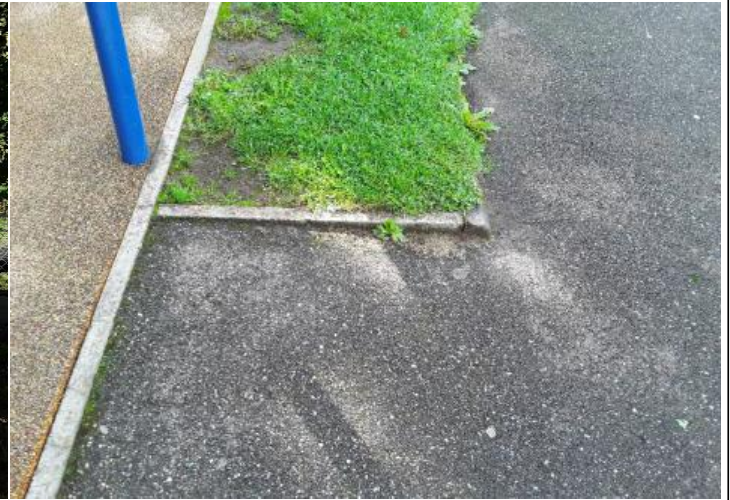
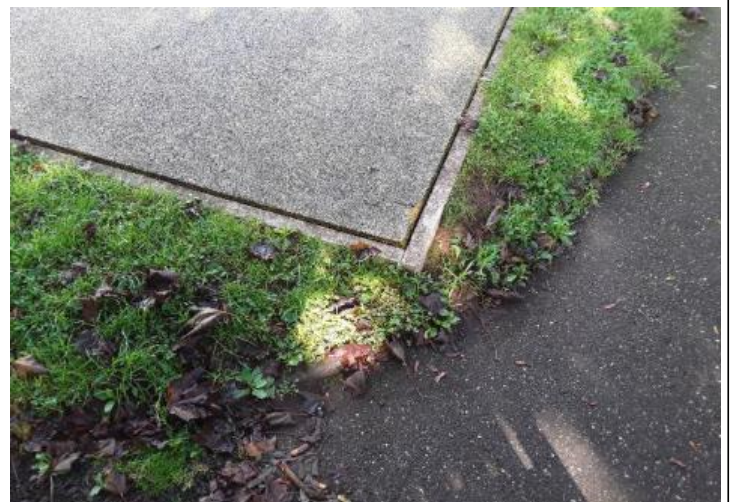
**Finding:** There are trip hazards present over the edgings

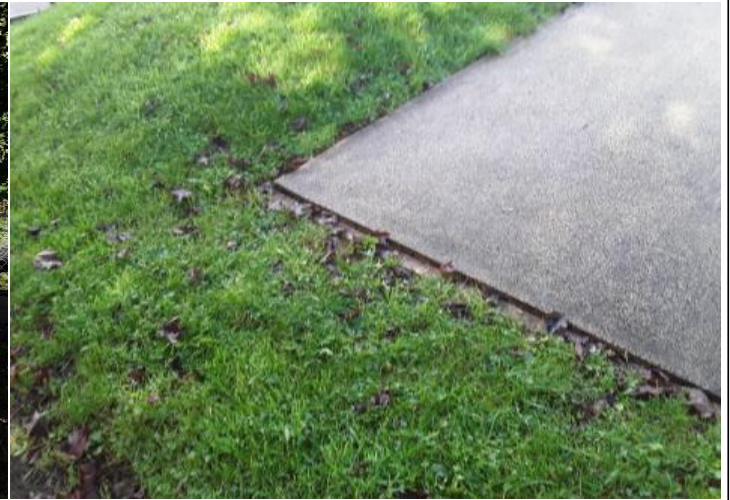
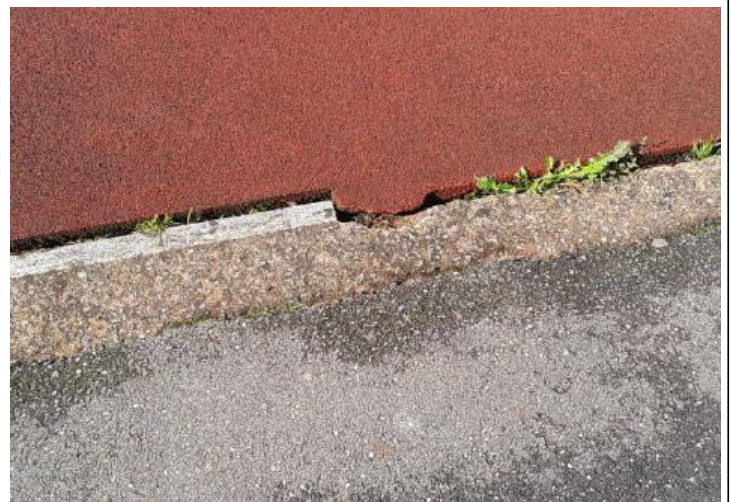
**Finding:** The surface is lifting at the edges and creating trip points  
**Action:** Repair perimeter of surfacing to remove trip points

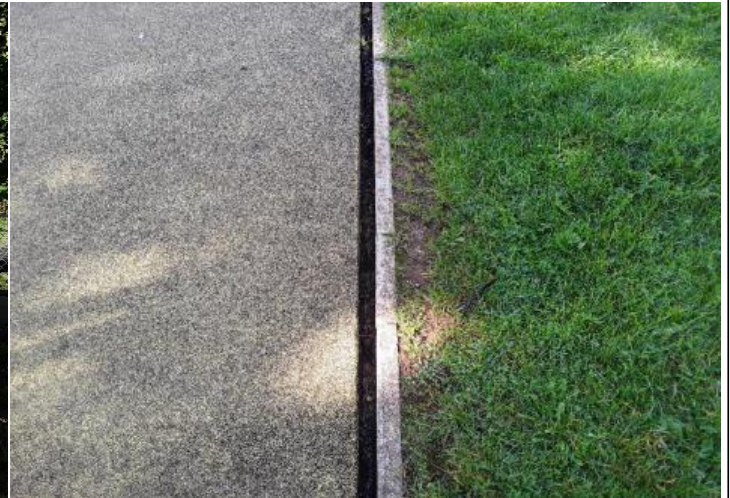
**Finding:** There are significant gaps (over 30mm) between the surface and the edging or between the joints in the surface; these are large enough for a small foot to enter

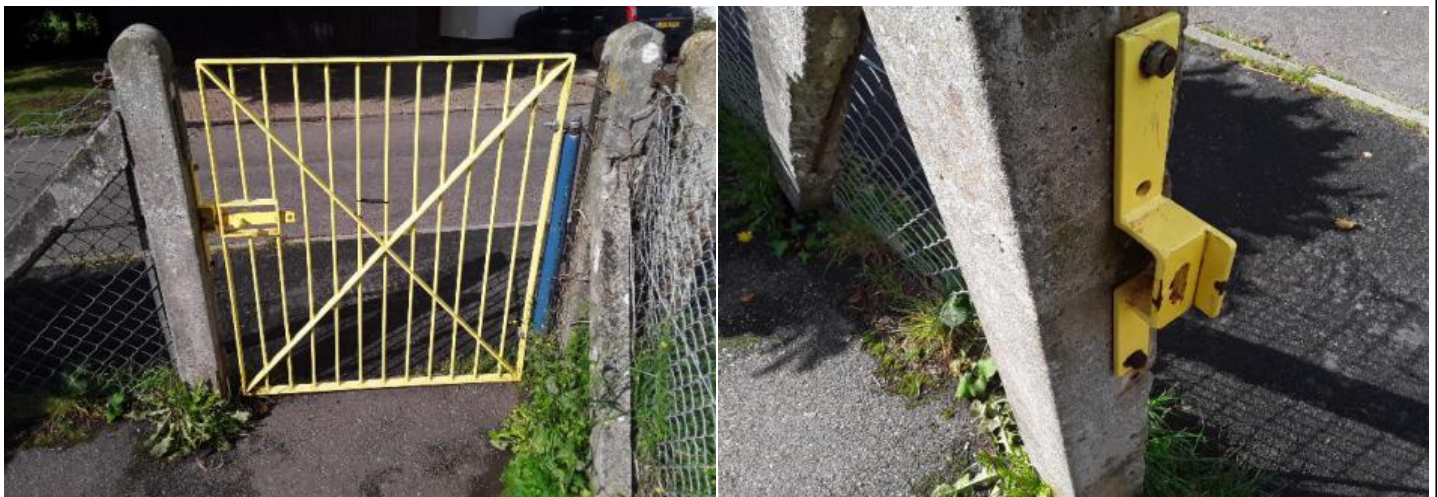
**Finding:** A number of fixing(s) have worked loose on the latch plate

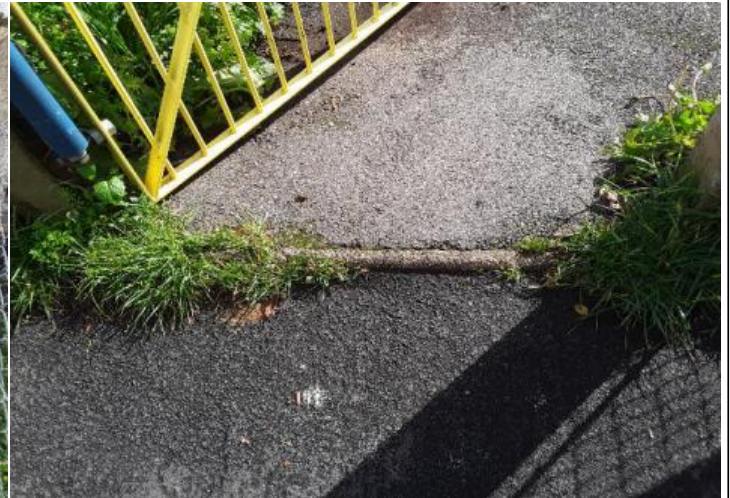
**Finding:** There are trip hazards present over the edgings under the gate

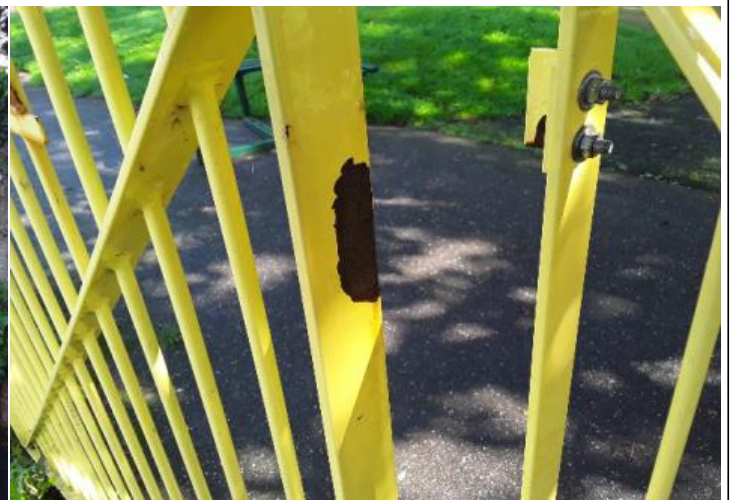
**Finding:** The paintwork on this item has been damaged or worn exposing the metal underneath which is rusting / corroding

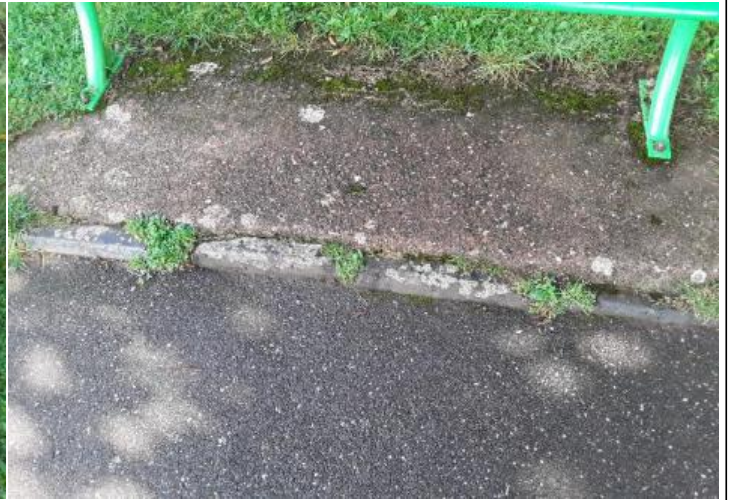
**Finding:** There are trip hazards present over the edgings adjacent to the bench

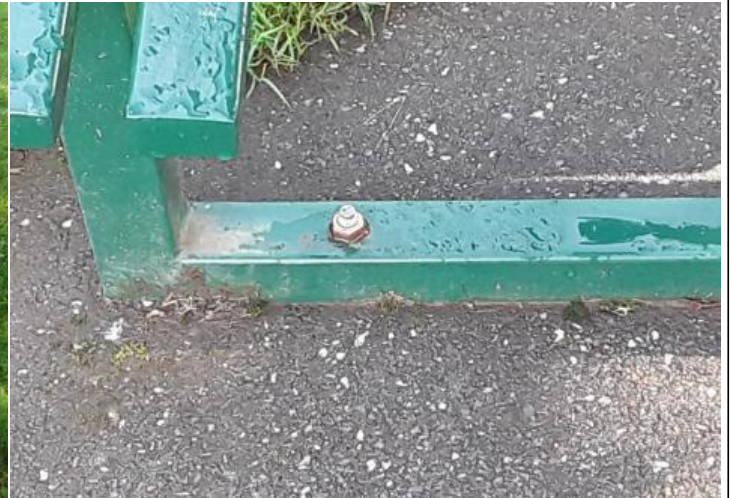
**Finding:** There is/are bolt cap covers missing or damaged on the item

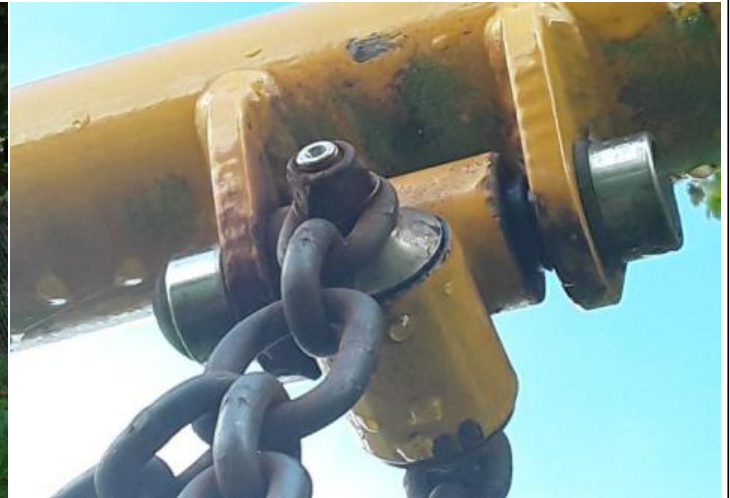
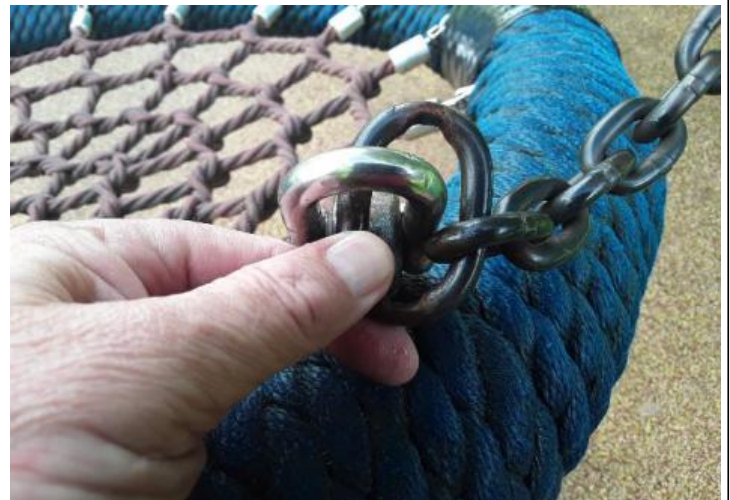
**Finding:** The chain links are worn in excess of 40% and require renewing

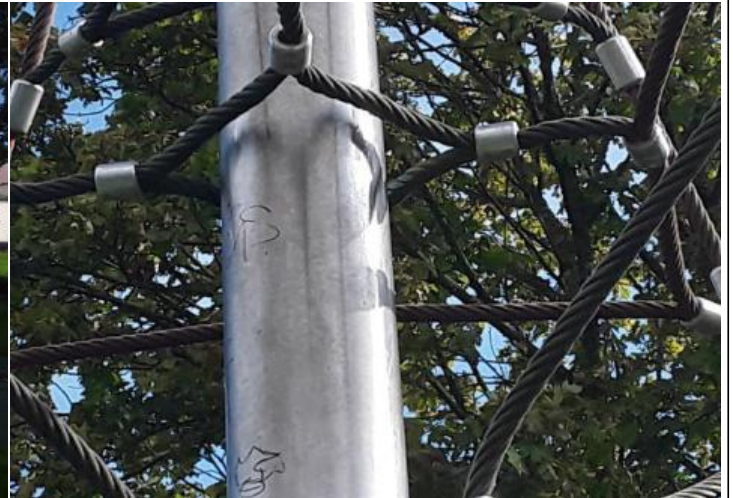
**Finding:** The ropes/nets are worn/damaged in places

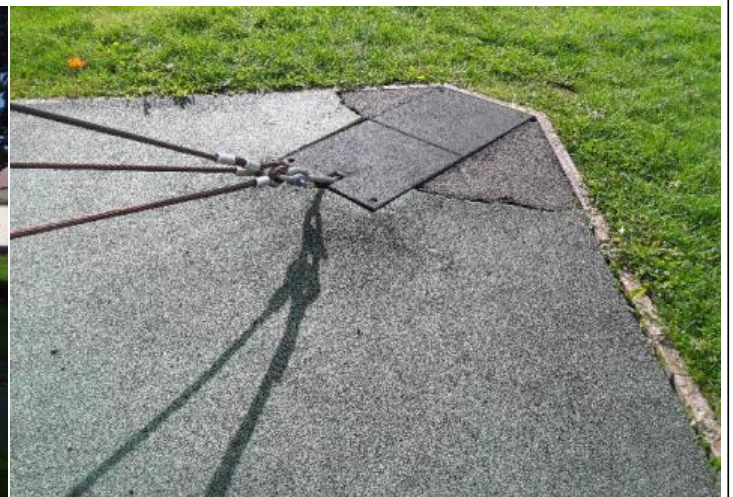
**Finding:** The surface has subsided creating unforeseen changes in levels adjacent to one inspection chamber

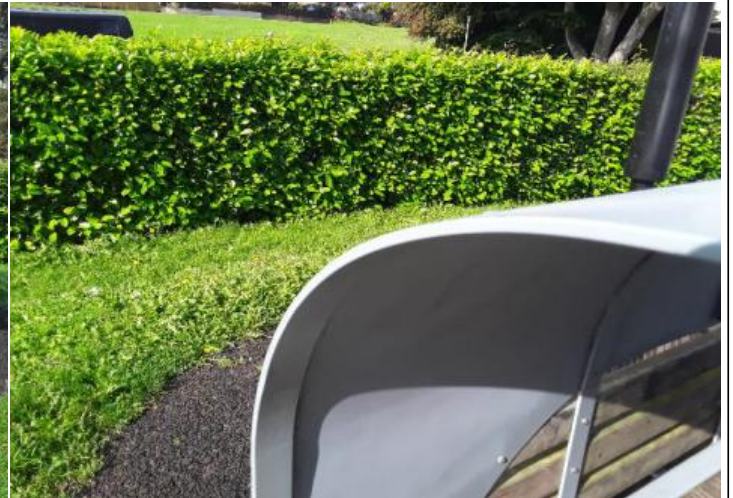
**Finding:** The item has exposed edges and corners with a radius of less than 3mm and fails the requirements of BS EN 1176  
**Action:** Provide a 3mm radius to all exposed edges and corners

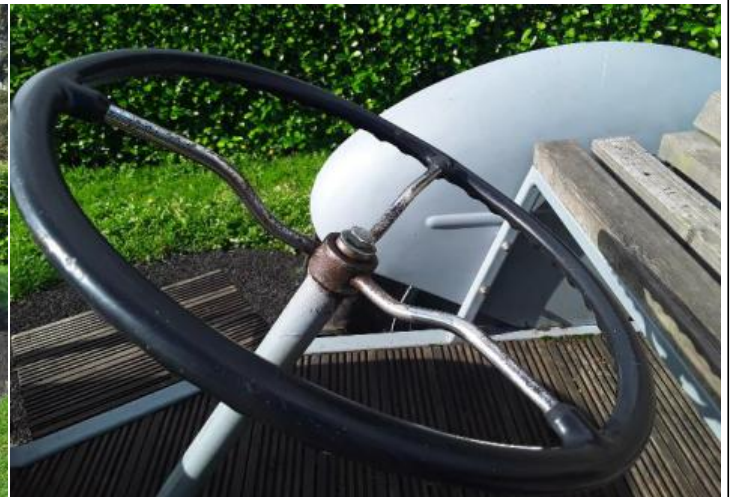
**Finding:** A number of fixing(s) have worked loose on the steering wheel  
**Action:** Secure all loose fixings
