NOTICE IS GIVEN THAT A SERVICES, PROPERTY AND OUTDOOR SPACES COMMITTEE OF  
CULLOMPTON TOWN COUNCIL  
WILL BE HELD AT THE TOWN HALL, CULLOMPTON  
ON THURSDAY, 9<sup>th</sup> NOVEMBER 2023 AT 7PM

**MINUTES OF MEETING OF THE SERVICES, PROPERTY AND OUTDOOR SPACES COMMITTEE  
DATED TUESDAY 12 SEPTEMBER 2023 AT 7:00PM AT CULLOMPTON TOWN HALL**

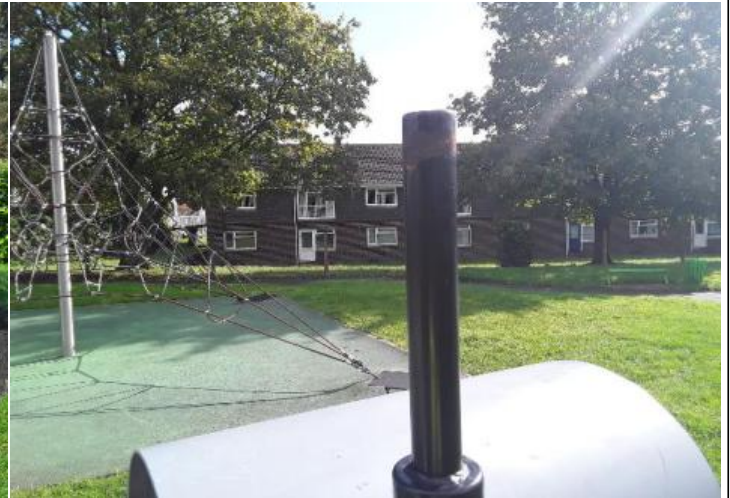
**Finding:** The paintwork on this item has been damaged or worn exposing the metal underneath which is rusting / corroding

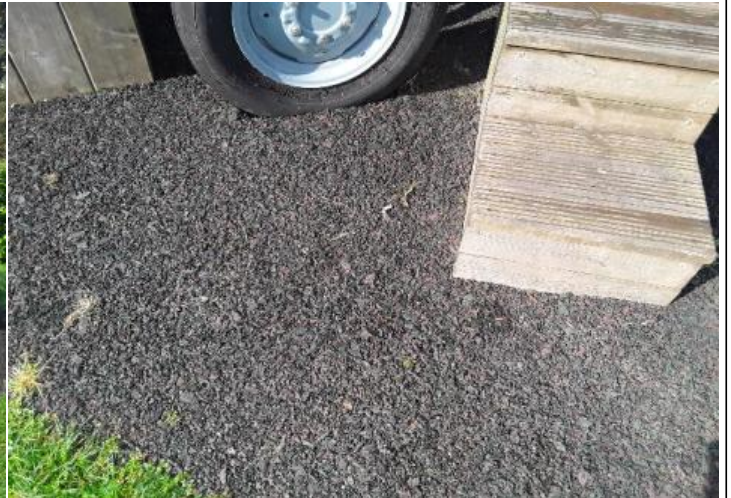
**Finding:** The surface has subsided in some areas

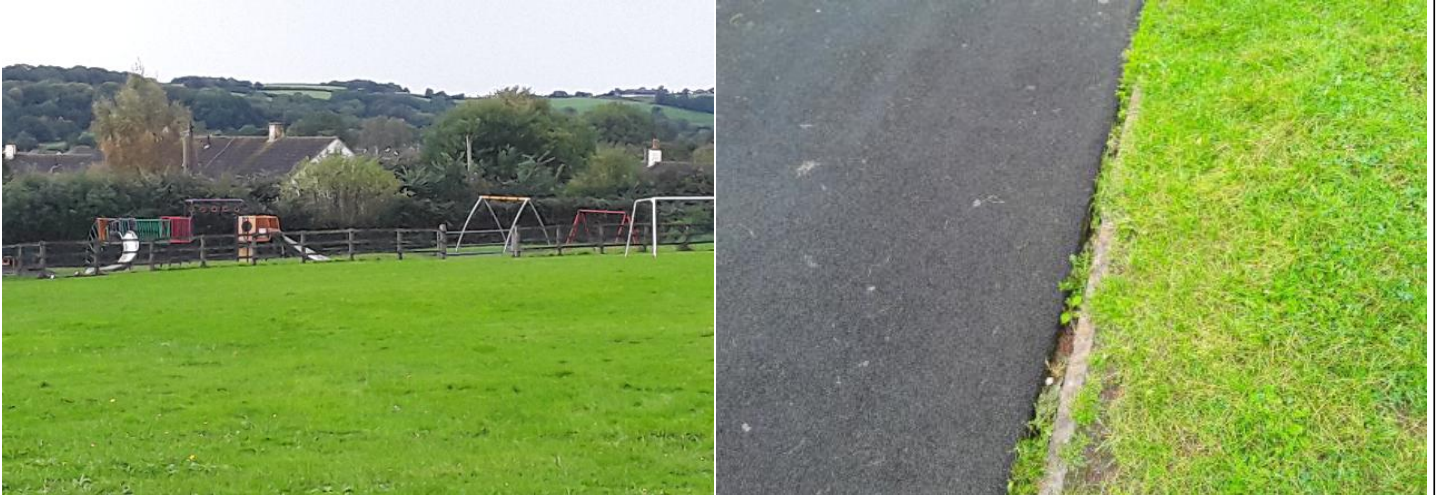
**Finding:** There are significant gaps (over 30mm) between the surface and the edging or between the joints in the surface; these are large enough for a small foot to enter

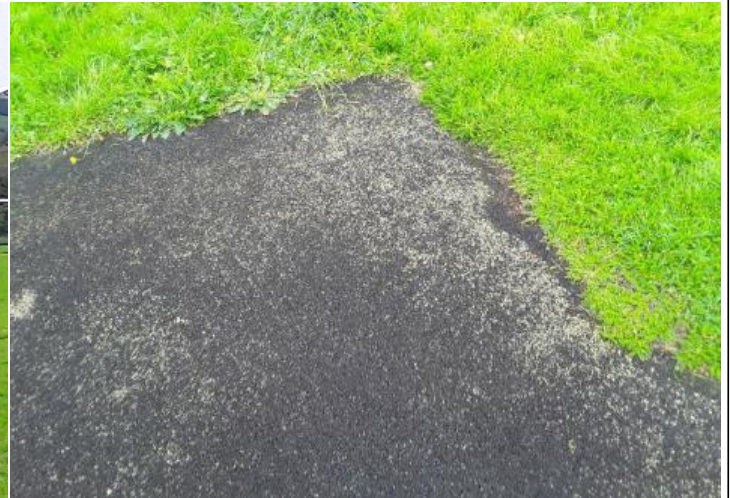
**Finding:** There is algae, silt or moss growth on the surface resulting in slippery conditions

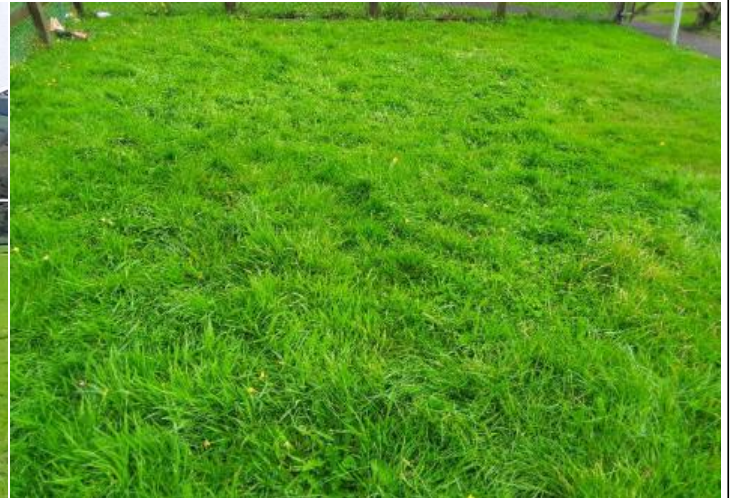
**Finding:** The grass is overgrown within the play area and may hide hazards

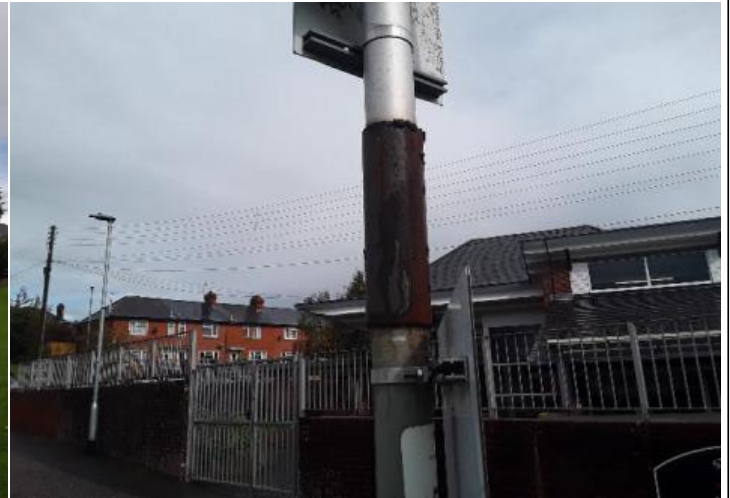
**Finding:** The paintwork on the extension sleeve has been damaged or worn exposing the metal underneath which is rusting / corroding

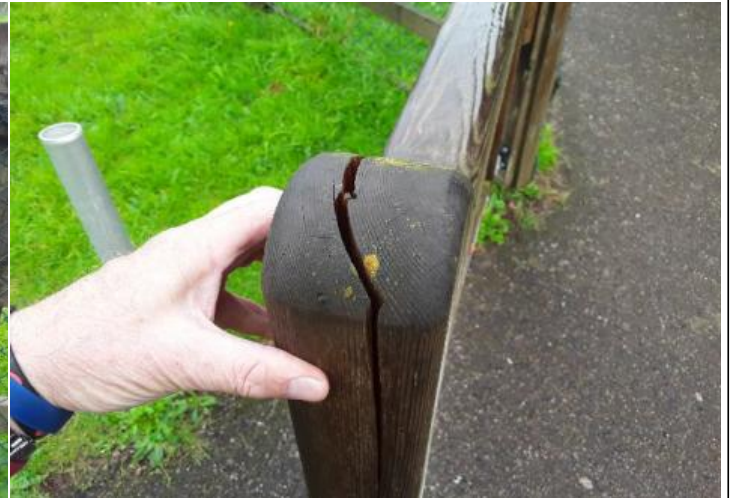
**Finding:** The timber has a number of splits/shakes or air cracks and this may affect the stability or allow water ingress which will accelerate the rotting process  
**Action:** Monitor to ensure the splits do not cross through fixing points of the structure and/or cause any instability

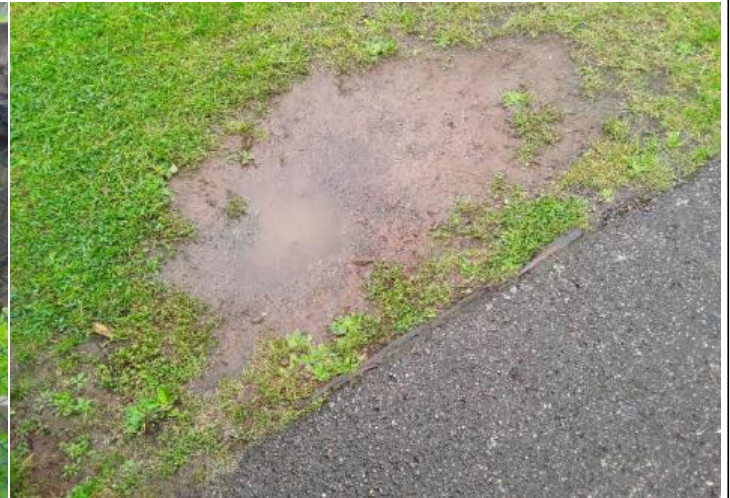
**Finding:** The surface has eroded adjacent to the gate creating trip hazards and may become slippery in wet conditions

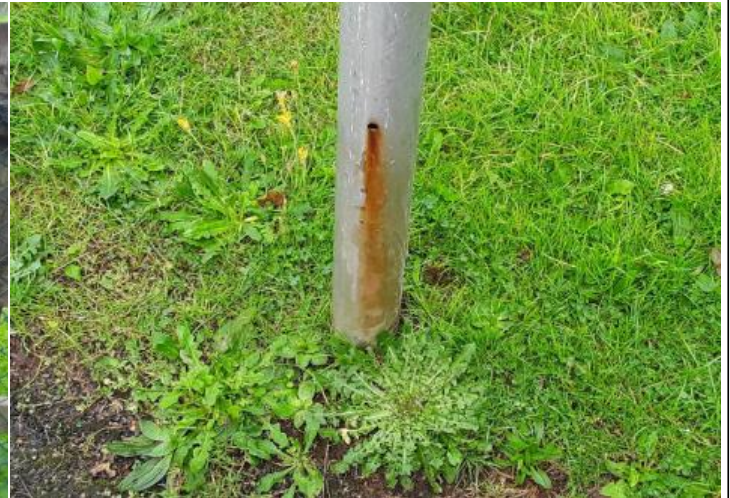
**Finding:** Holes have been drilled into the tube to release captured water. The metal has started to corrode

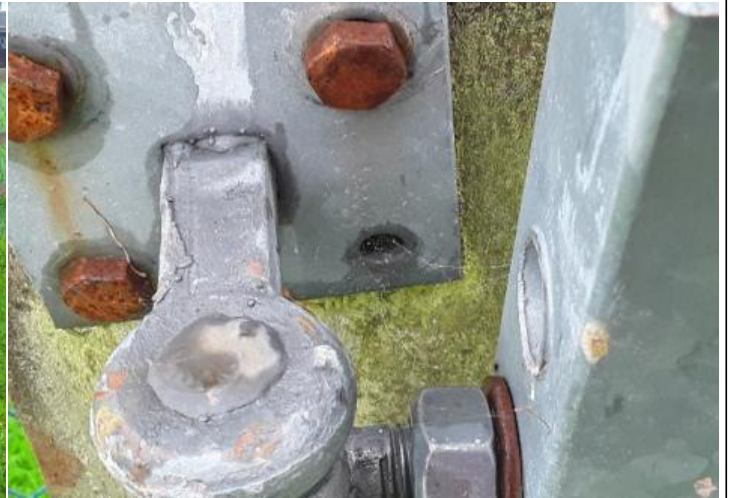
**Finding:** There is or are fixings missing on the item

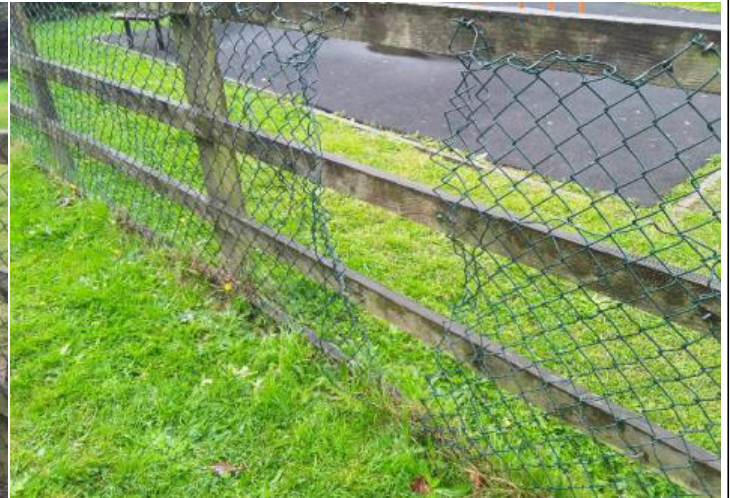
**Finding:** The fence mesh is severely damaged in places

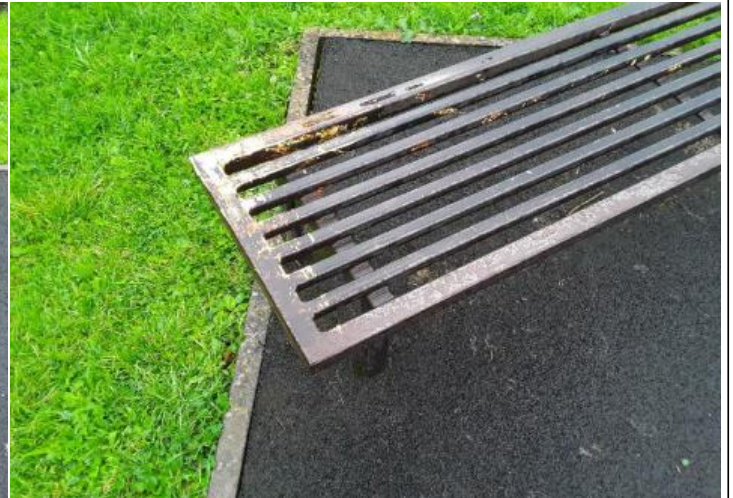
**Finding:** There is surface corrosion / rust present on the item

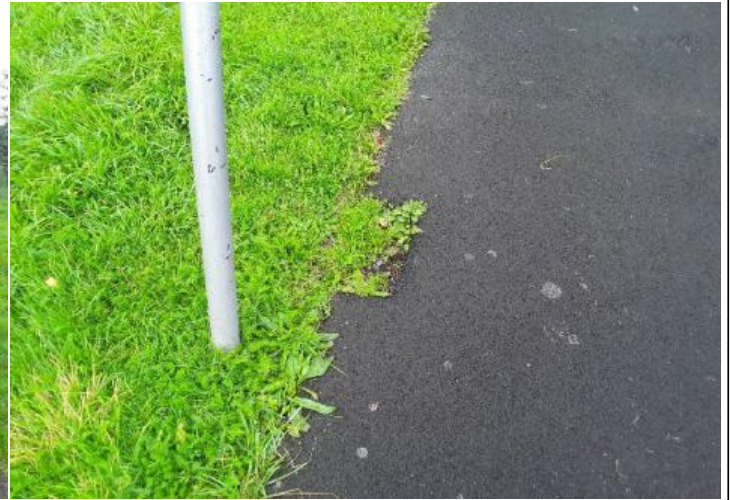
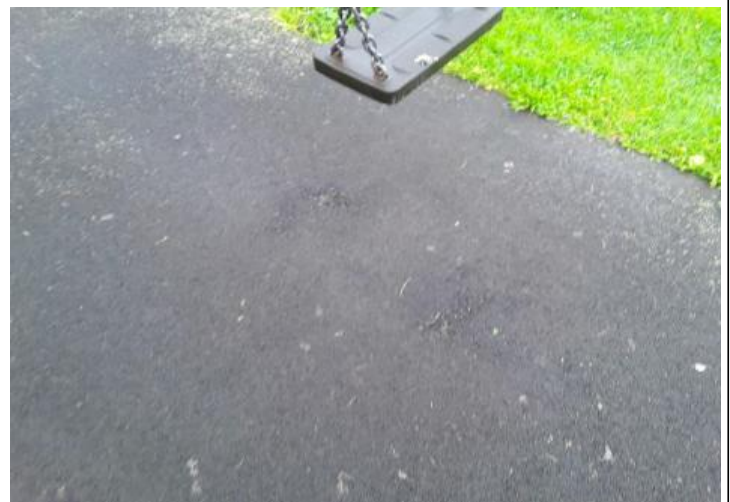
**Finding:** There is damage to the surface

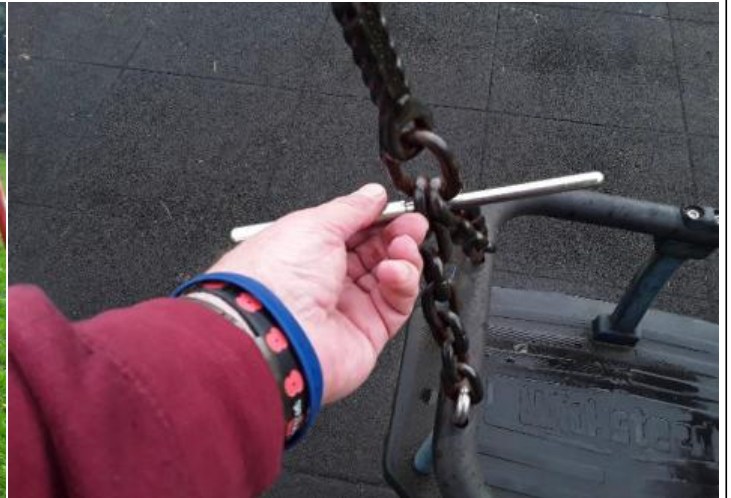
**Finding:** The chain openings are in excess of the 8.6mm as recommended by BS EN 1176 **Action:** Monitor - No remedial work recommended

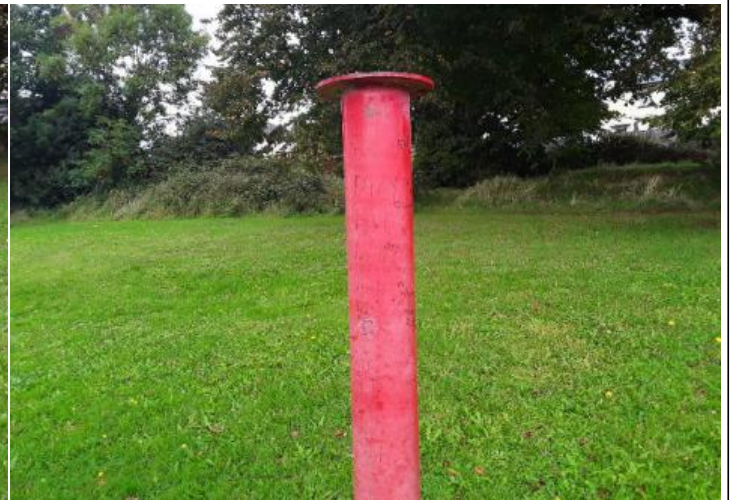
**Finding:** The top section has been removed  
**Action:** Replace the missing components or remove the item completely
