NOTICE IS GIVEN THAT A SERVICES, PROPERTY AND OUTDOOR SPACES COMMITTEE OF  
CULLOMPTON TOWN COUNCIL  
WILL BE HELD AT THE TOWN HALL, CULLOMPTON  
ON THURSDAY, 9<sup>th</sup> NOVEMBER 2023 AT 7PM

**MINUTES OF MEETING OF THE SERVICES, PROPERTY AND OUTDOOR SPACES COMMITTEE  
DATED TUESDAY 12 SEPTEMBER 2023 AT 7:00PM AT CULLOMPTON TOWN HALL**

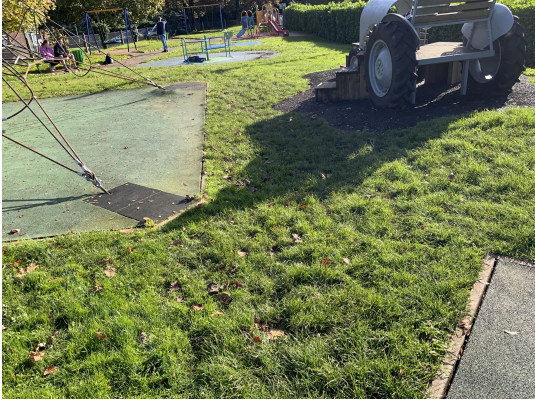
1

- Investigate the subsidence at Tuffti park which seems to be rather extensive. I would recommend a short daily visual inspection to ensure no significant changes have occurred along with the weekly documented park checks. It is concerning that a large circa 1m wide and deep hole appeared as it sank into the ground, the surface under the climbing frame is now out of shape and the ground under the tractor is evidently lower as all 4 tyres are off the ground. Any further rapid or substantial changes such as this should result in closing and fencing off this part of the park until further investigations have been completed. [Please refer to photograph 1]

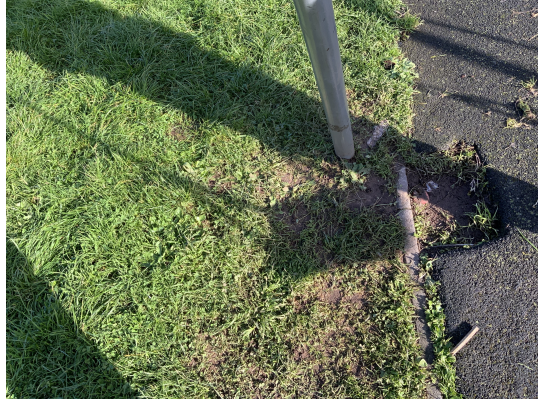
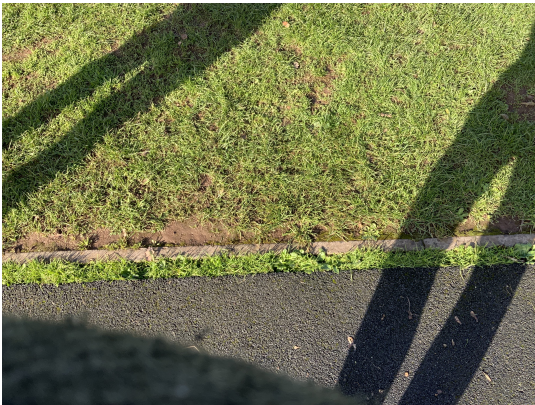
- Repair the shrunken edges of the park safety flooring. [Please refer to photographs 2 and 3]
- Add in any additional hazards to the play park inspection app such as manhole covers, drain covers, furniture etc so that a documented check is performed and recorded. [Please refer to photograph 4]

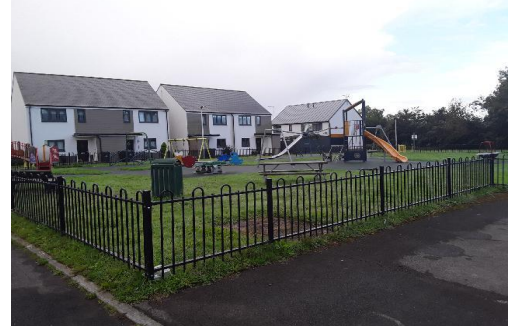
The grass is overgrown within the play area and may hide hazards - Reduce the length of grass to an acceptable height and maintain

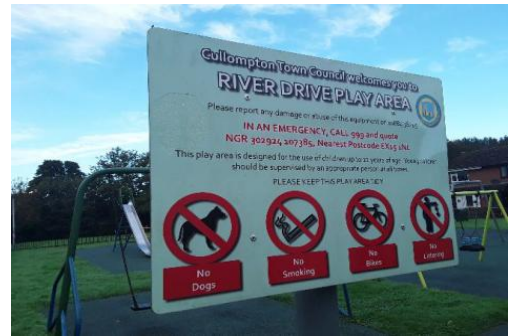
The site name (Culm Lea) does not match the name on the site sign, the report will be headed Culm Lea and may cause some confusion - Consider amending the site name to match the sign and location

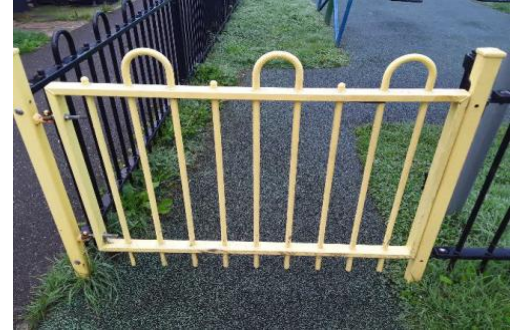
The paintwork on this item has been damaged or worn exposing the metal underneath which is rusting / corroding - Treat affected areas and repaint

The gate latches are broken and the gates pass the slamming plates - Replace the damaged latches

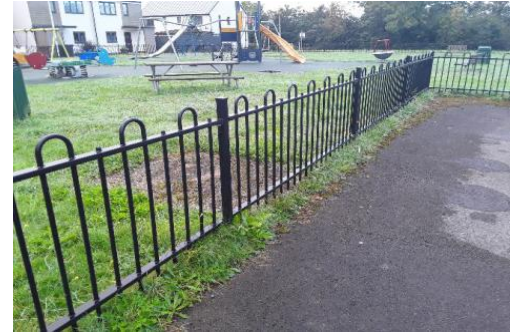
A number of fixings have worked loose around the fencing - Secure all loose fixings

There is some damage to the fence sections - Monitor for any further deterioration and repair as required

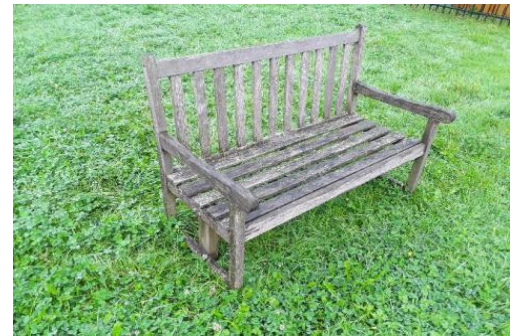
The middle timber seat brace has been damaged / removed - Replace the brace

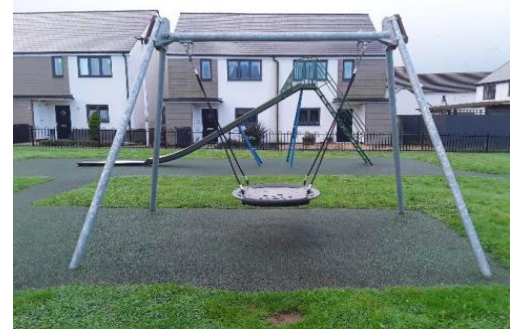
The grass has eroded within the impact area of the equipment and may not provide the necessary impact attenuating properties for the equipment fall height; the surface may also be slippery in wet weather - Reinstate the grass or provide an all weather surface

The shackle securing the safety chain to the suspension chain has been removed - Replace the missing shackle

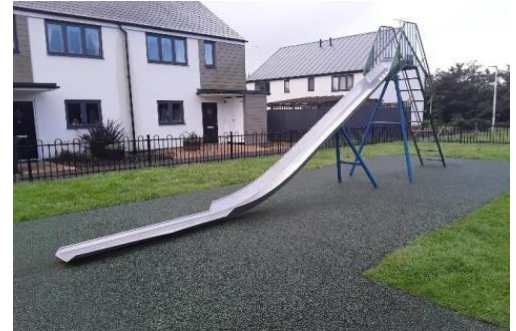
The side of the slide is damaged - Monitor for any further deterioration and repair as required

The item fails to meet the requirements of BS EN 1176 Part 1 4.2.7.2 head and neck entrapment in the barriers and/or steps - Monitor - No remedial work recommended

There are a number of dents in the slide surface - Monitor for any further deterioration and repair as required

There is surface corrosion / rust present on the item - Consider treating the item

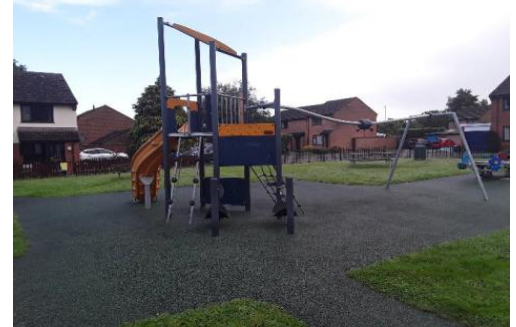
The mono rail traveller pull rope has been replaced with a boot lace - Provide the correct component

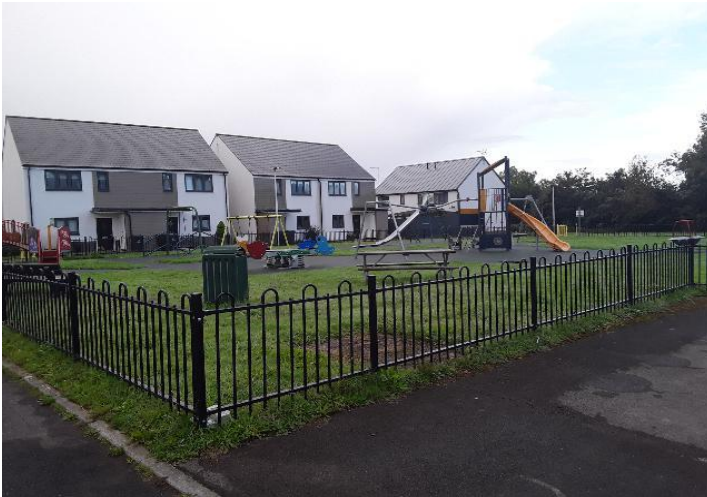
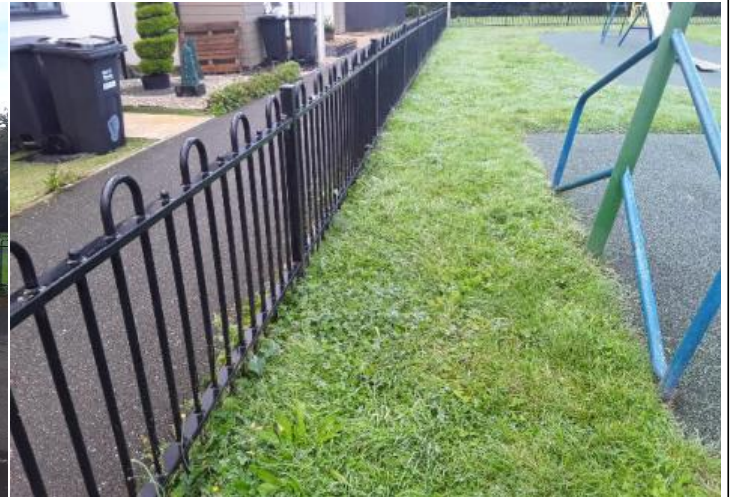
**Finding:** The grass is overgrown within the play area and may hide hazards

**Action:** Reduce the length of grass to an acceptable height and maintain

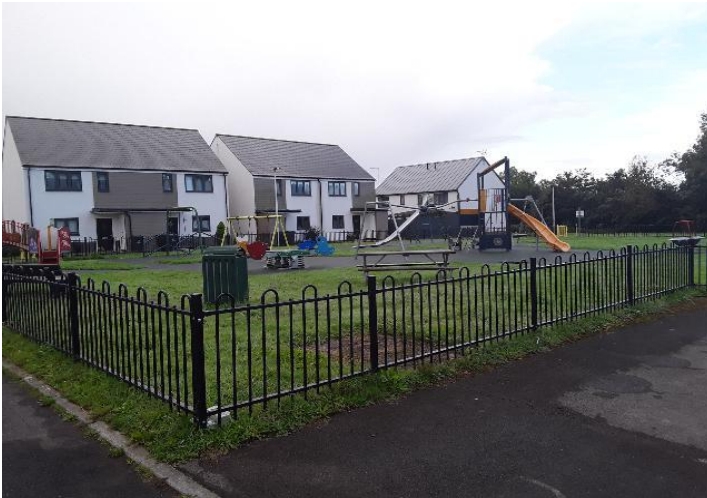
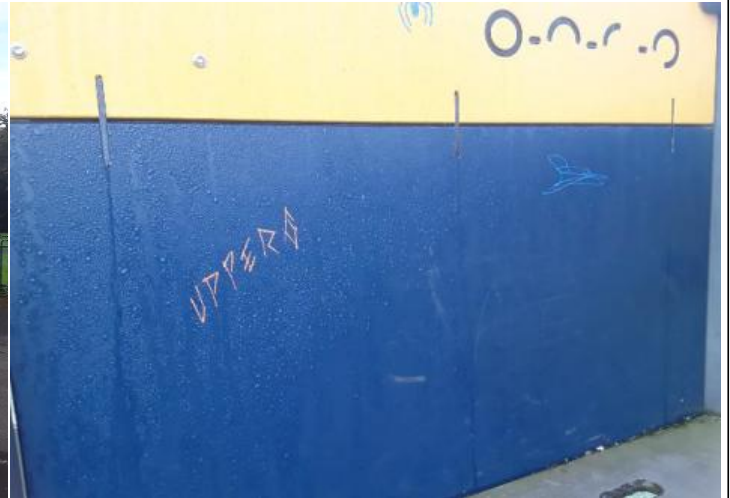
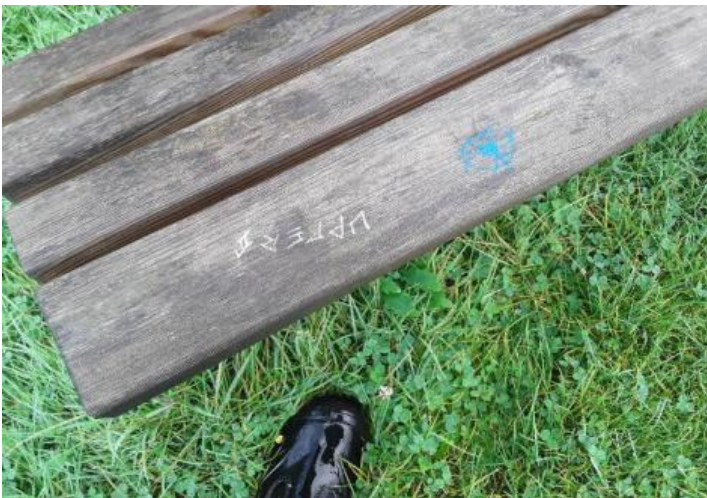
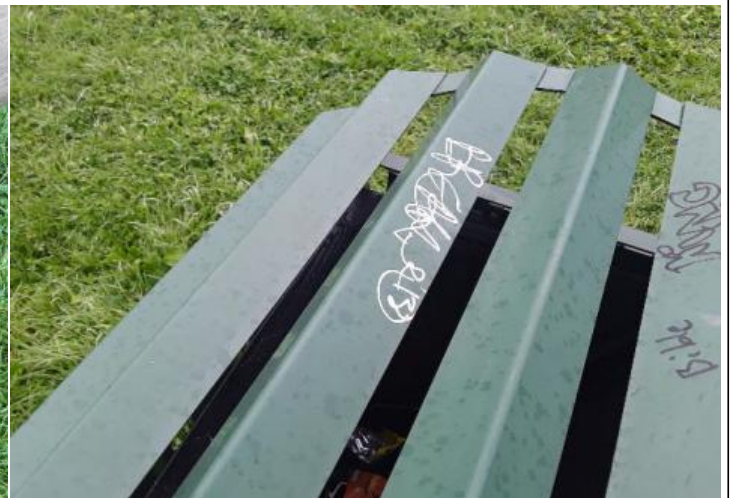
**Finding:** There is some graffiti present

**Action:** Remove the graffiti

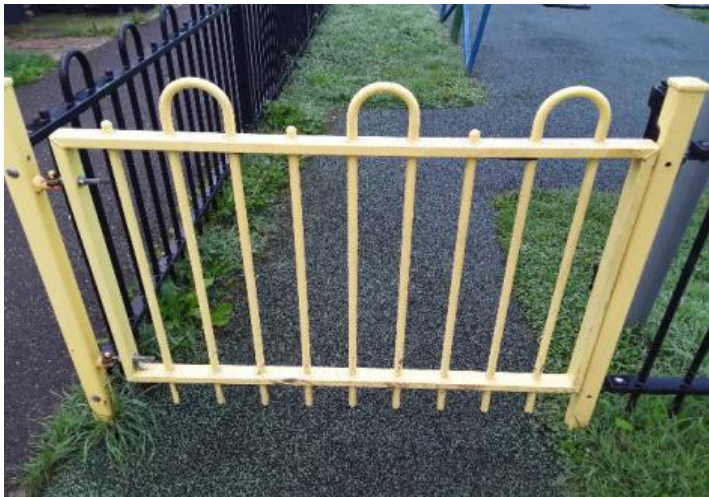
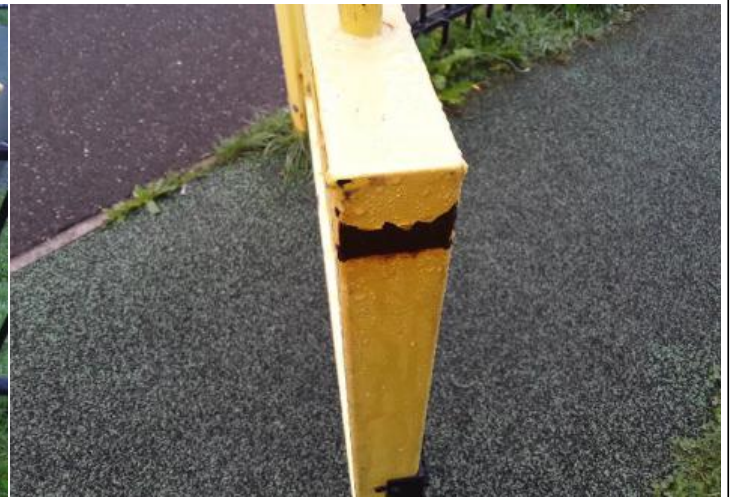
**Item:** Gates - Gate - Pedestrian  
**Manufacturer:** Not Identified

**Finding:** The paintwork on this item has been damaged or worn exposing the metal underneath which is rusting / corroding

**Action:** Treat affected areas and repaint

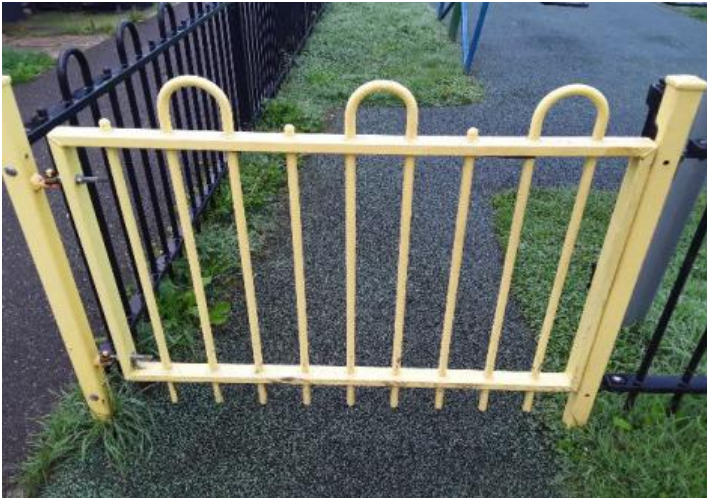
**Item:** Gates - Gate - Pedestrian  
**Manufacturer:** Not Identified

**Finding:** The gate latches are broken and the gates pass the slamming plates

**Action:** Replace the damaged latches

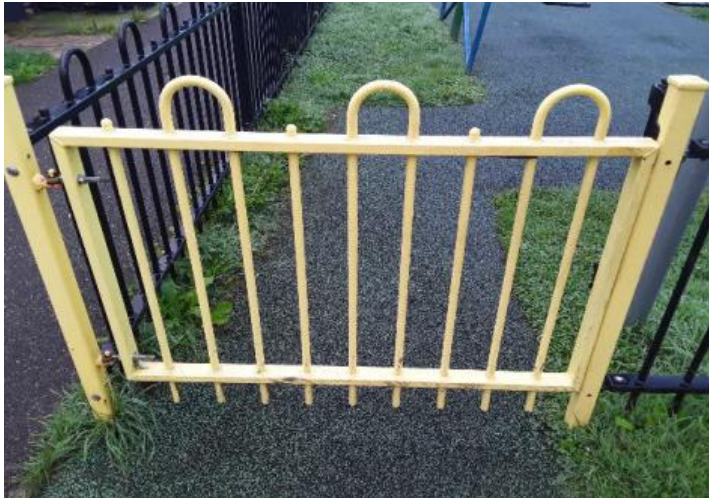
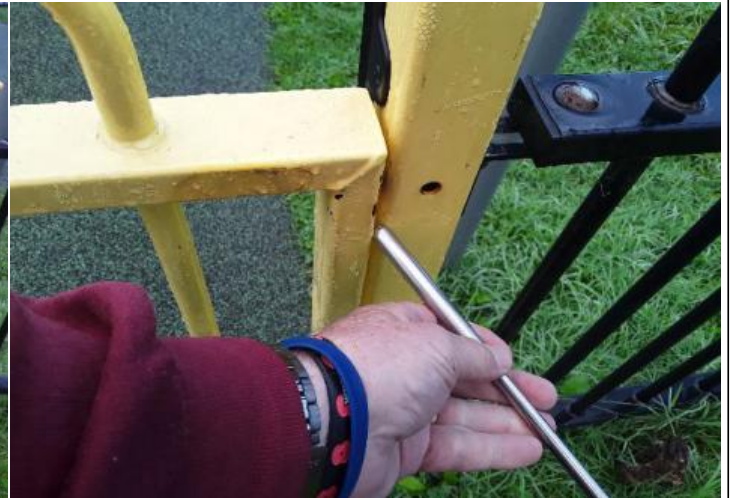
**Item:** Gates - Gate - Pedestrian  
**Manufacturer:** Not Identified

**Finding:** There are openings that are less than 12mm that could trap or crush fingers

**Action:** Provide a 12mm gap throughout full range of motion at both sides of gate

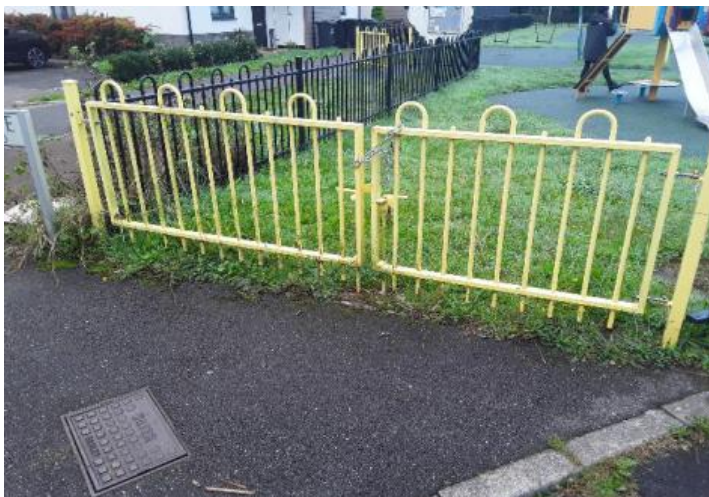
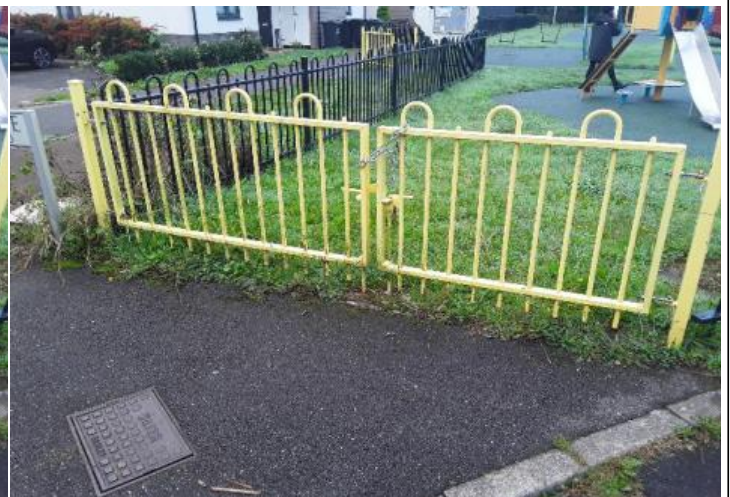
**Item:** Gates - Gate - Maintenance  
**Manufacturer:** Not Identified

**Finding:** The maintenance gate was correctly padlocked at the time of inspection, however this means that the inspector was unable to fully assess the gate

**Action:** Ensure that there are 12mm gaps throughout the full range of motion on gate/s and between leaves where relevant

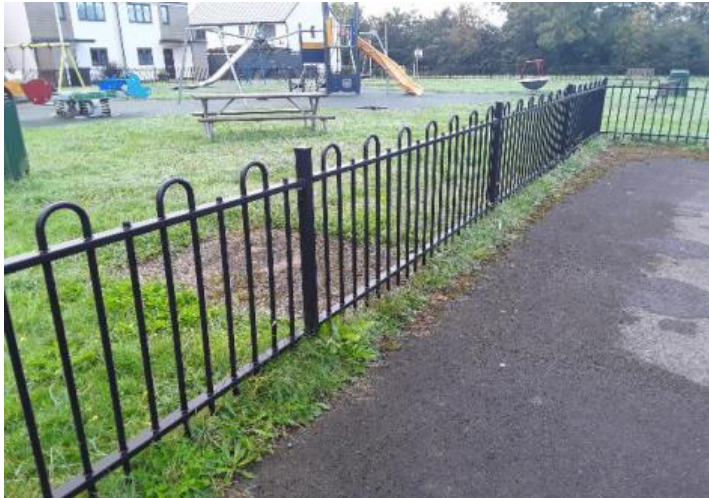
**Item:** Fences - Fence - Bow Top  
**Manufacturer:** Jacksons Fencing

**Finding:** A number of fixings have worked loose around the fencing  
**Action:** Secure all loose fixings

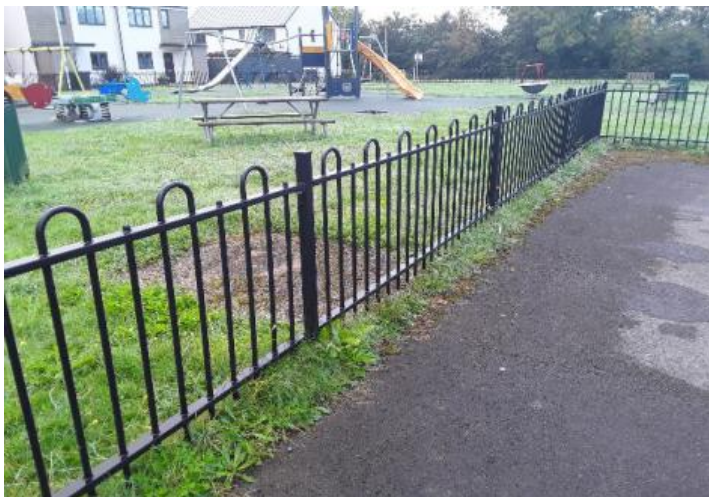
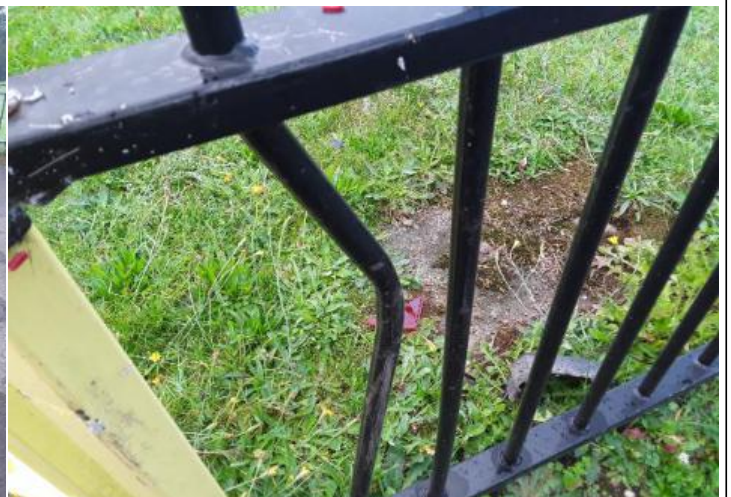
**Item:** Fences - Fence - Bow Top  
**Manufacturer:** Jacksons Fencing

**Finding:** There is some damage to the fence sections  
**Action:** Monitor for any further deterioration and repair as required

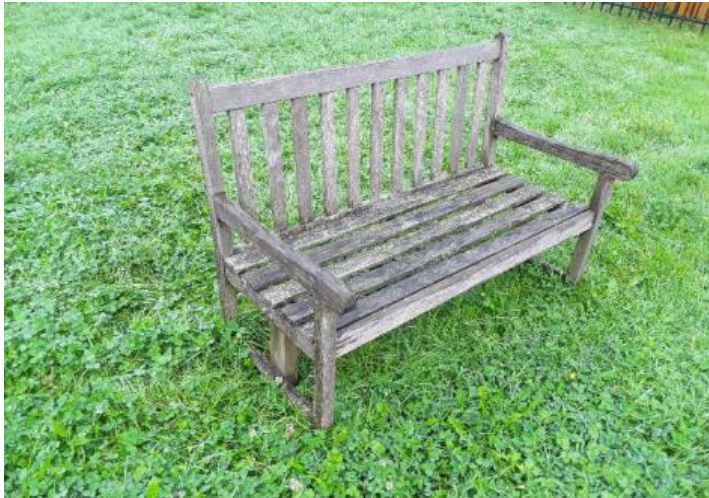
**Item:** Ancillary Items - Bench  
**Manufacturer:** Not Identified

**Finding:** The middle timber seat brace has been damaged / removed  
**Action:** Replace the brace

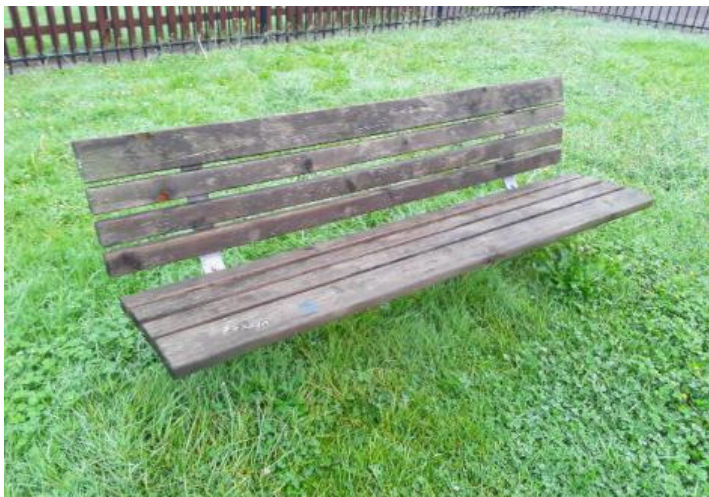
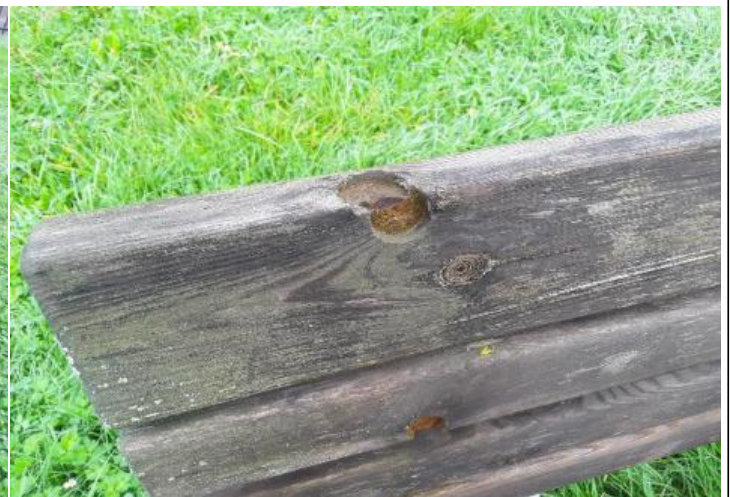
**Item:** Ancillary Items - Bench  
**Manufacturer:** Not Identified

**Finding:** Parts of the timber are rough or splintered  
**Action:** Remove all rough or sharp edges

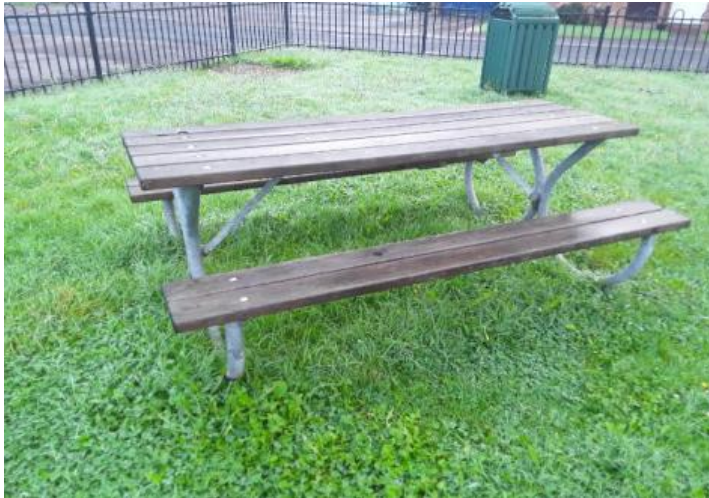
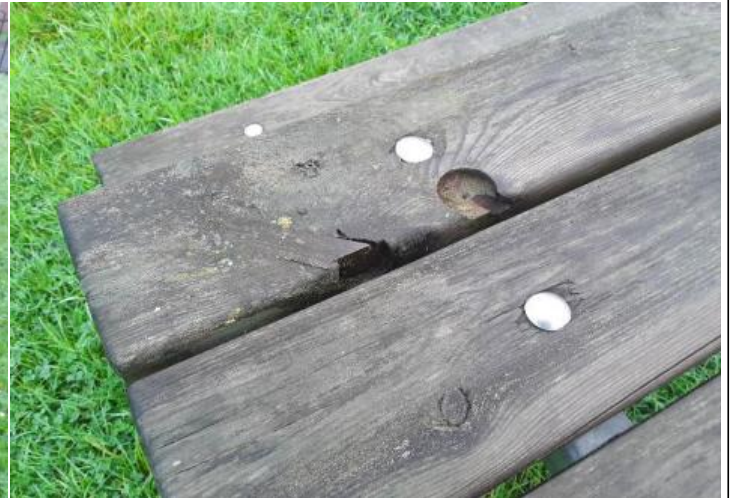
**Item:** Ancillary Items - Picnic Table  
**Manufacturer:** Not Identified

**Finding:** Parts of the timber are rough or splintered

**Action:** Remove all rough or sharp edges

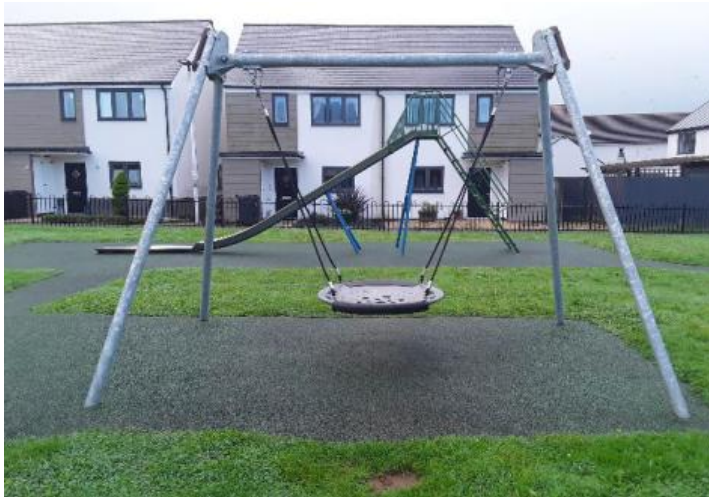
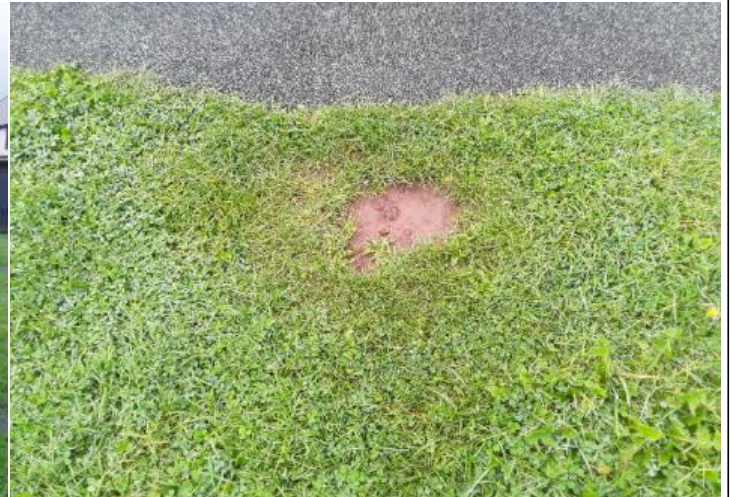
**Item:** Swings - Basket Swing - Type 1  
**Manufacturer:** Kompan Ltd

**Finding:** The grass has eroded within the impact area of the equipment and may not provide the necessary impact attenuating properties for the equipment fall height; the surface may also be slippery in wet weather

**Action:** Reinstate the grass or provide an all weather surface

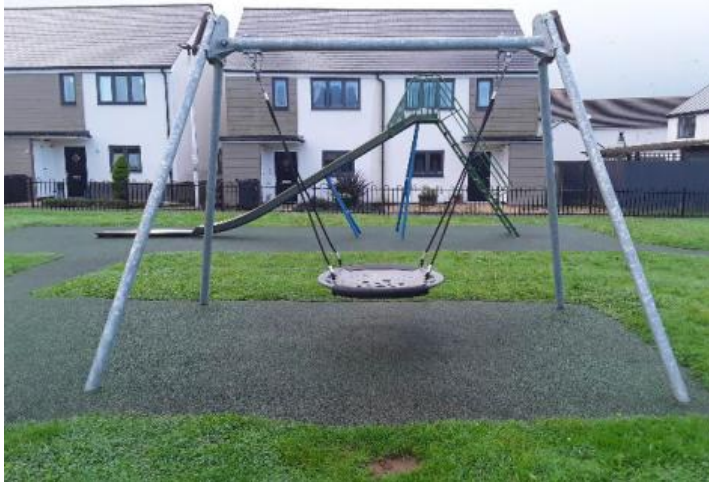
**Item:** Swings - Basket Swing - Type 1  
**Manufacturer:** Kompan Ltd

**Finding:** The shackle securing the safety chain to the suspension chain has been removed

**Action:** Replace the missing shackle

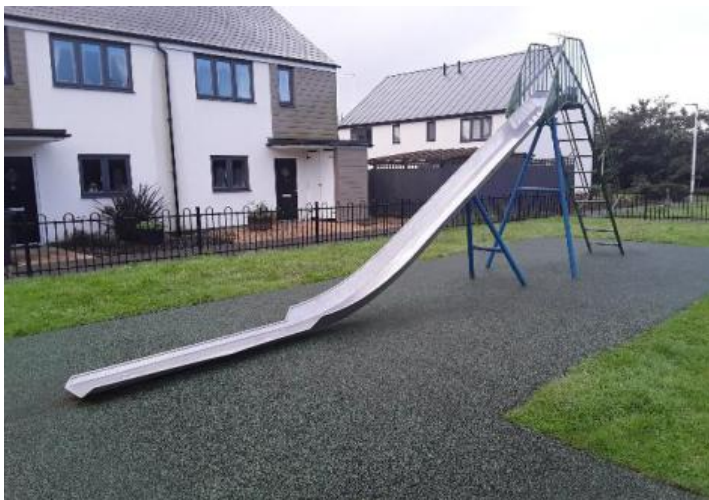
**Item:** Other - Free Standing Slide  
**Manufacturer:** Levercrest

**Finding:** The side of the slide is damaged

**Action:** Monitor for any further deterioration and repair as required

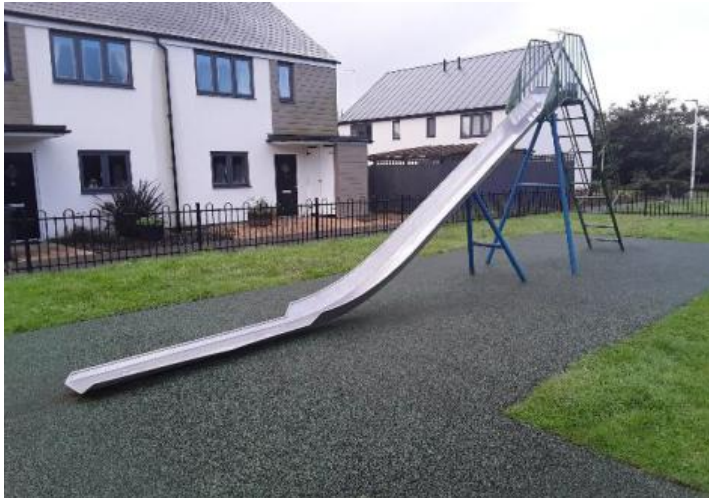
**Item:** Other - Free Standing Slide  
**Manufacturer:** Levercrest

**Finding:** There are a number of dents in the slide surface

**Action:** Monitor for any further deterioration and repair as required

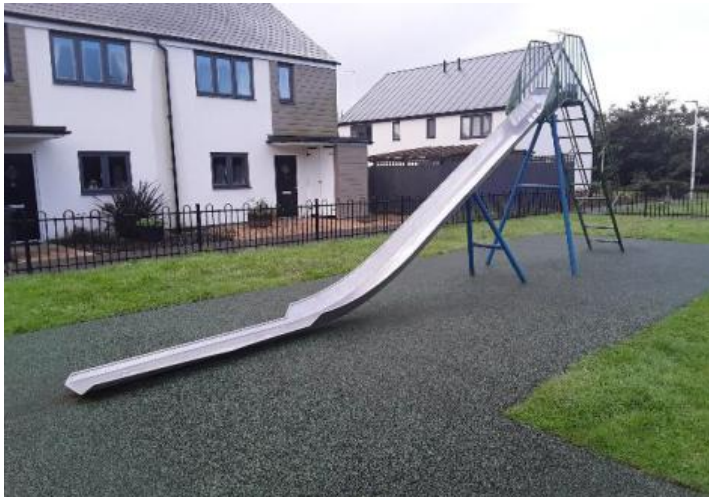
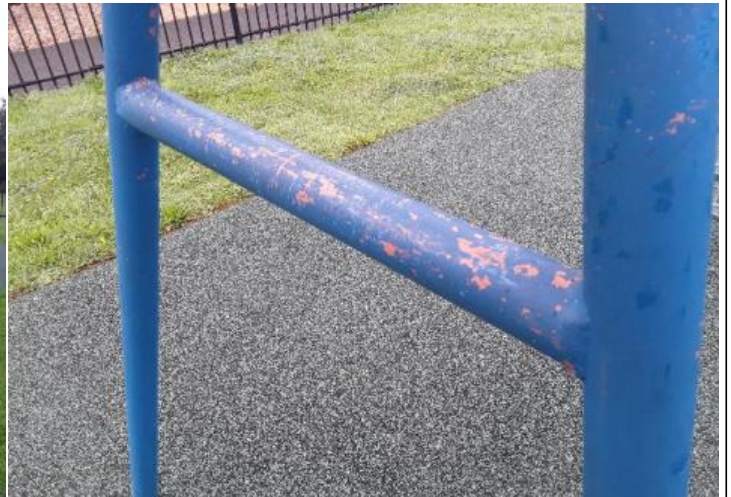
**Item:** Other - Free Standing Slide  
**Manufacturer:** Levercrest

**Finding:** The paint is flaking off the metalwork

**Action:** Rub down and re-paint

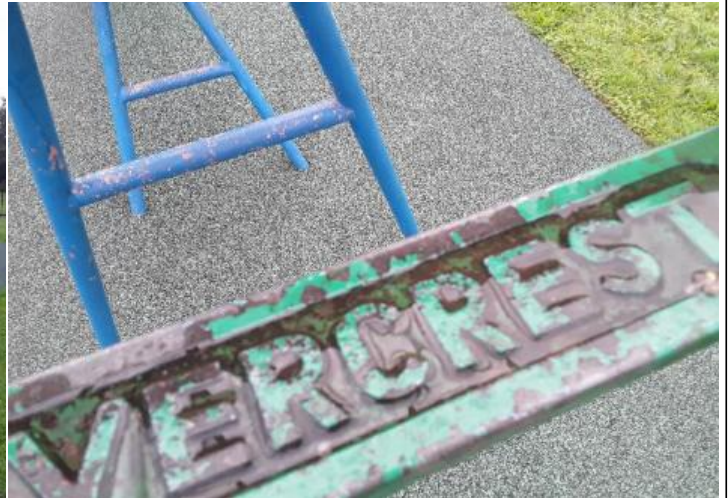
**Item:** Other - Free Standing Slide  
**Manufacturer:** Levercrest

**Finding:** There is surface corrosion / rust present on the item

**Action:** Consider treating the item

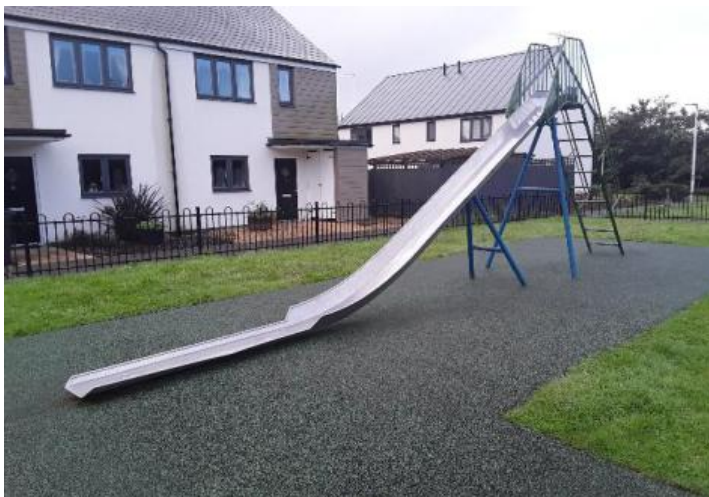
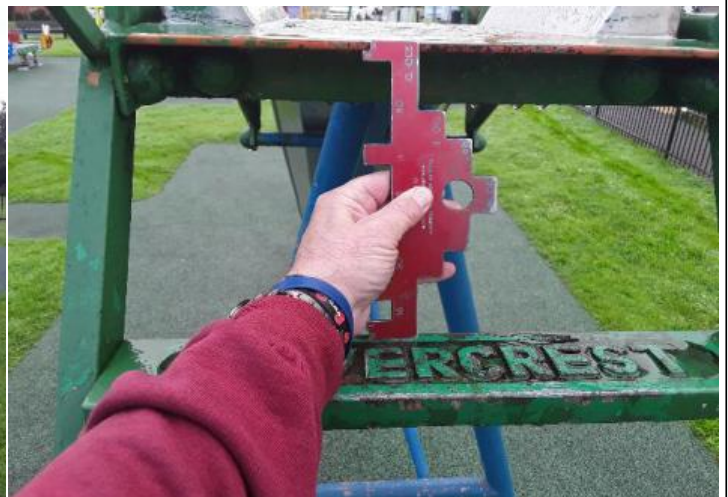
**Item:** Other - Free Standing Slide  
**Manufacturer:** Levercrest

**Finding:** The item fails to meet the requirements of BS EN 1176 Part 1 4.2.7.2 head and neck entrapment in the barriers and/or steps

**Action:** Monitor - No remedial work recommended

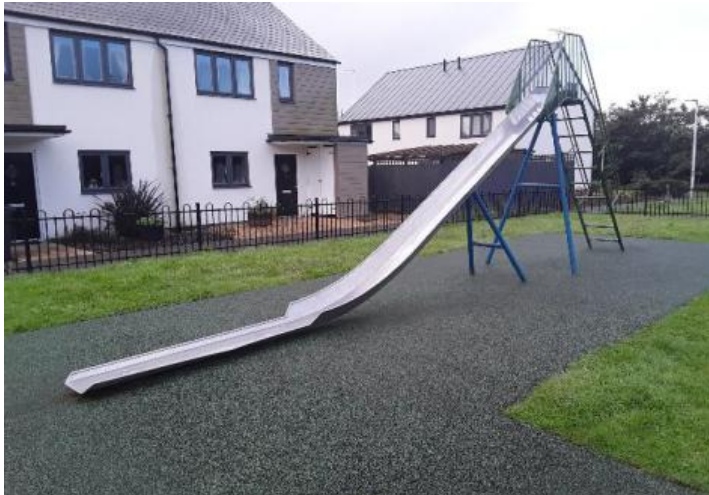
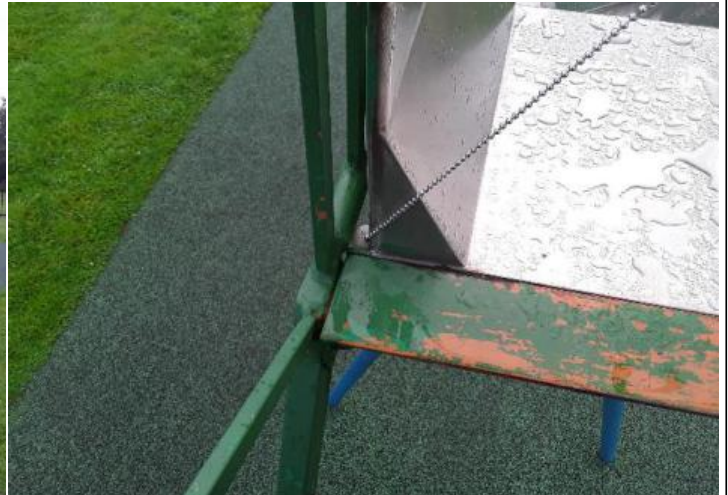
There is / are toggle entrapment/s present in contravention of the recommendations set out in BS EN 1176 Part 3 - Monitor - no remedial work recommended

**Item:** Other - Free Standing Slide  
**Manufacturer:** Levercrest

**Finding:** There is / are toggle entrapment/s present in contravention of the recommendations set out in BS EN 1176 Part 3

**Action:** Monitor - no remedial work recommended

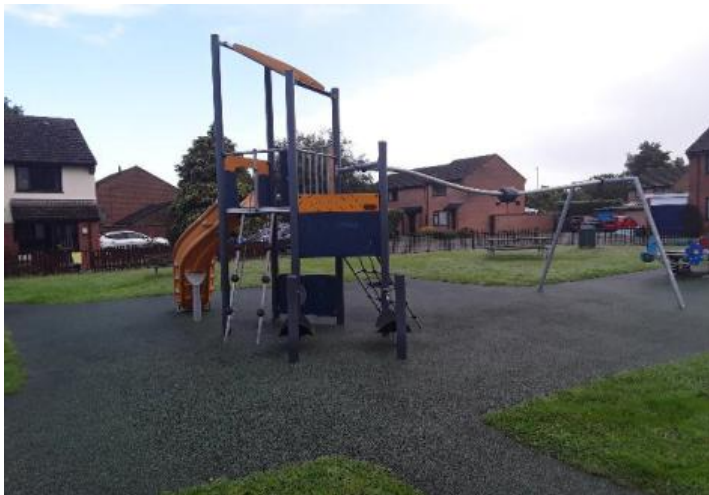
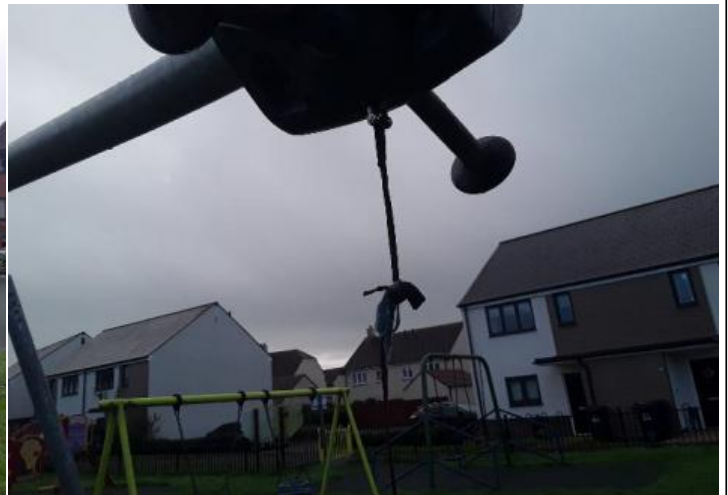
**Item:** Activity Equipment - Multi Play (Junior)  
**Manufacturer:** Kompan Ltd

**Finding:** The mono rail traveller pull rope has been replaced with a boot lace **Action:** Provide the correct component

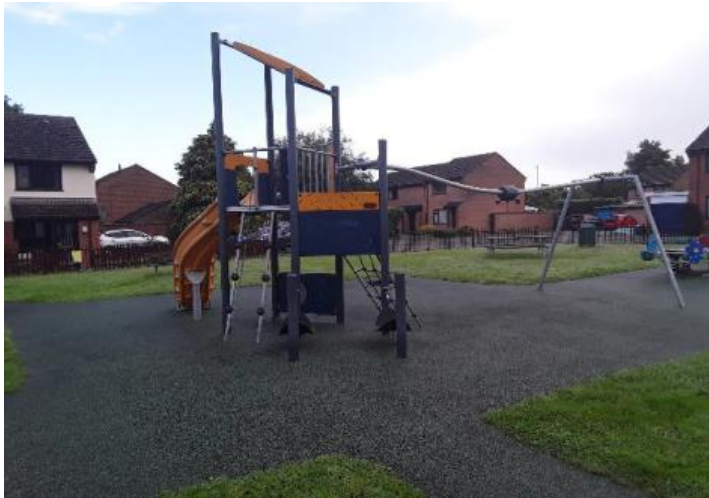
There is or are fixings missing on the cargo net - Replace all missing fixings

**Item:** Activity Equipment - Multi Play (Junior)  
**Manufacturer:** Kompan Ltd

**Finding:** There is or are fixings missing on the cargo net

**Action:** Replace all missing fixings

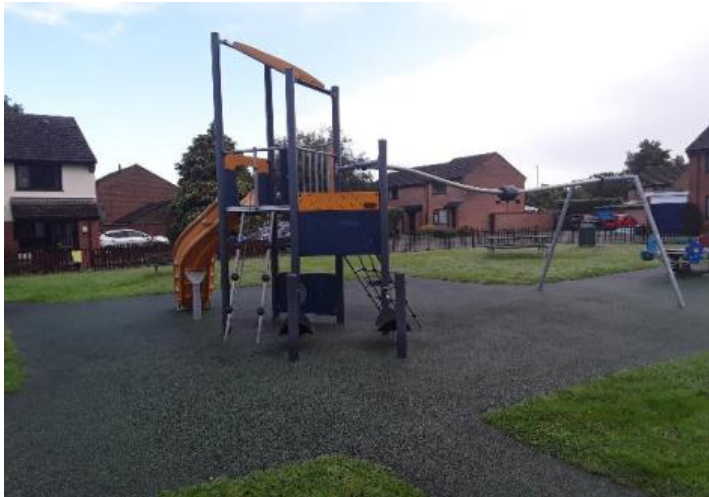
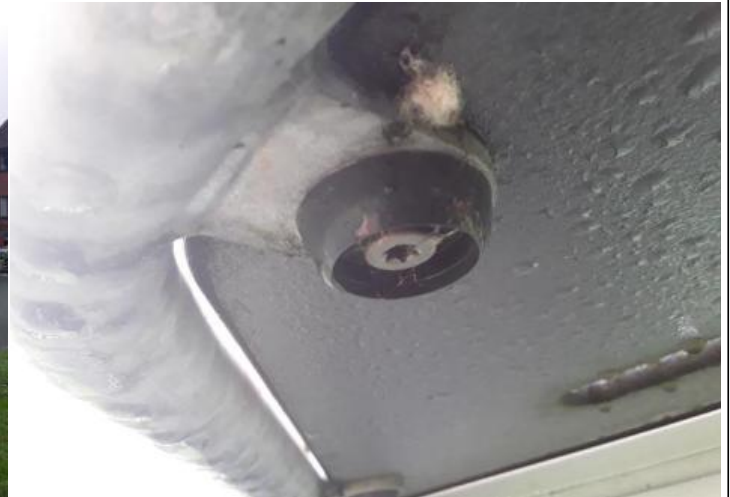
There is/are bolt cap covers missing or damaged on the item - Replace missing or damaged bolt cap covers

**Item:** Activity Equipment - Multi Play (Junior)  
**Manufacturer:** Kompan Ltd

**Finding:** There is/are bolt cap covers missing or damaged on the item

**Action:** Replace missing or damaged bolt cap covers

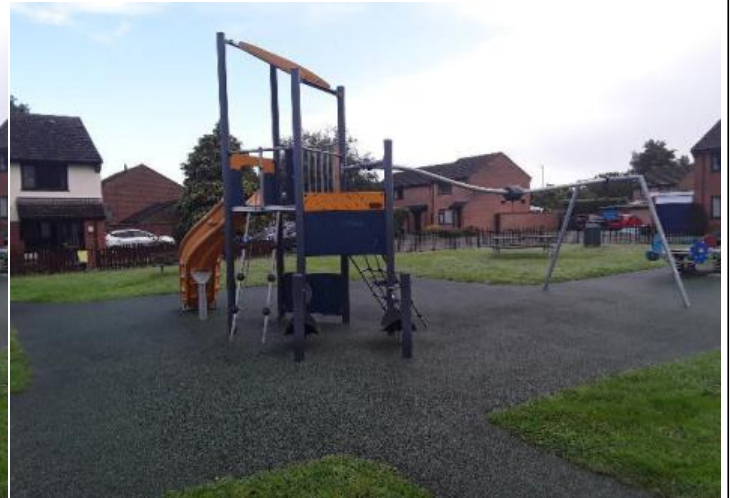
**Item:** Activity Equipment - Multi Play (Junior)  
**Manufacturer:** Kompan Ltd

**Finding:** The height of the guardrail to the mono rail exceeds the maximum 850mm required by BS EN 1176 Part 1. We note however, that this is an intentional design feature to allow easier access onto the overhead glide and is supported by a Kompan design risk assessment

**Action:** Refer to manufacturer design risk assessment

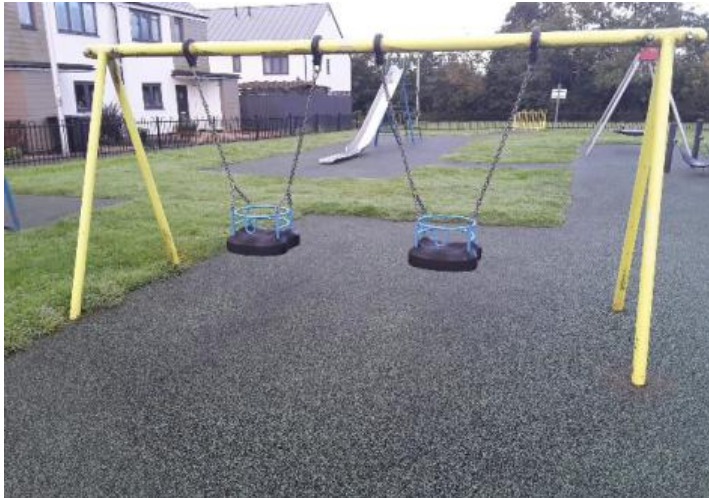
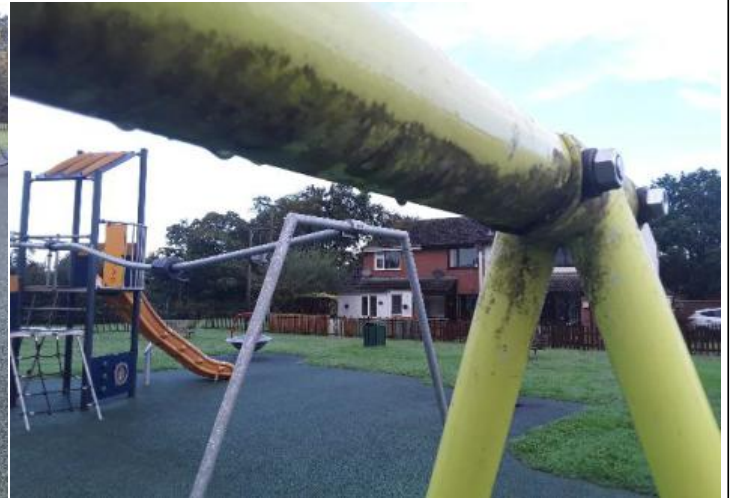
**Item:** Swings - 1 Bay 2 Seat (Cradle)  
**Manufacturer:** SMP

**Finding:** There is algae or moss on the surface of the equipment

**Action:** Clean and treat appropriately

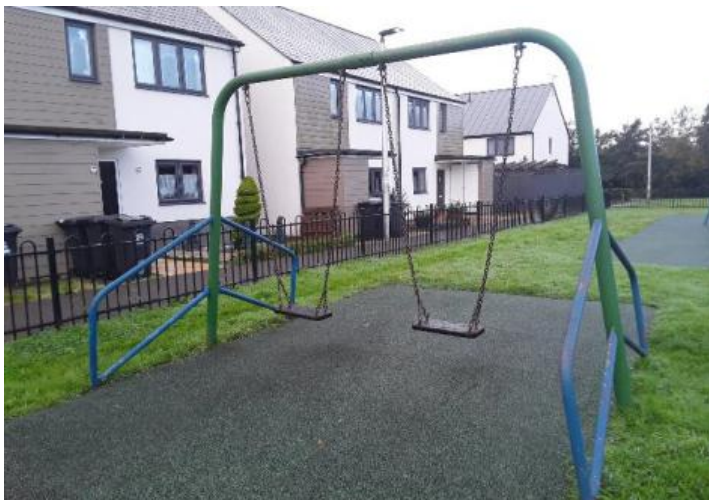
The seat has minor damage or wear - Monitor for any further deterioration and replace as required

**Item:** Swings - 1 Bay 2 Seat (Flat)  
**Manufacturer:** Record RSS

**Finding:** The seat has minor damage or wear

**Action:** Monitor for any further deterioration and replace as required

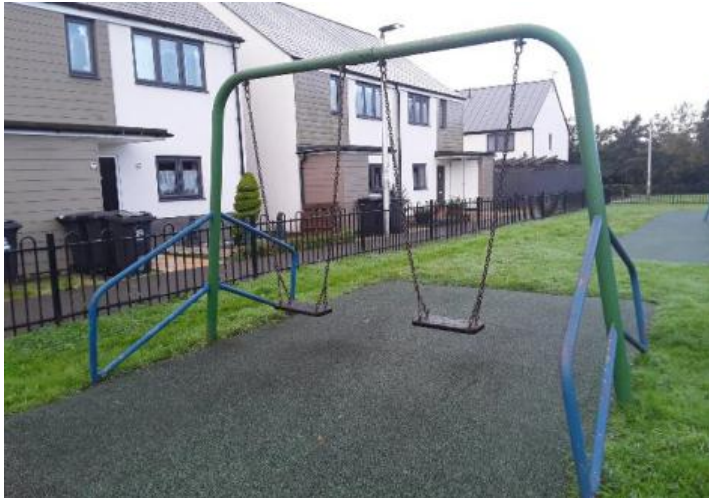
There is some wear to the shackles. - Monitor for any further deterioration and replace when 40% worn

**Item:** Swings - 1 Bay 2 Seat (Flat)  
**Manufacturer:** Record RSS

**Finding:** There is some wear to the shackles.

**Action:** Monitor for any further deterioration and replace when 40% worn

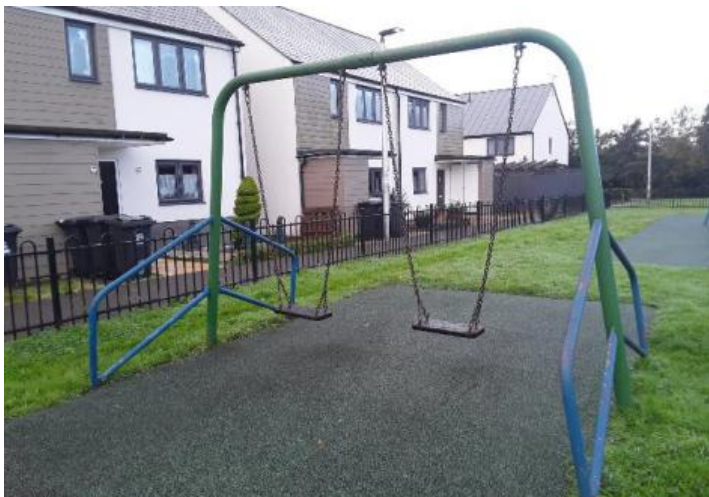
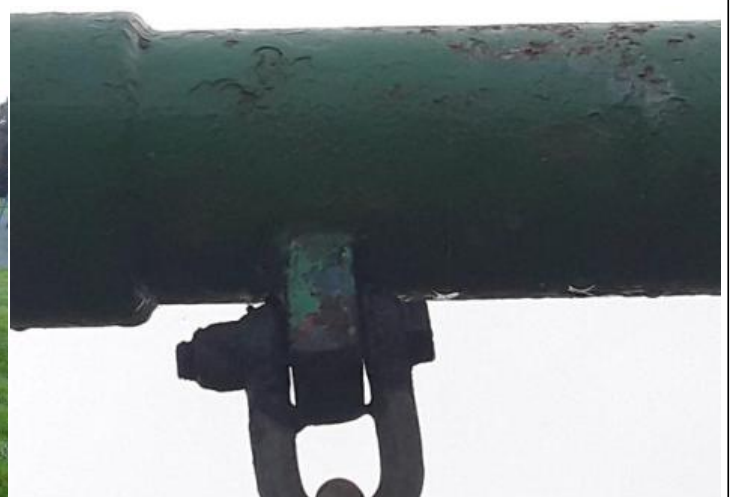
The bushes are worn or missing - Replace worn or missing bushes

**Item:** Swings - 1 Bay 2 Seat (Flat)  
**Manufacturer:** Record RSS

**Finding:** The bushes are worn or missing

**Action:** Replace worn or missing bushes

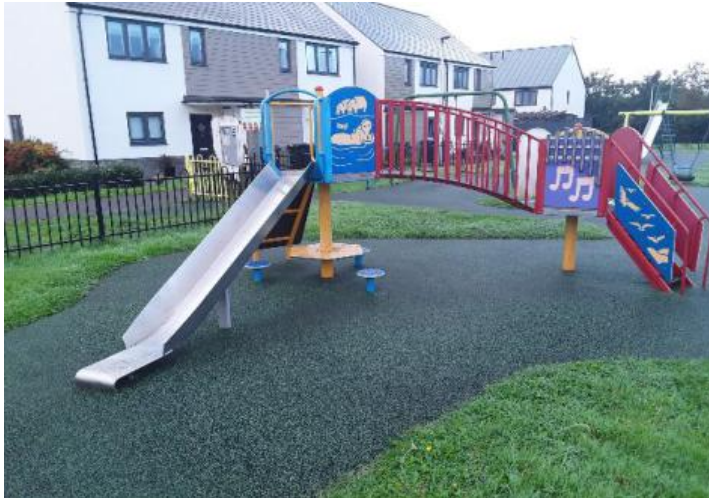
**Item:** Activity Equipment - Multi Play (Toddler)  
**Manufacturer:** SMP

**Finding:** There is or are fixings missing on the item

**Action:** Replace all missing fixings

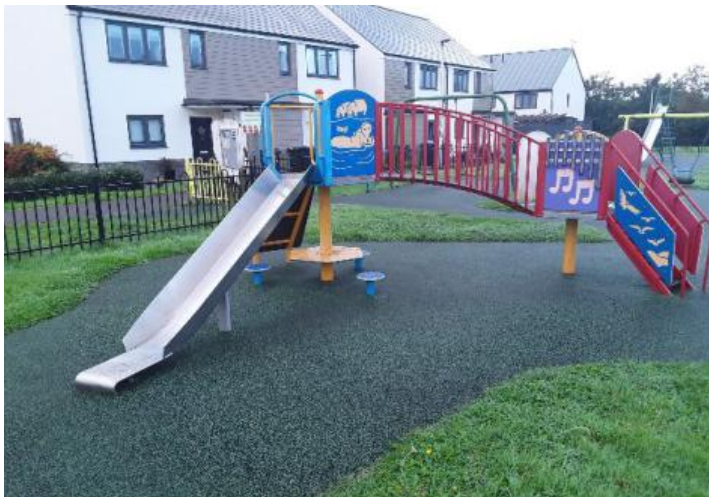
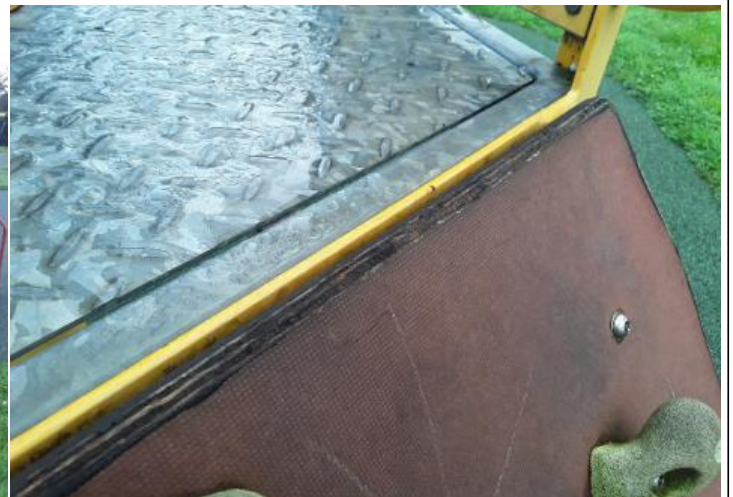
**Item:** Activity Equipment - Multi Play (Toddler)  
**Manufacturer:** SMP

**Finding:** Parts of the timber are rough or splintered

**Action:** Remove all rough or sharp edges

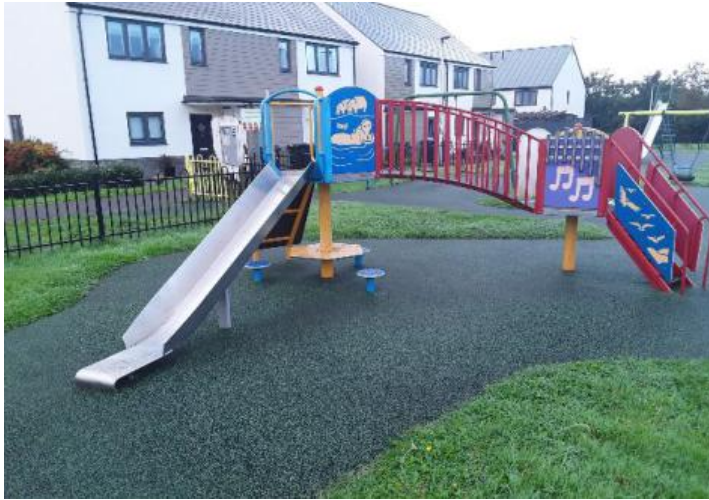
**Item:** Activity Equipment - Multi Play (Toddler)  
**Manufacturer:** SMP

**Finding:** There is/are finger entrapment/s in the side panel due to missing components and the item fails to meet the requirements of BS EN 1176 Part 1 4.2.7.6 Entrapment of fingers

**Action:** Replace the missing components

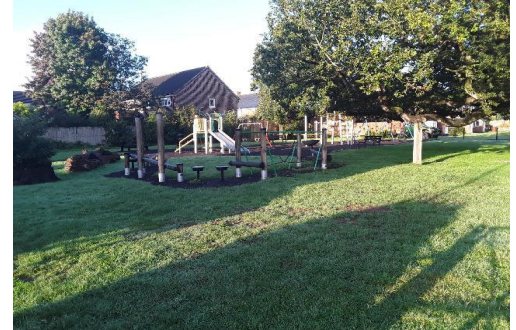
**Item:** Site General  
**Manufacturer:** Owner/Operator  
**Surface Type:** N/A  
**Item Quantity:** 1  
**Equipment Compliance:** N/A  
**Surface Area Compliance:** N/A

The surface has eroded in some areas and may be slippery in wet conditions - Reinstate the surface

There is an oak tree within the play area with a span in excess of 10 metres. One branch has been supported to reduce the likelihood of failure due to the self weight of the branch. Other branch extremities extend over play equipment and seating - Ensure that there is an appropriate risk assessment in place carried out by a specialist within the arboriculture industry

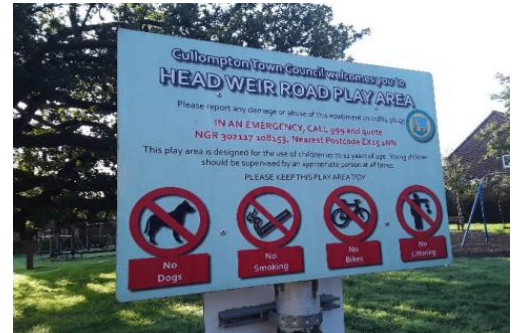
**Item:** Sign  
**Manufacturer:** Owner/Operator  
**Surface Type:** Grass  
**Item Quantity:** 1  
**Equipment Compliance:** N/A  
**Surface Area Compliance:** N/A
