NOTICE IS GIVEN THAT A SERVICES, PROPERTY AND OUTDOOR SPACES COMMITTEE OF  
CULLOMPTON TOWN COUNCIL  
WILL BE HELD AT THE TOWN HALL, CULLOMPTON  
ON THURSDAY, 9<sup>th</sup> NOVEMBER 2023 AT 7PM

**MINUTES OF MEETING OF THE SERVICES, PROPERTY AND OUTDOOR SPACES COMMITTEE  
DATED TUESDAY 12 SEPTEMBER 2023 AT 7:00PM AT CULLOMPTON TOWN HALL**

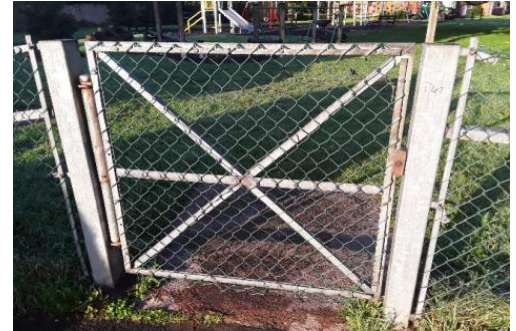
**Item:** Gate - Self Closing  
**Manufacturer:** Not Identified  
**Surface Type:** Mixed Surface  
**Item Quantity:** 2  
**Equipment Compliance:** N/A  
**Surface Area Compliance:** N/A

There is surface corrosion / rust present on the item - Consider treating the item

The cut off ends of the infill mesh are exposed and may cause puncture wounds - Remove any sharp protrusions

The rubber buffer is missing from the latch plate - Replace rubber buffer

There is wear damage to the concrete base under and in front of the gate - Monitor and repair if trip hazards become apparent

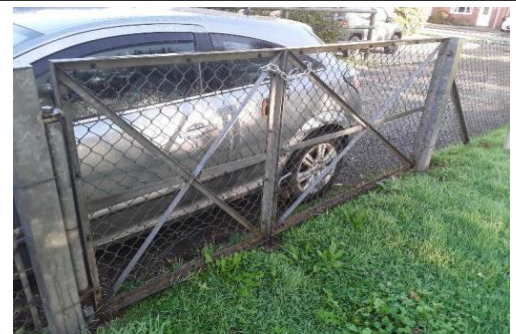
**Item:** Gate - Maintenance  
**Manufacturer:** Not Identified  
**Surface Type:** Grass  
**Item Quantity:** 1  
**Equipment Compliance:** N/A  
**Surface Area Compliance:** N/A

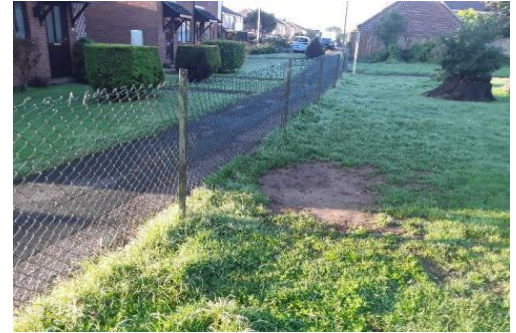
**Item:** Fence - Chainlink  
**Manufacturer:** Not Identified  
**Surface Type:** Grass  
**Item Quantity:** 1  
**Equipment Compliance:** N/A  
**Surface Area Compliance:** N/A

There is some evidence of rot in the timber - Monitor for any further deterioration and replace as required

An incorrect fixing or fixing method has been used - Replace with appropriate fixings to the manufacturer's specification

The line wires are not secured to the posts and the mesh is loose - Secure the line wires

Line wires are broken - Repair / replace the damaged line wires

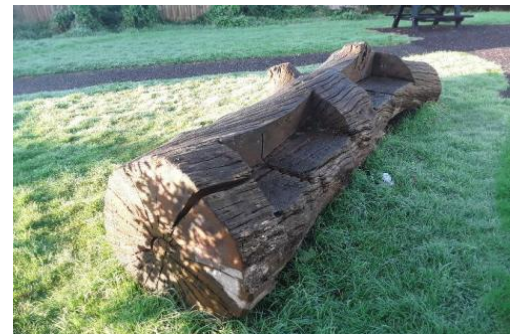
**Item:** Tree Trunk  
**Manufacturer:** Natural Feature  
**Surface Type:** Grass  
**Item Quantity:** 1  
**Equipment Compliance:** N/A  
**Surface Area Compliance:** N/A

There is some evidence of rot in the timber - Monitor for any further deterioration and replace as required

The timber has a number of splits/shakes or air cracks and this may affect the stability or allow water ingress which will accelerate the rotting process - Monitor to ensure the splits do not cross through fixing points of the structure and/or cause any instability

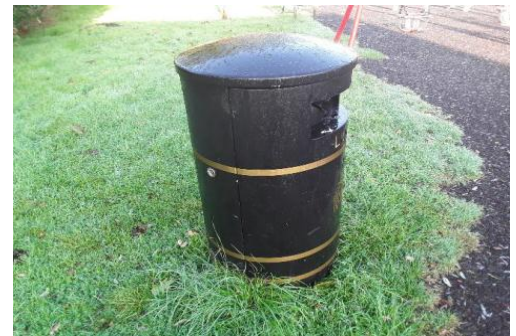
**Item:** Litter Bin  
**Manufacturer:** Not Identified  
**Surface Type:** Grass  
**Item Quantity:** 1  
**Equipment Compliance:** N/A  
**Surface Area Compliance:** N/A

There are redundant concrete litter bin bases within the play area causing trip hazards - Remove the concrete bases

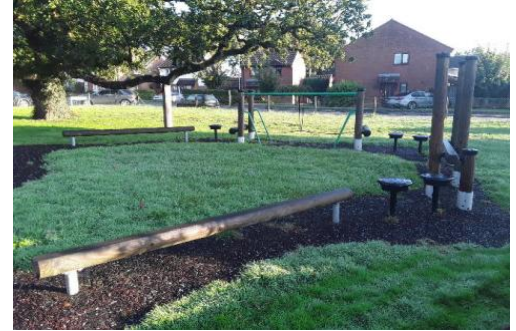
**Item:** Activity Trail  
**Manufacturer:** Sutcliffe Play Limited  
**Surface Type:** Bonded Rubber Mulch  
**Item Quantity:** 1  
**Equipment Compliance:** Yes  
**Surface Area Compliance:** Yes

A number of cap fixing(s) have worked loose - Secure all loose fixings

There is or are cap fixings missing - Replace all missing fixings

The timber has a number of splits/shakes or air cracks and this may affect the stability or allow water ingress which will accelerate the rotting process - Monitor to ensure the splits do not cross through fixing points of the structure and/or cause any instability

The ropes/nets are worn/damaged in places - Monitor for any further deterioration and repair or replace as required

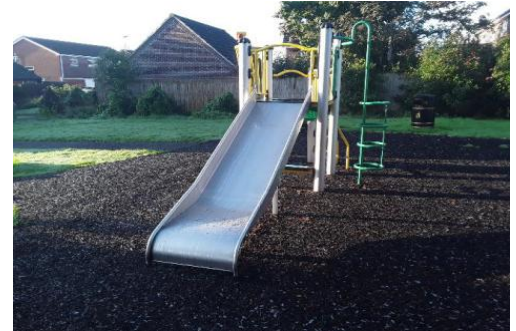
**Item:** Multi Play (Junior)  
**Manufacturer:** Sutcliffe Play Limited  
**Surface Type:** Bonded Rubber Mulch  
**Item Quantity:** 1  
**Equipment Compliance:** Yes  
**Surface Area Compliance:** Yes

There is minor damage to the handgrips - Monitor and replace if required

There is surface corrosion / rust present on the item - Consider treating the item

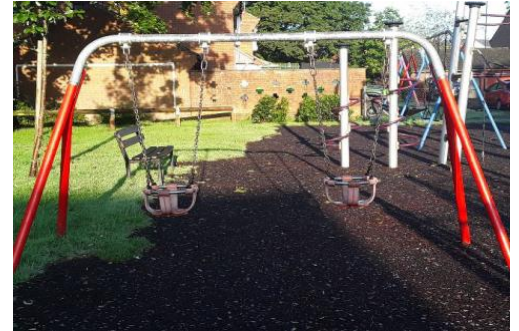
**Item:** 1 Bay 2 Seat (Cradle)  
**Manufacturer:** Sutcliffe Play Limited  
**Surface Type:** Bonded Rubber Mulch  
**Item Quantity:** 1  
**Equipment Compliance:** No  
**Surface Area Compliance:** Yes

The chain openings are in excess of the 8.6mm as recommended by BS EN 1176 - Monitor - No remedial work recommended

There is some notable evidence of chain wear - Monitor for any further deterioration and replace when 40% worn

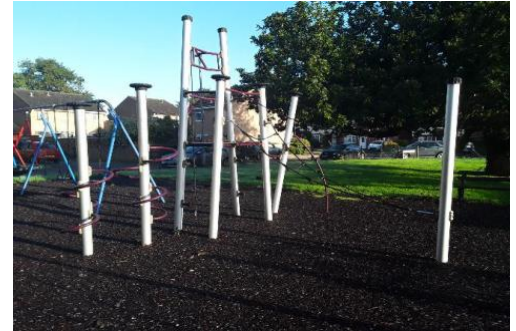
**Item:** Climbing Frame  
**Manufacturer:** Sutcliffe Play Limited  
**Surface Type:** Bonded Rubber Mulch  
**Item Quantity:** 1  
**Equipment Compliance:** Yes  
**Surface Area Compliance:** Yes

One foot peg cover has been removed - Replace the missing cover

The bushes / pins are showing signs of wear - Monitor for any further deterioration and replace as required

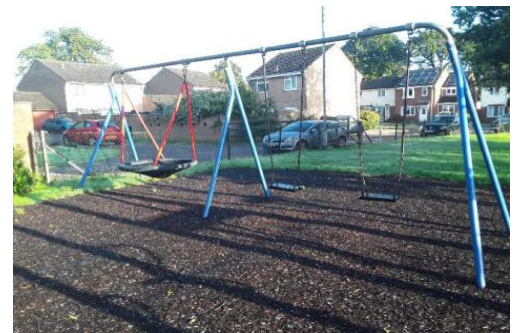
**Item:** 2 Bay 2 Flat 1 Basket Seat  
**Manufacturer:** Sutcliffe Play Limited  
**Surface Type:** Bonded Rubber Mulch  
**Item Quantity:** 1  
**Equipment Compliance:** No  
**Surface Area Compliance:** Yes

The chain openings are in excess of the 8.6mm as recommended by BS EN 1176 - Monitor - No remedial work recommended

There is some notable evidence of chain wear - Monitor for any further deterioration and replace when 40% worn

The Anti Wrap bearings are dry and not moving freely - Lubricate bearings in accordance with the manufacturers recommendations

The seat connection cannot be inspected fully as the chain cover cannot be lifted - Cut the cover to allow access to the shackle and assess the wear

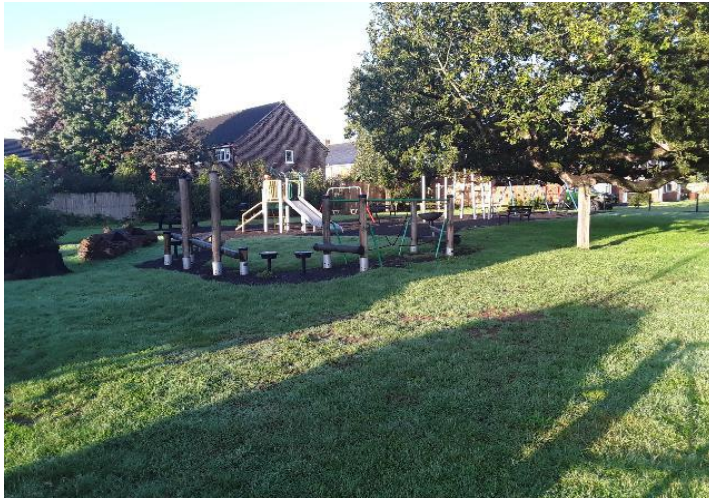
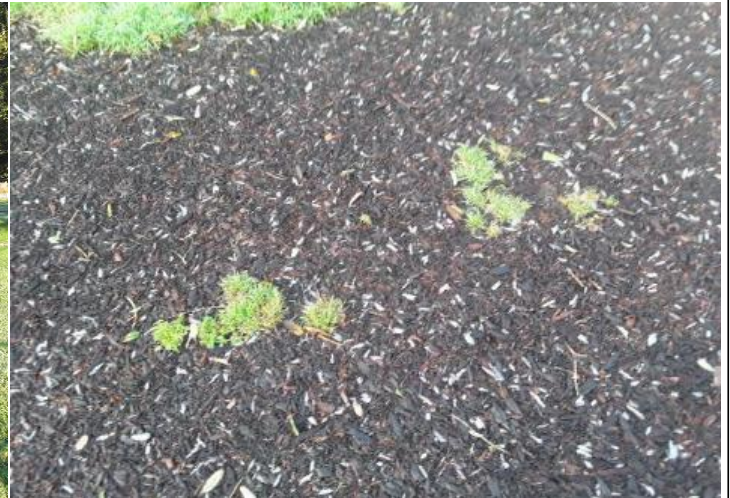
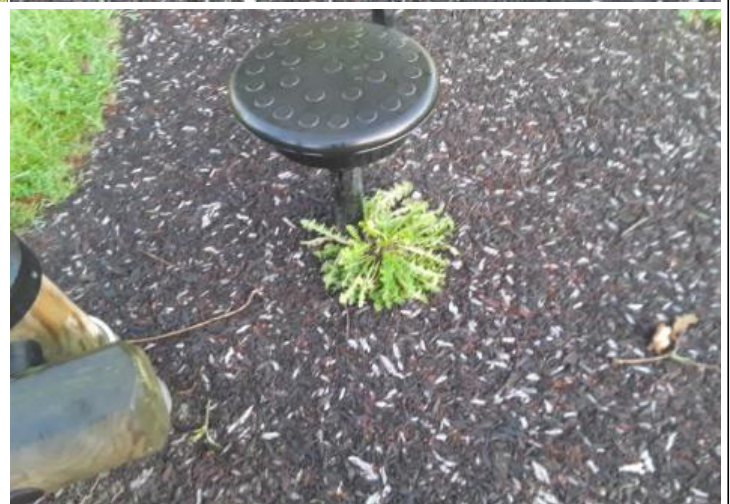
**Item:** Ancillary Items - Site General  
**Manufacturer:** Owner/Operator

**Finding:** There is weed / vegetation growth on, between, or around the edges of the surfacing  
**Action:** Remove weed / vegetation growth

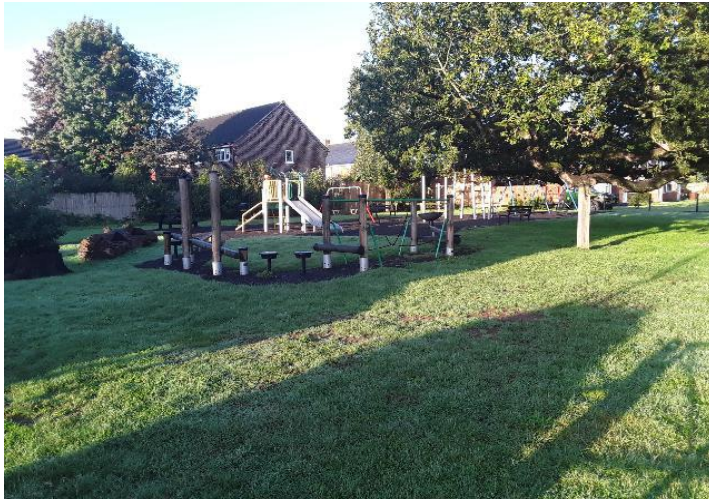
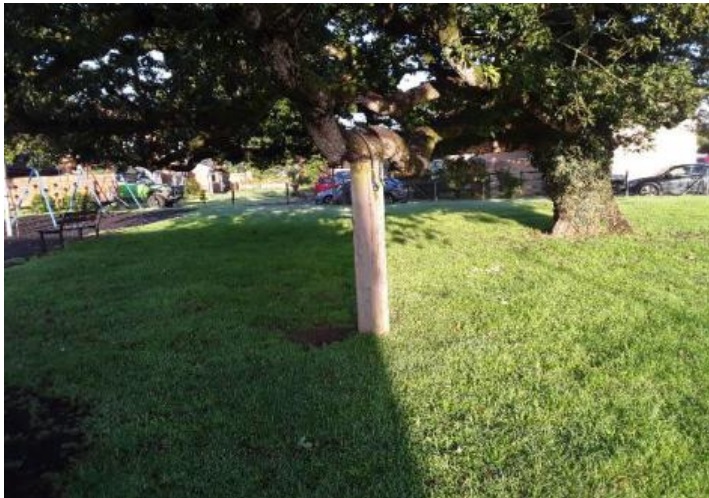
**Finding:** There is an oak tree within the play area with a span in excess of 10 metres. One branch has been supported to reduce the likelihood of failure due to the self weight of the branch. Other branch extremities extend over play equipment and seating

**Action:** Ensure that there is an appropriate risk assessment in place carried out by a specialist within the arboriculture industry

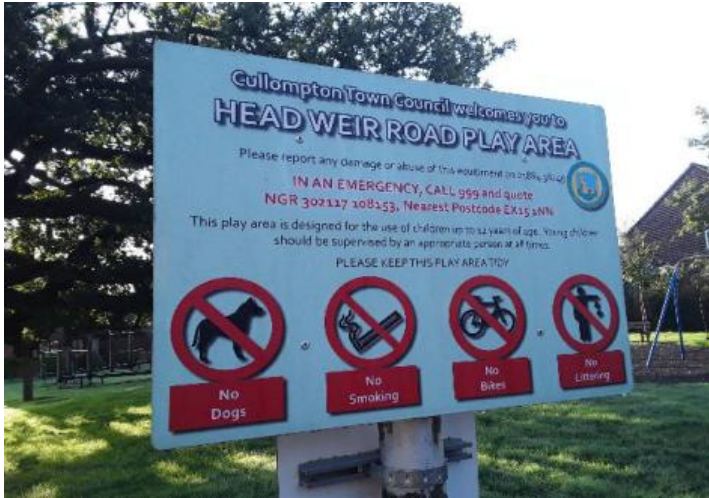
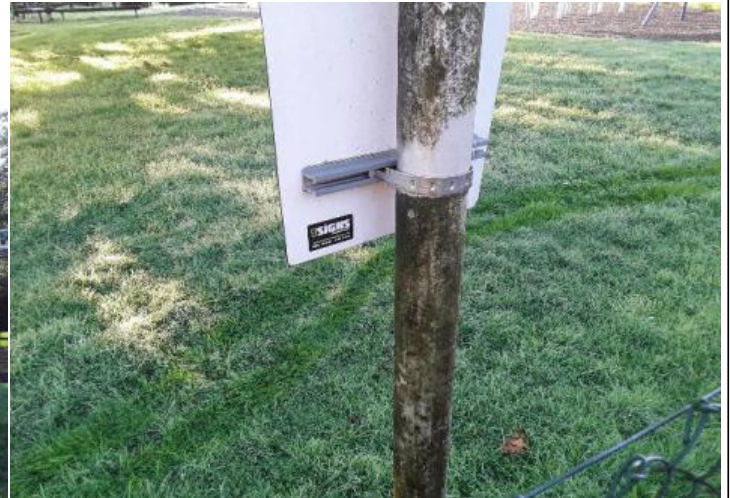
**Item:** Ancillary Items - Sign  
**Manufacturer:** Owner/Operator

**Finding:** There is algae or moss on the surface of the post **Action:** Clean and treat appropriately

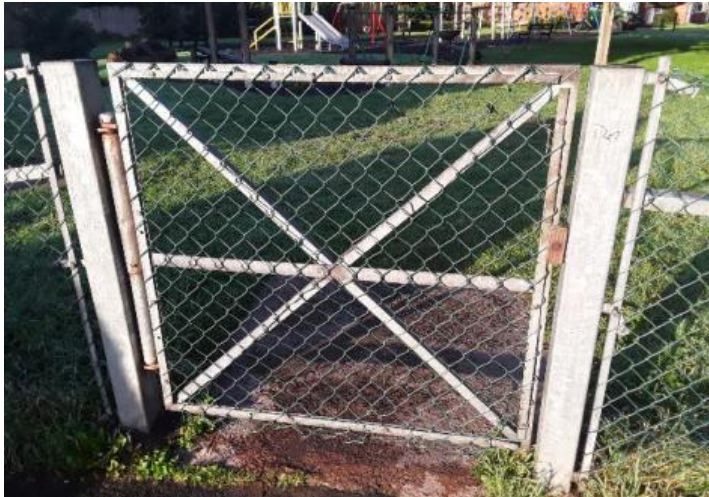
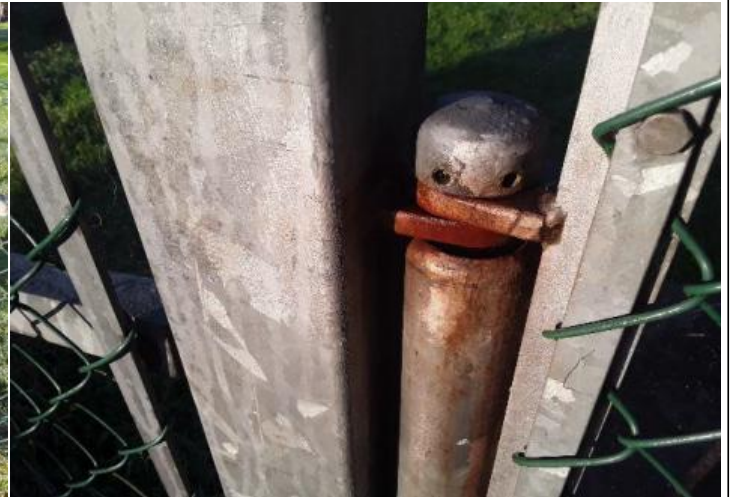
**Finding:** There is surface corrosion / rust present on the item **Action:** Consider treating the item

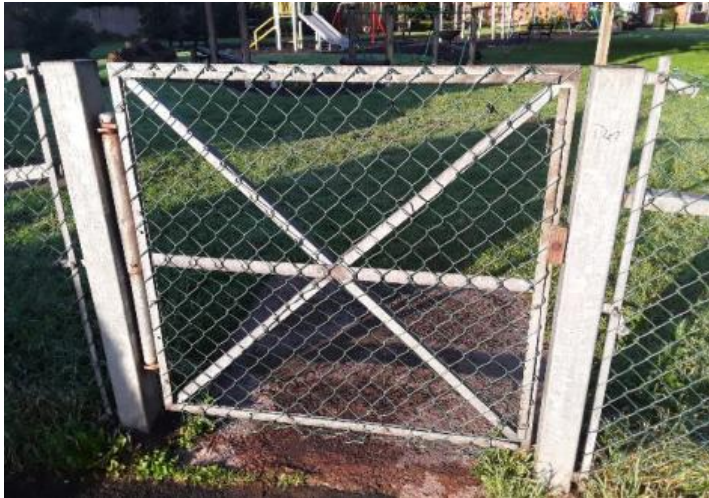
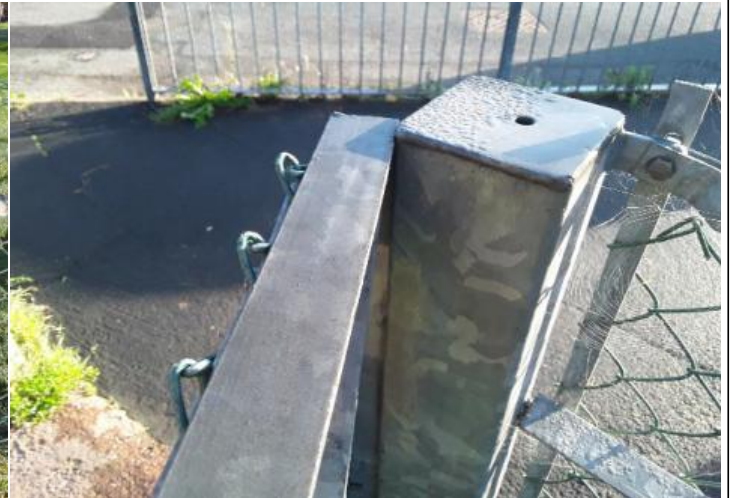
**Finding:** There are openings that are less than 12mm that could trap or crush fingers

**Action:** Provide a 12mm gap throughout full range of motion at both sides of gate

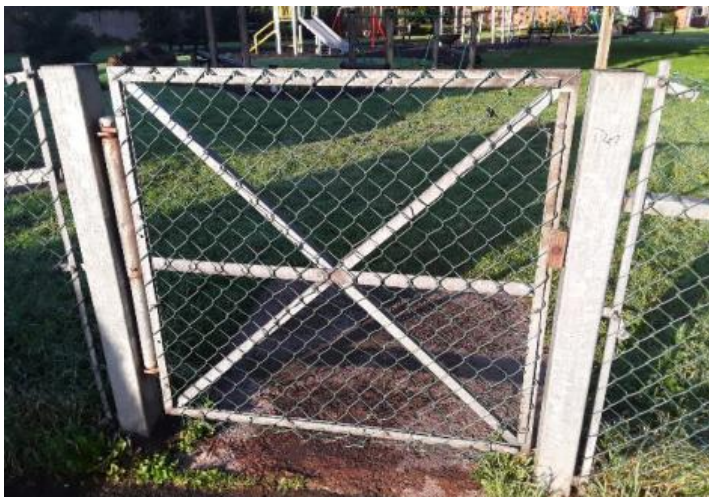
**Finding:** The cut off ends of the infill mesh are exposed and may cause puncture wounds

**Action:** Remove any sharp protrusions

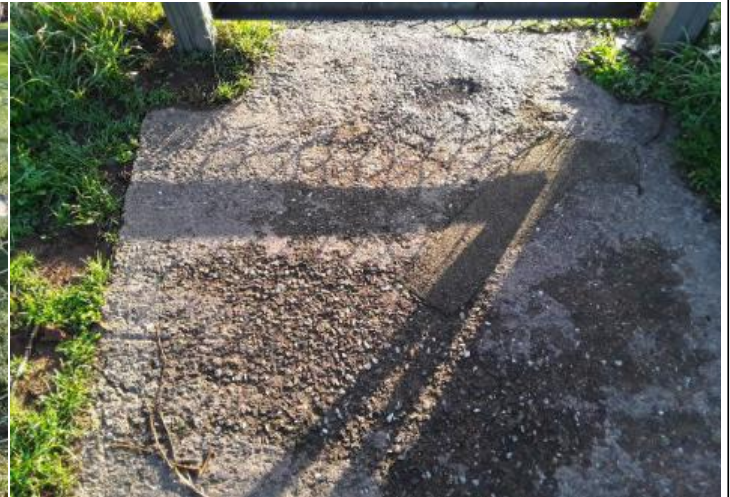
**Finding:** There is wear damage to the concrete base under and in front of the gate

**Action:** Monitor and repair if trip hazards become apparent

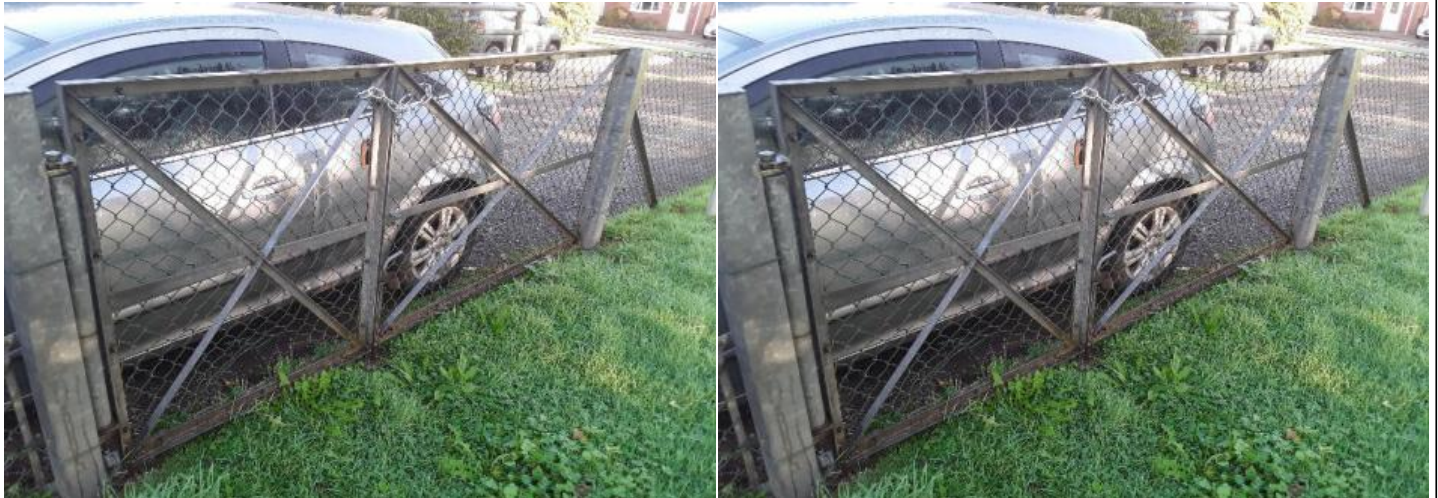
**Finding:** The maintenance gate was correctly padlocked at the time of inspection, however this means that the inspector was unable to fully assess the gate

**Action:** Ensure that there are 12mm gaps throughout the full range of motion on gate/s and between leaves where relevant

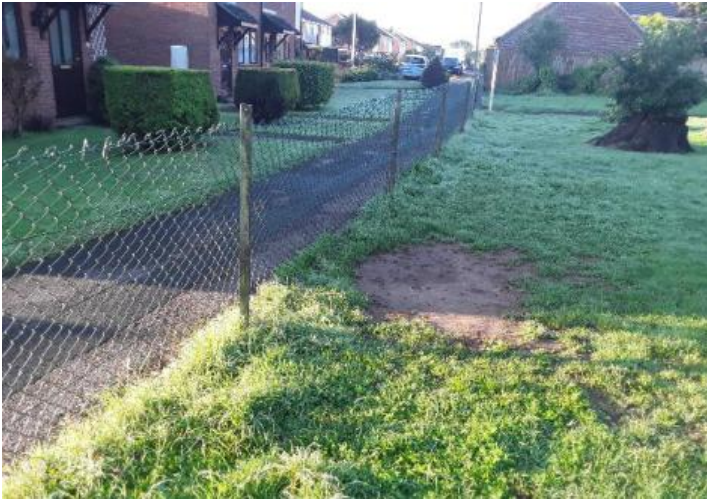
**Finding:** There is some evidence of rot in the timber

**Action:** Monitor for any further deterioration and replace as required

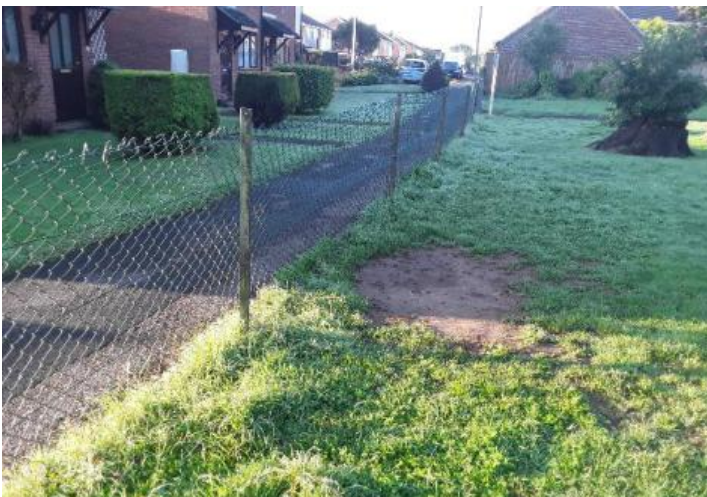
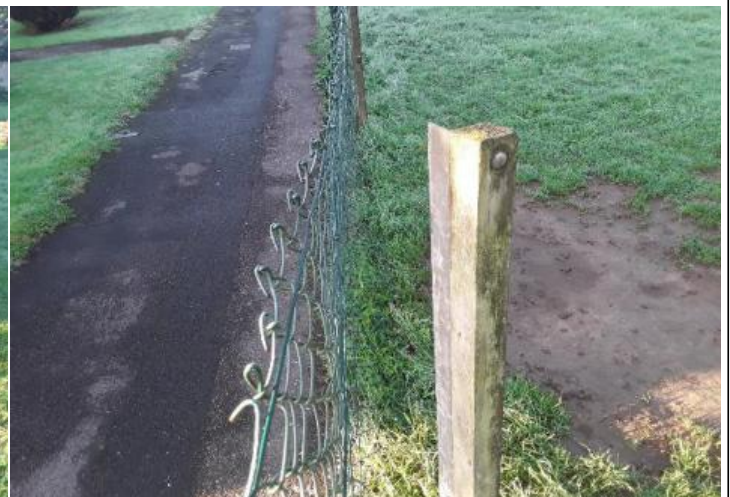
**Finding:** The line wires are not secured to the posts and the mesh is loose **Action:** Secure the line wires

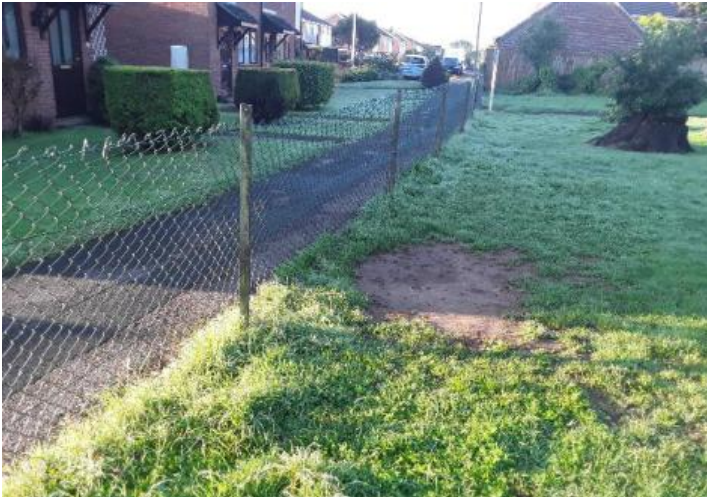
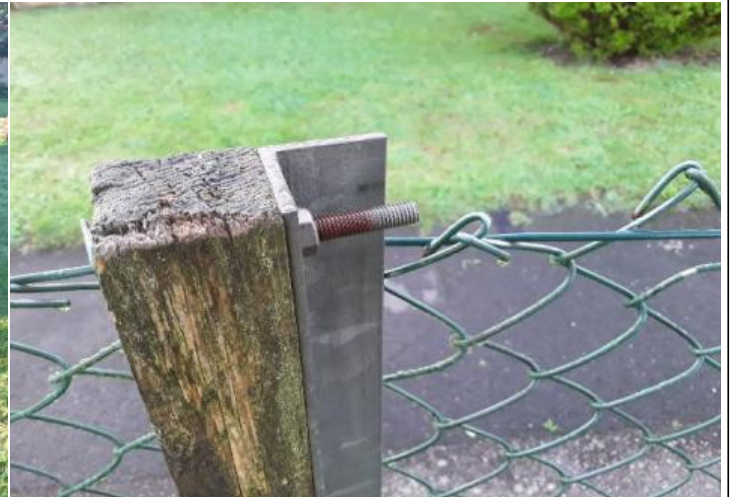
**Finding:** There are projecting bolt thread(s) present

**Action:** Remove excess thread length and deburr or provide cap

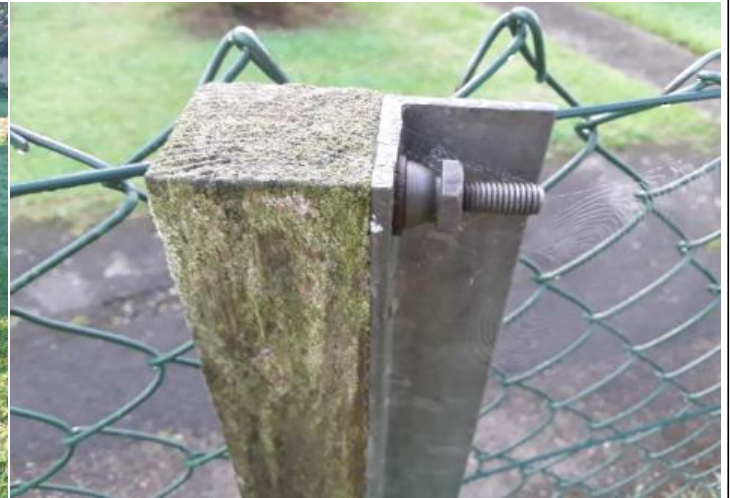
**Finding:** Shear nuts have not been fully tightened and are still present on fixings

**Action:** Tighten heads on nuts to shear off and secure

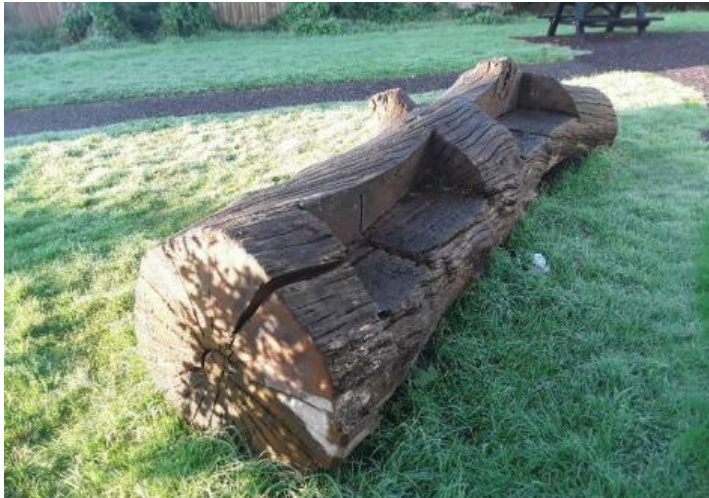
**Finding:** There is some evidence of rot in the timber

**Action:** Monitor for any further deterioration and replace as required

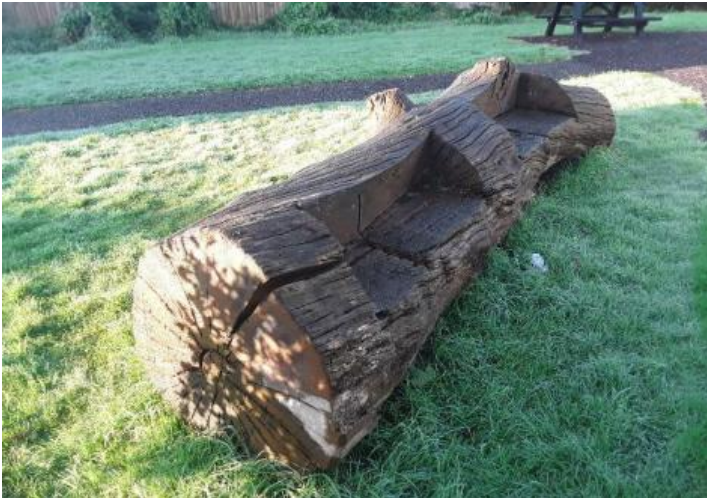
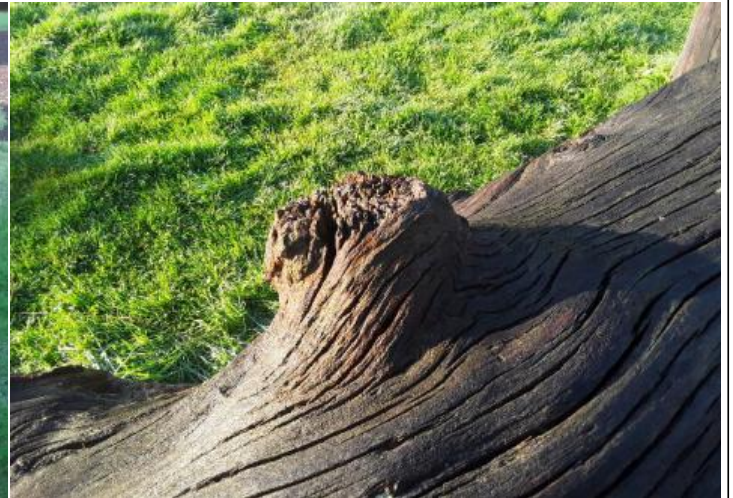
**Finding:** Parts of the timber are rough or splintered

**Action:** Remove all rough or sharp edges

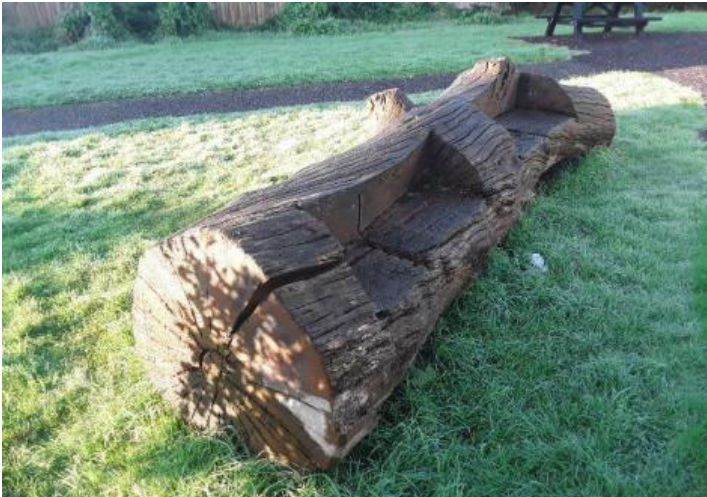
**Finding:** The timber has a number of splits/shakes or air cracks and this may affect the stability or allow water ingress which will accelerate the rotting process

**Action:** Monitor to ensure the splits do not cross through fixing points of the structure and/or cause any instability

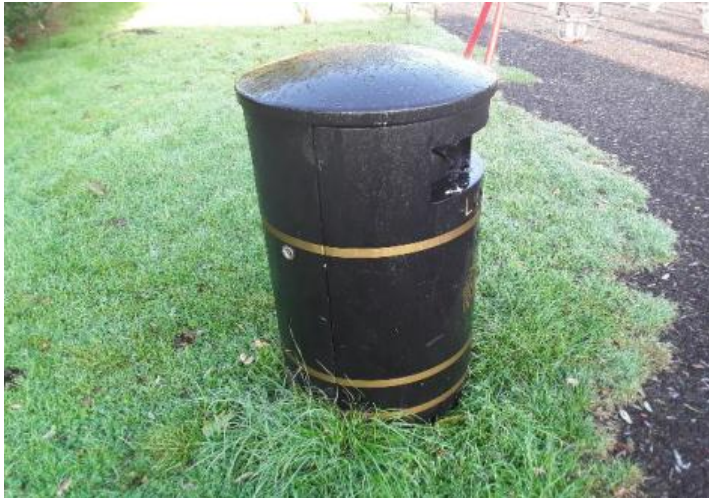
**Finding:** There are redundant concrete litter bin bases within the play area causing trip hazards

**Action:** Remove the concrete bases

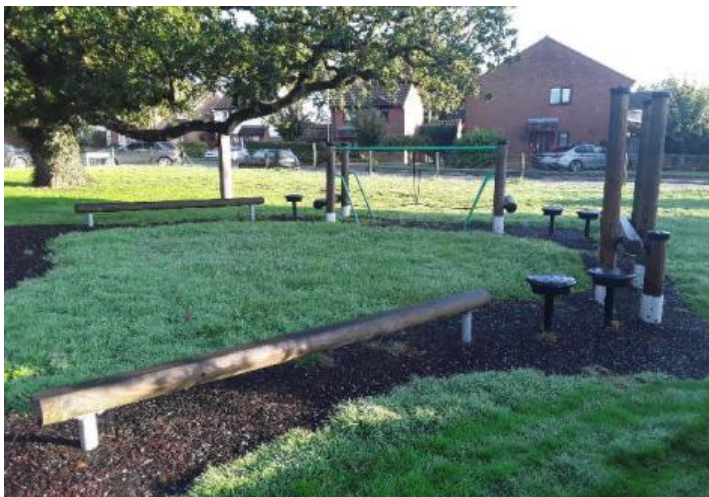
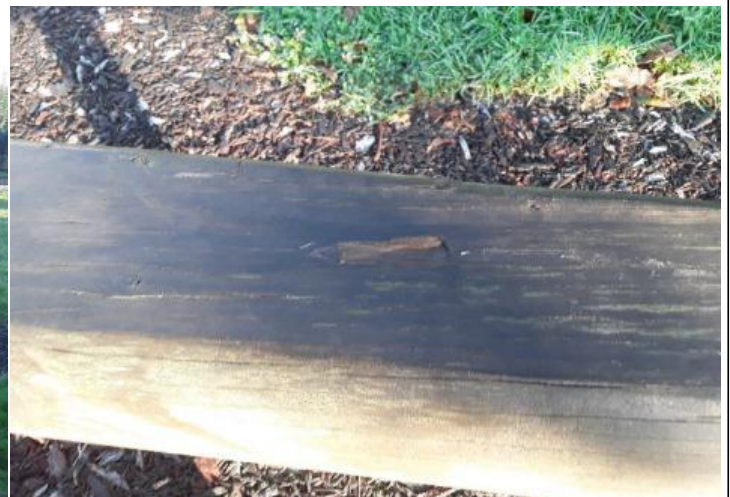
**Finding:** Parts of the timber are rough or splintered

**Action:** Remove all rough or sharp edges

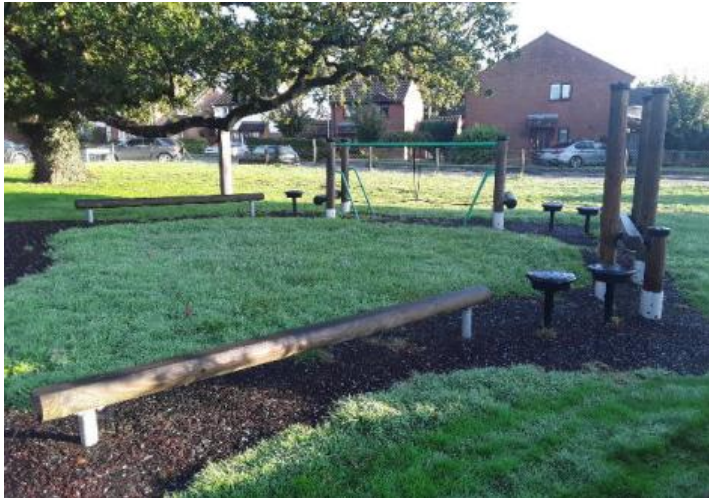
**Finding:** A number of cap fixing(s) have worked loose

**Action:** Secure all loose fixings

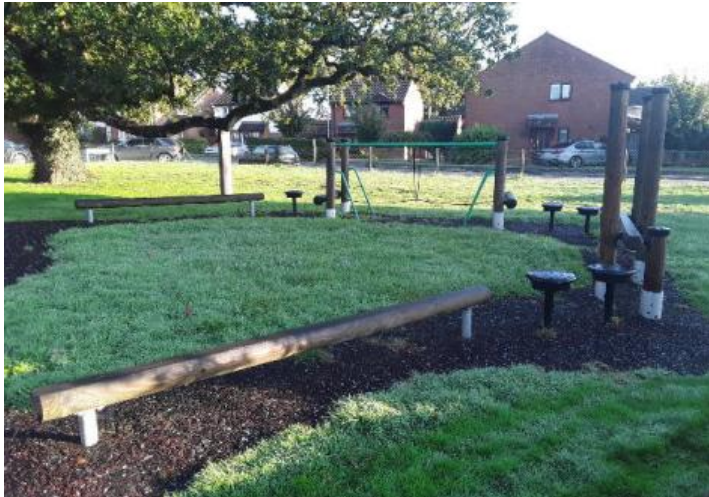
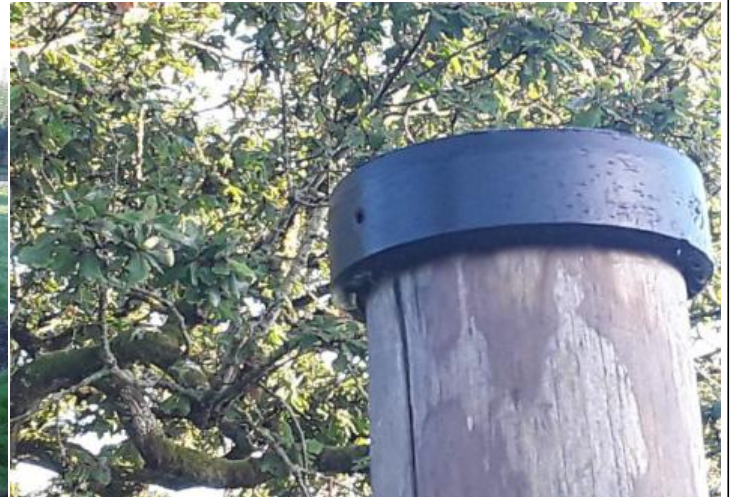
**Finding:** There is or are cap fixings missing

**Action:** Replace all missing fixings

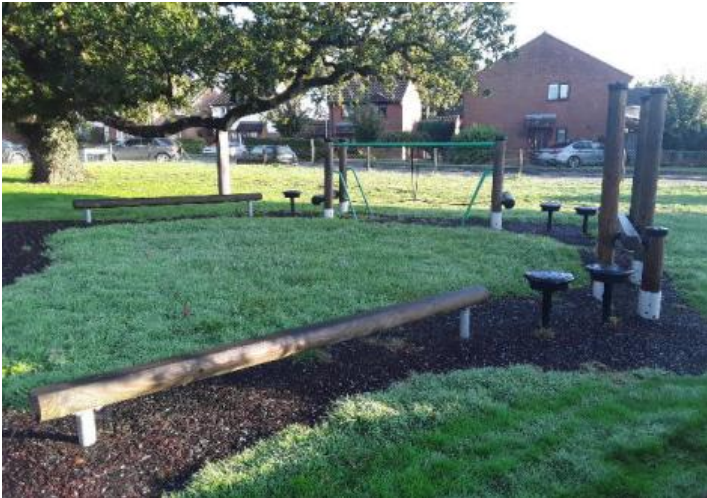
**Finding:** The timber has a number of splits/shakes or air cracks and this may affect the stability or allow water ingress which will accelerate the rotting process

**Action:** Monitor to ensure the splits do not cross through fixing points of the structure and/or cause any instability

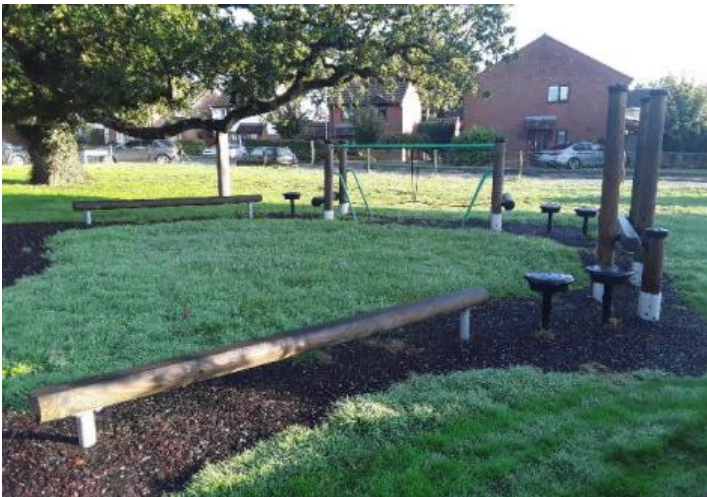
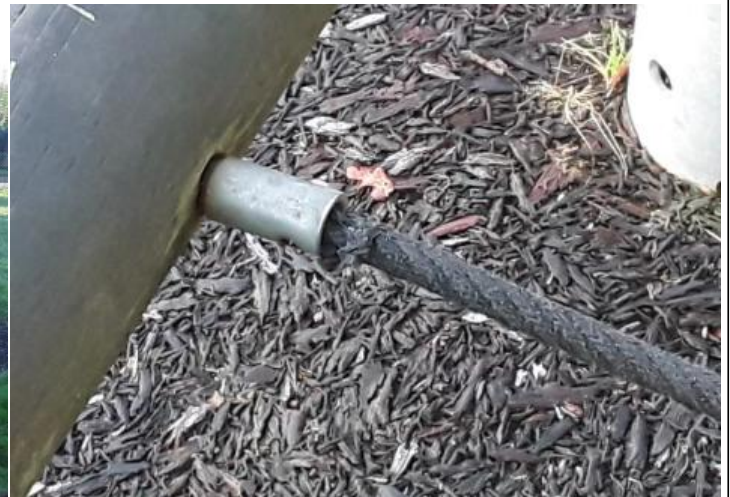
**Finding:** The ropes/nets are worn/damaged in places

**Action:** Monitor for any further deterioration and repair or replace as required

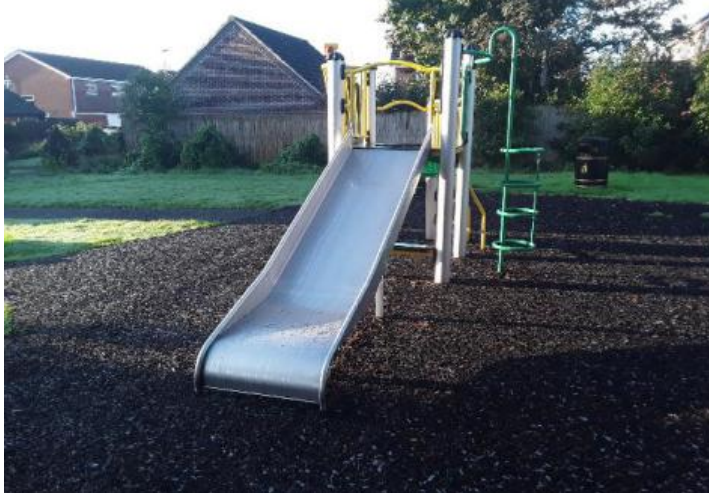
**Finding:** There is minor damage to the handgrips

**Action:** Monitor and replace if required

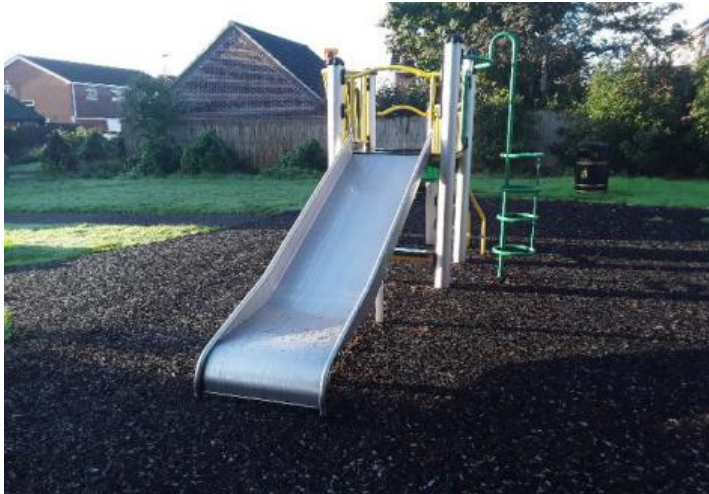
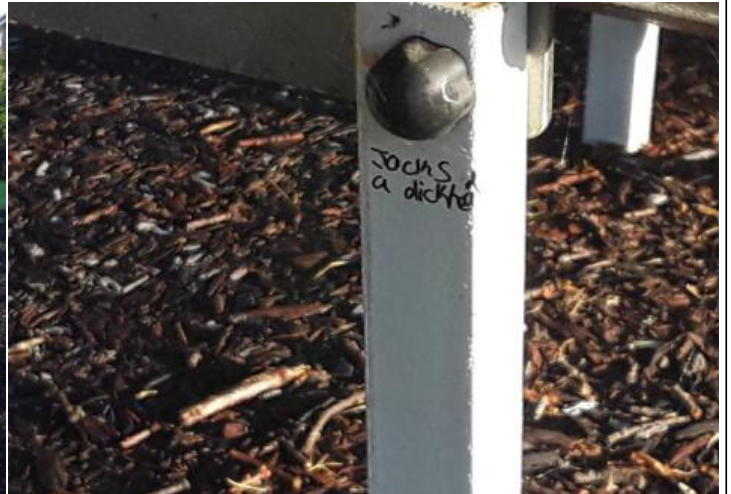
**Finding:** There is some graffiti present

**Action:** Remove the graffiti

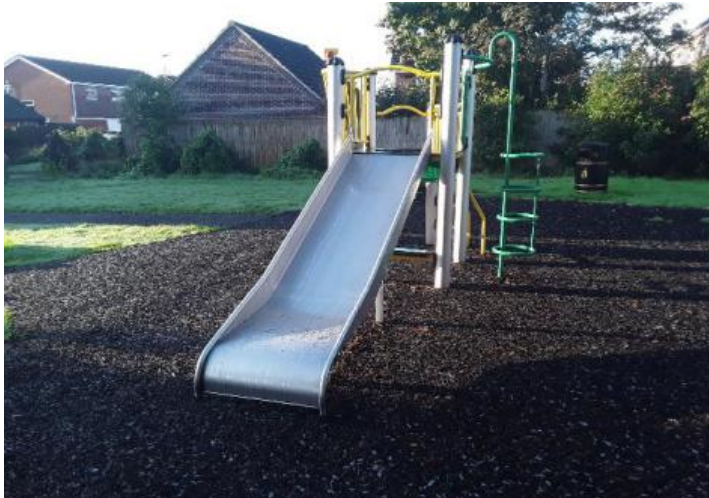
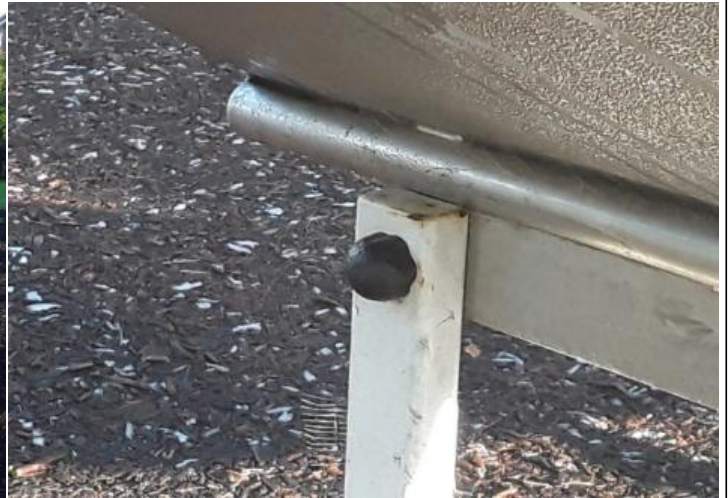
**Finding:** There is surface corrosion / rust present on the item

**Action:** Consider treating the item

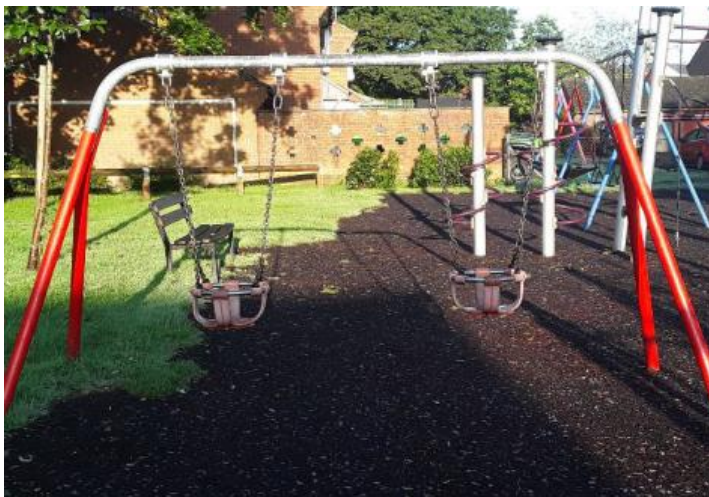
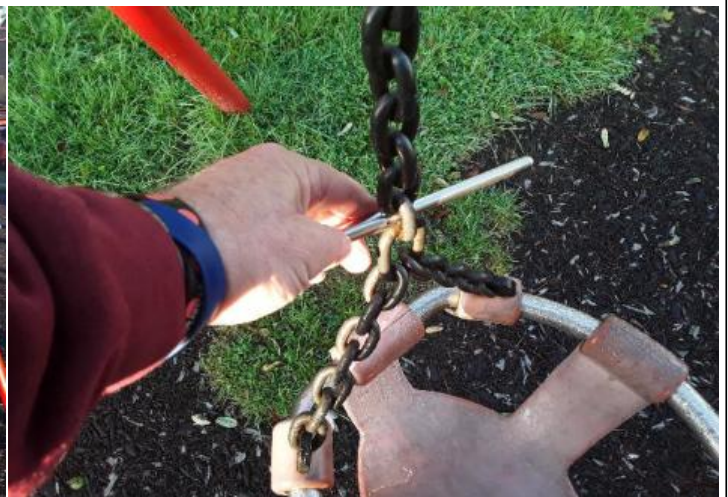
**Finding:** The chain openings are in excess of the 8.6mm as recommended by BS EN 1176

**Action:** Monitor - No remedial work recommended

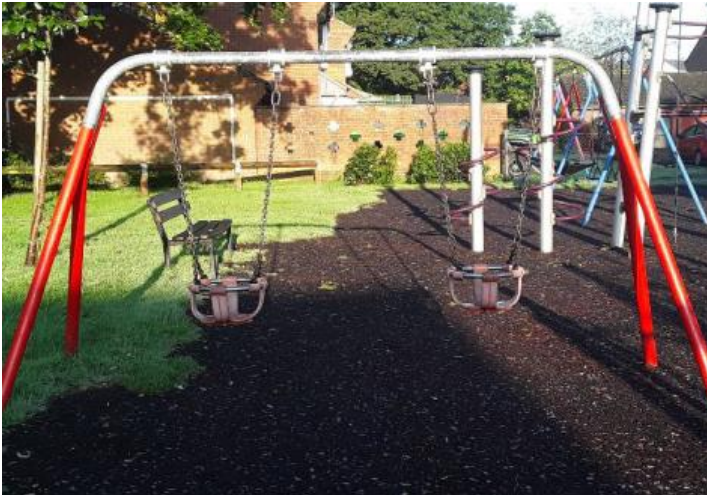
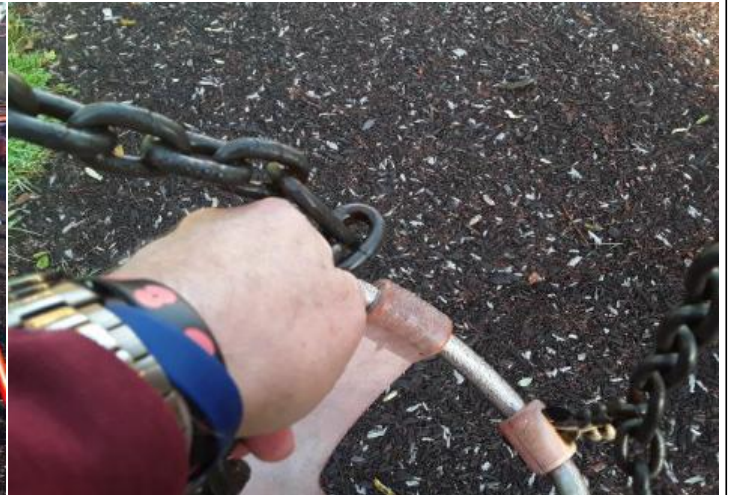
**Finding:** There is some notable evidence of chain wear

**Action:** Monitor for any further deterioration and replace when 40% worn

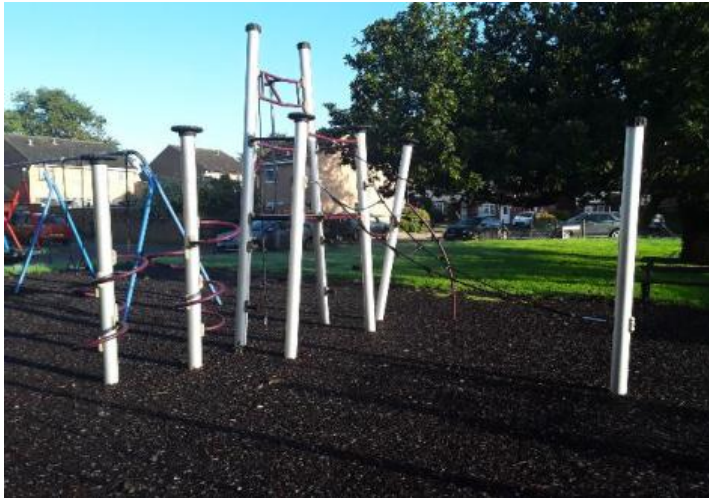
**Finding:** One foot peg cover has been removed

**Action:** Replace the missing cover

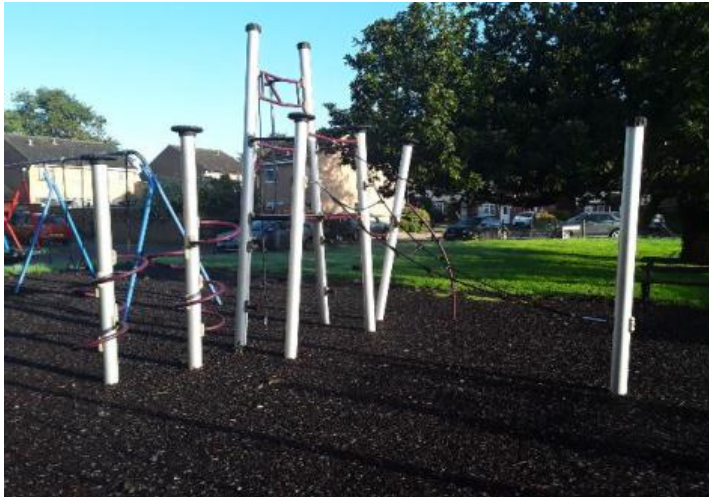
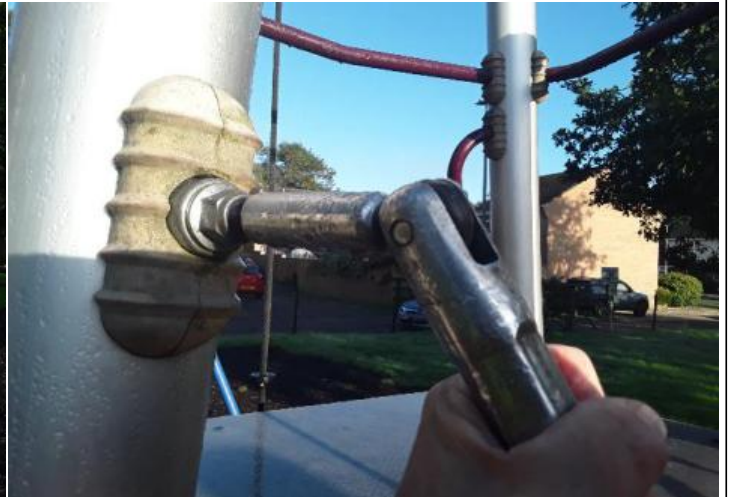
**Finding:** The bushes / pins are showing signs of wear

**Action:** Monitor for any further deterioration and replace as required

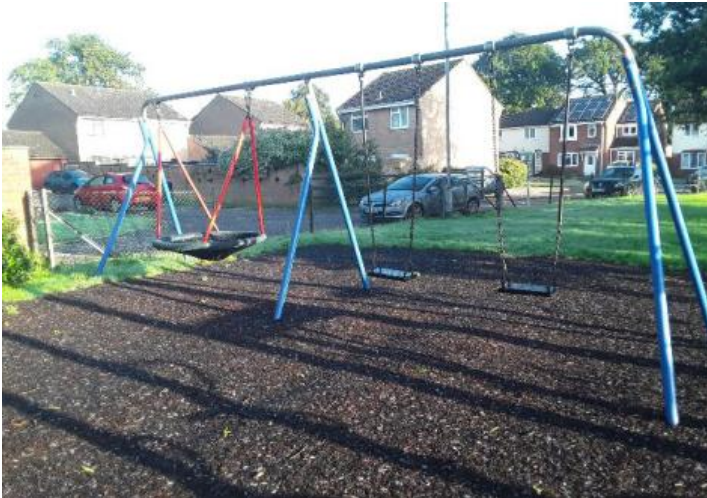
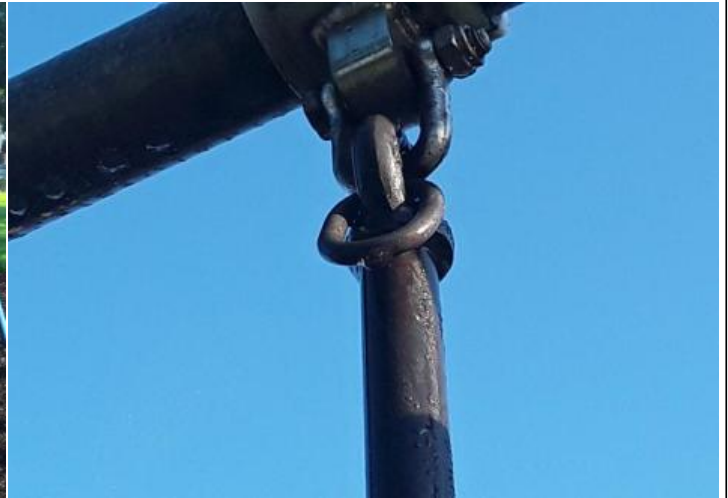
**Finding:** There is a redundant chain link on the suspension bar **Action:** Consider removing the link

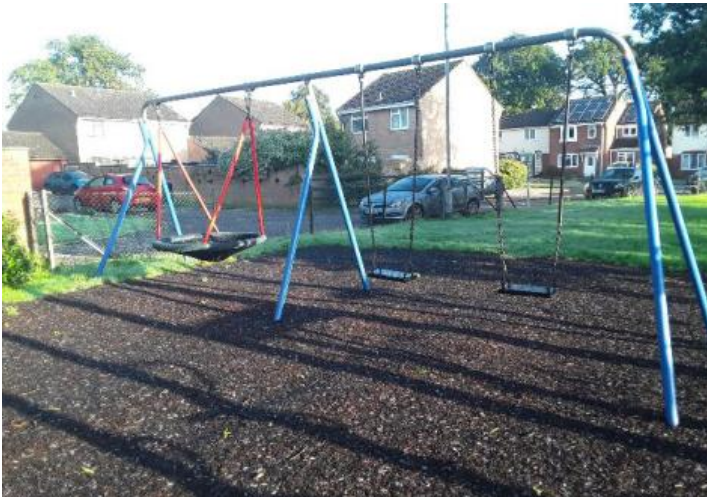
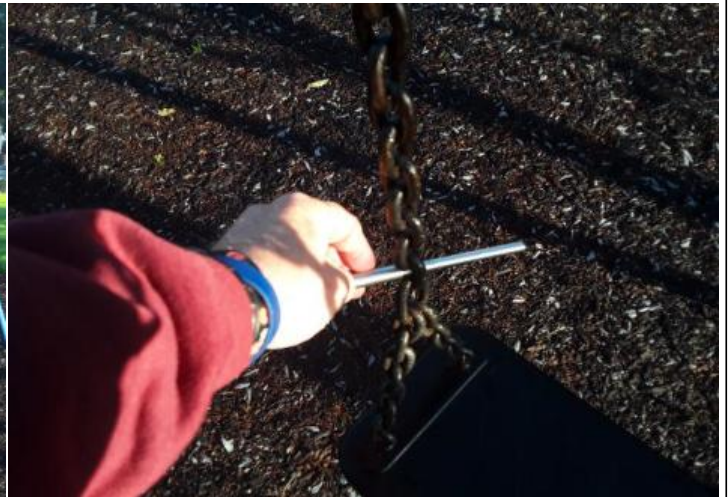
**Finding:** The chain openings are in excess of the 8.6mm as recommended by BS EN 1176 **Action:** Monitor - No remedial work recommended

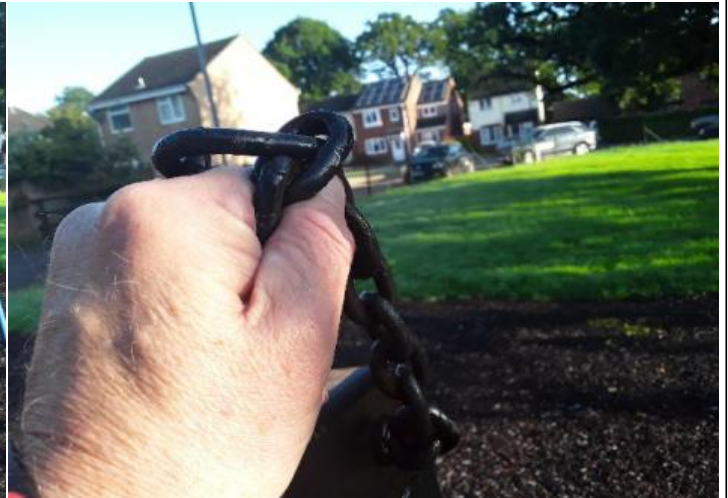
**Finding:** There is some notable evidence of chain wear

**Action:** Monitor for any further deterioration and replace when 40% worn
