NOTICE IS GIVEN THAT A SERVICES, PROPERTY AND OUTDOOR SPACES COMMITTEE OF  
CULLOMPTON TOWN COUNCIL  
WILL BE HELD AT THE TOWN HALL, CULLOMPTON  
ON THURSDAY, 9<sup>th</sup> NOVEMBER 2023 AT 7PM

**MINUTES OF MEETING OF THE SERVICES, PROPERTY AND OUTDOOR SPACES COMMITTEE  
DATED TUESDAY 12 SEPTEMBER 2023 AT 7:00PM AT CULLOMPTON TOWN HALL**

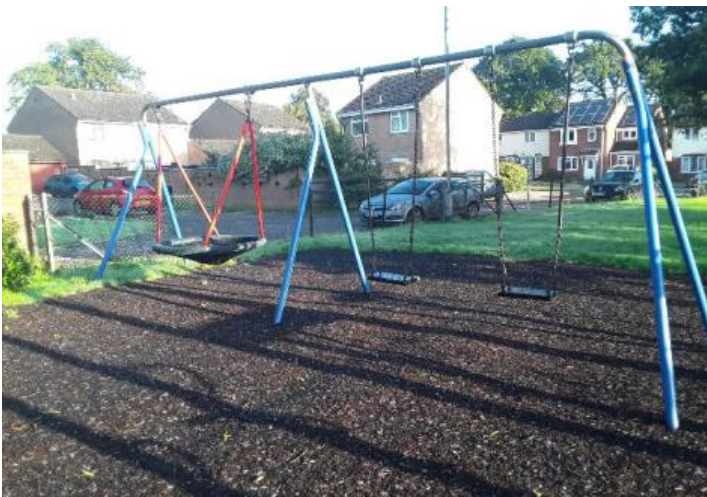
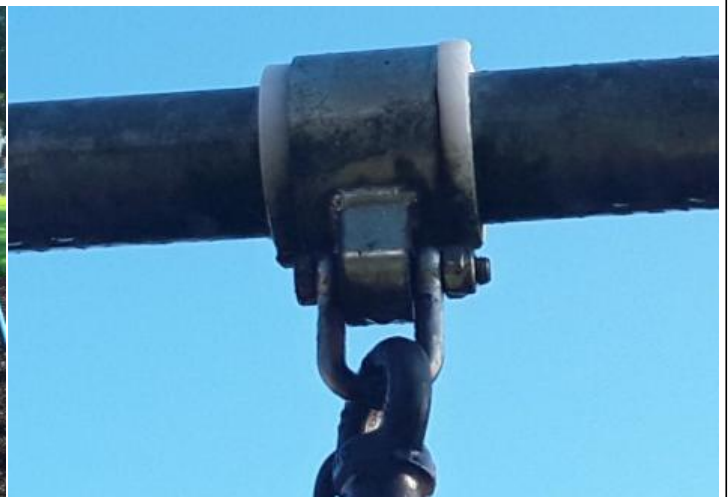
**Finding:** The Anti Wrap bearings are dry and not moving freely

**Action:** Lubricate bearings in accordance with the manufacturers recommendations

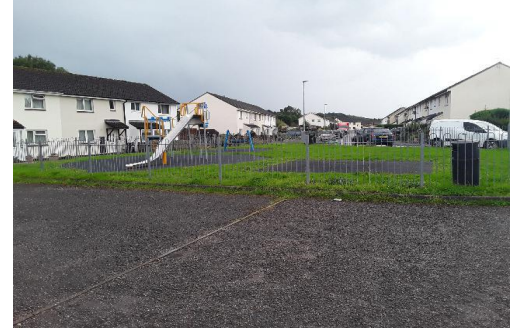
There is weed / vegetation growth on, between, or around the edges of the surfacing - Remove weed / vegetation growth

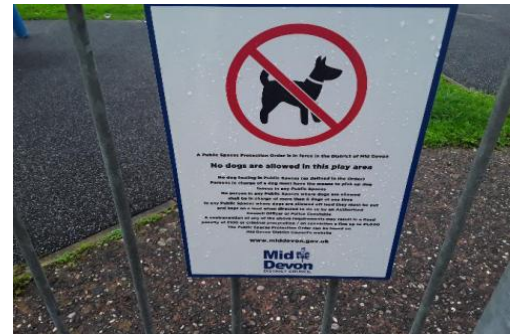
It is recommended that signage, with information including the site address, contact information for maintenance issues and emergency contact details are provided for the facility - Provide in accordance with the recommendations

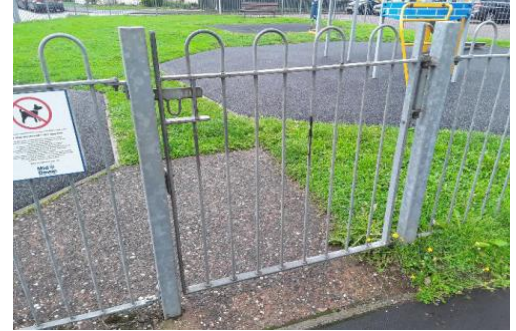
There is surface corrosion / rust present on the item - Consider treating the item

The gate rebounds when opened quickly and could strike the next user entering the area - Monitor use and adjust/replace as required

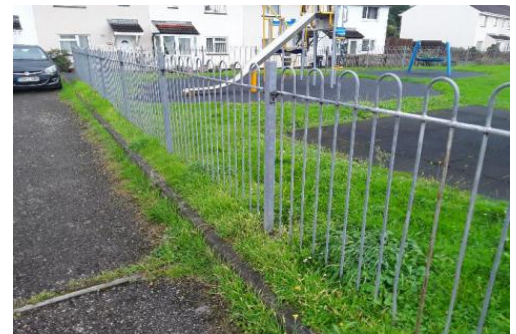
There is some damage to the fence sections - Monitor for any further deterioration and repair as required

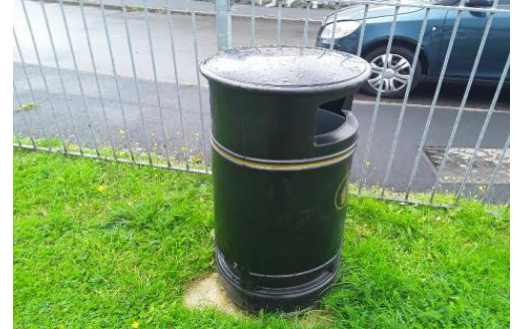
The paintwork on this item has been damaged or worn exposing the metal underneath which is rusting / corroding - Treat affected areas and repaint

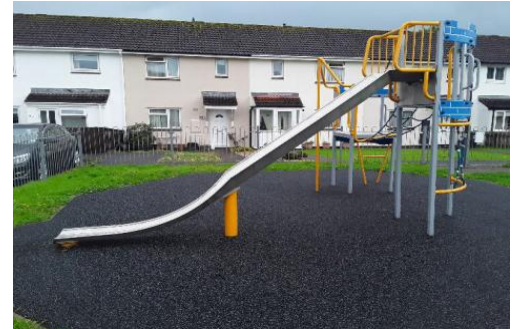
There are minor hairline fracture in the slide surface - Monitor and repair if required

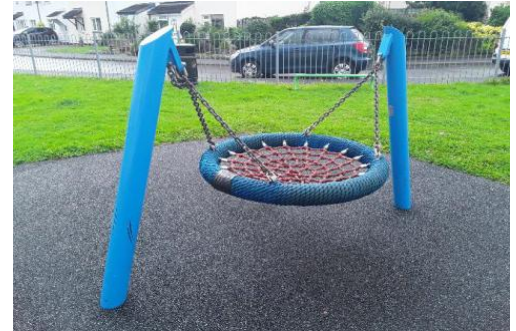
The chain openings are in excess of the 8.6mm as recommended by BS EN 1176 - Monitor - No remedial work recommended

There is some wear to the shackles. - Monitor for any further deterioration and replace when 40% worn

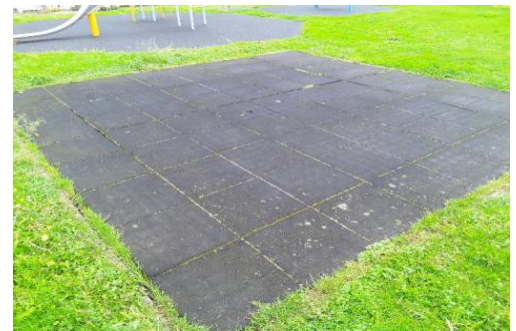
Cut off tubes are exposed in the tiles - Reduce the tubes and repair the surfacing

There are gaps opening in between the tiles - Monitor for any further deterioration and repair as required

There are significant gaps (over 30mm) between the tiled surface and the edging or between the joints in the tiled surface; these are large enough for a small foot to enter - Repair the surfacing

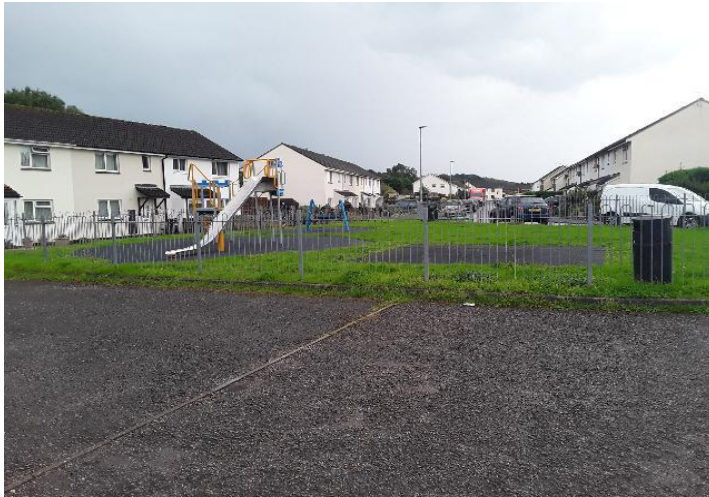
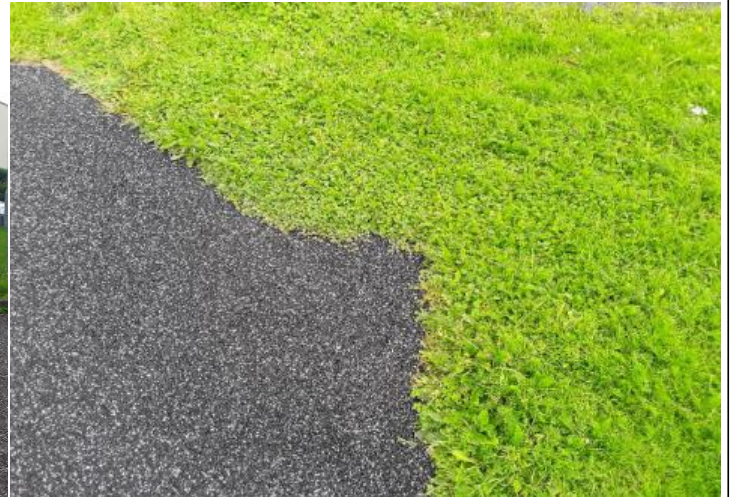
**Finding:** There is weed / vegetation growth on, between, or around the edges of the surfacing  
**Action:** Remove weed / vegetation growth

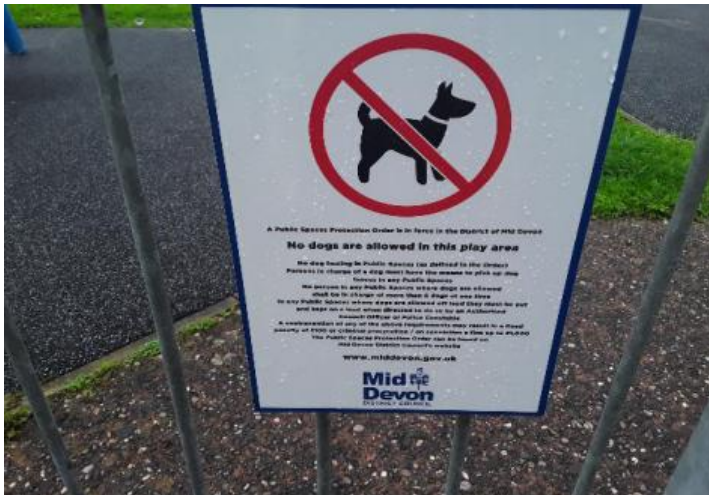
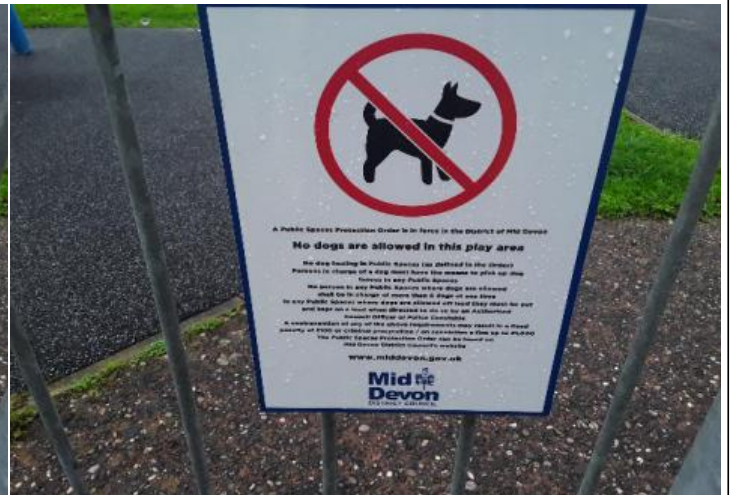
**Finding:** It is recommended that signage, with information including the site address, contact information for maintenance issues and emergency contact details are provided for the facility  
**Action:** Provide in accordance with the recommendations

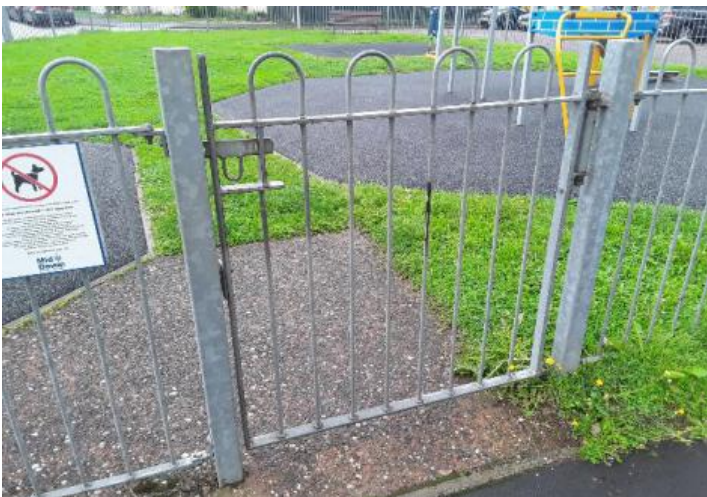
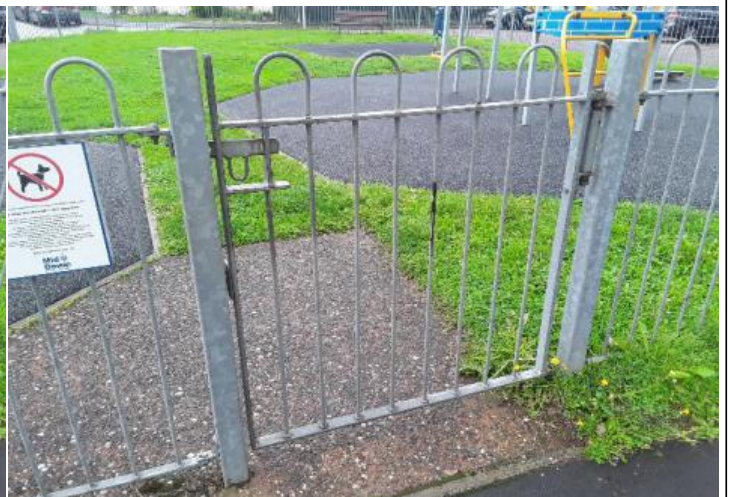
**Finding:** The gate rebounds when opened quickly and could strike the next user entering the area

**Action:** Monitor use and adjust/replace as required

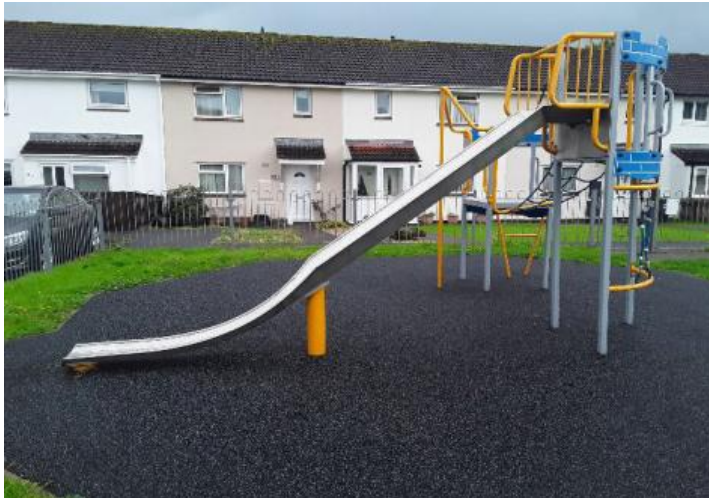
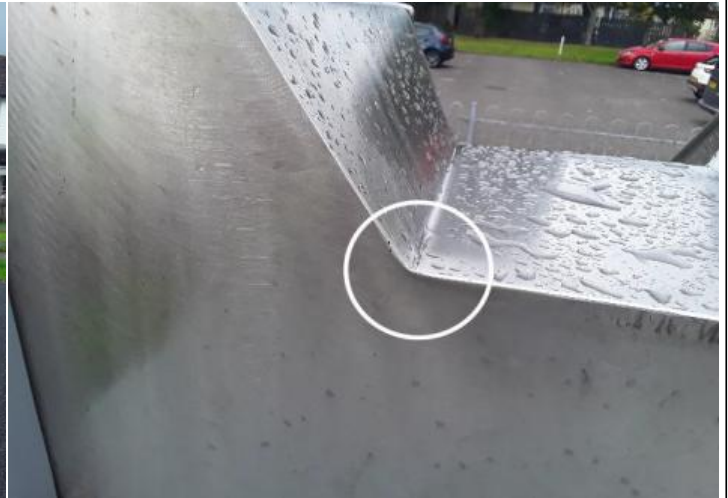
**Finding:** There are minor hairline fracture in the slide surface

**Action:** Monitor and repair if required

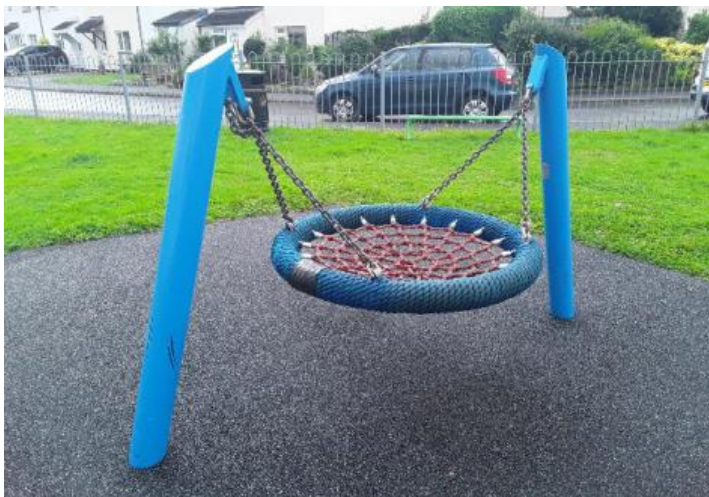
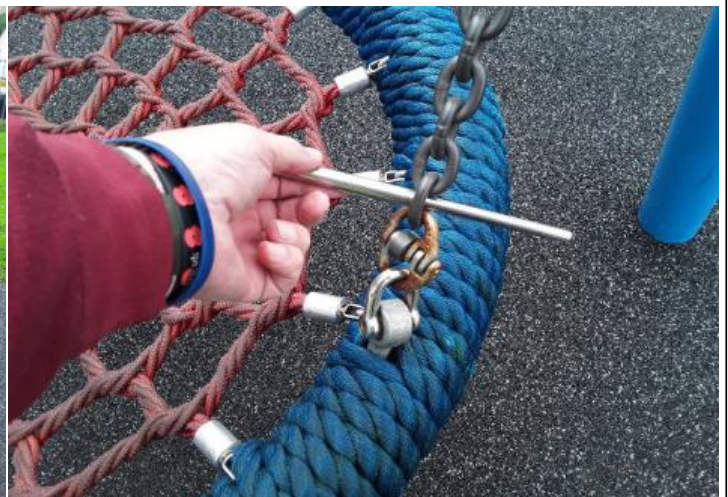
**Finding:** The chain openings are in excess of the 8.6mm as recommended by BS EN 1176

**Action:** Monitor - No remedial work recommended

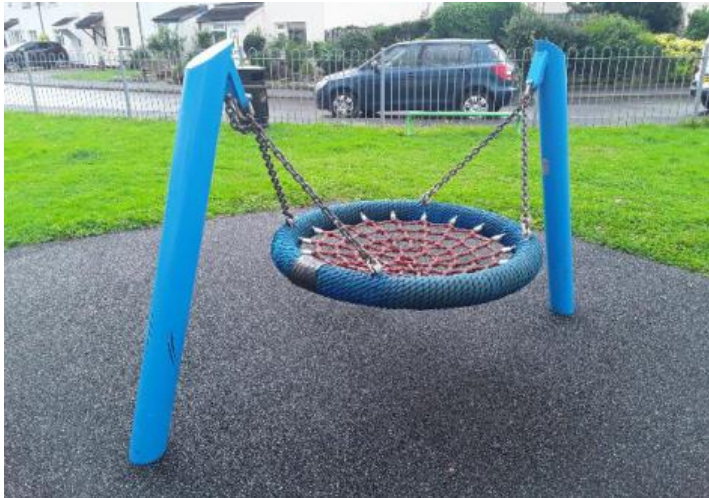
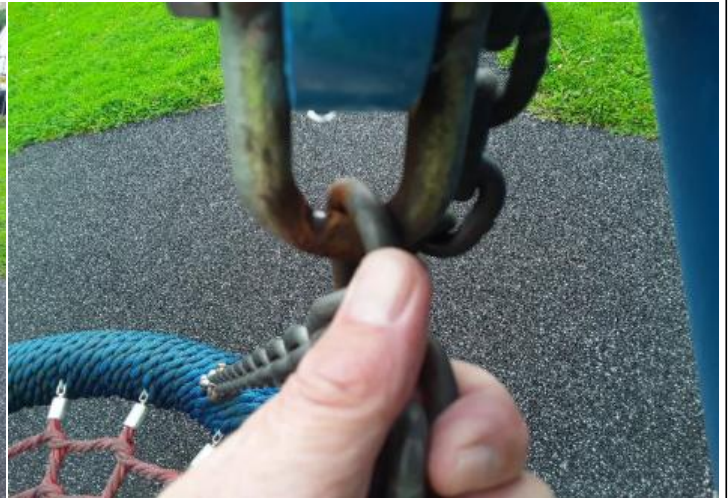
**Finding:** There is some wear to the shackles.

**Action:** Monitor for any further deterioration and replace when 40% worn

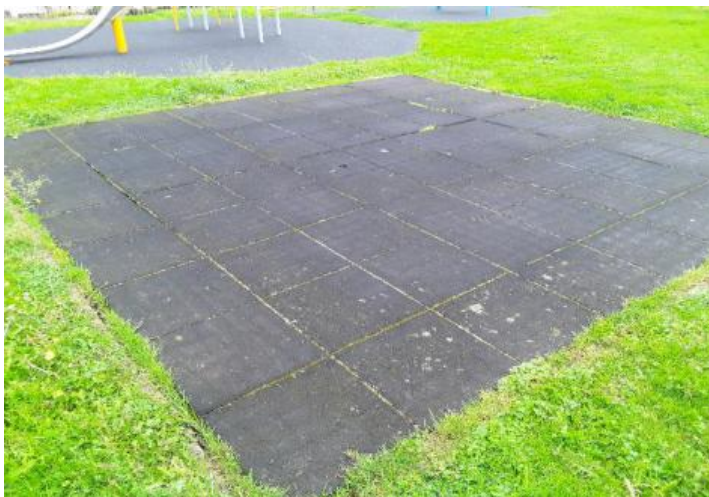
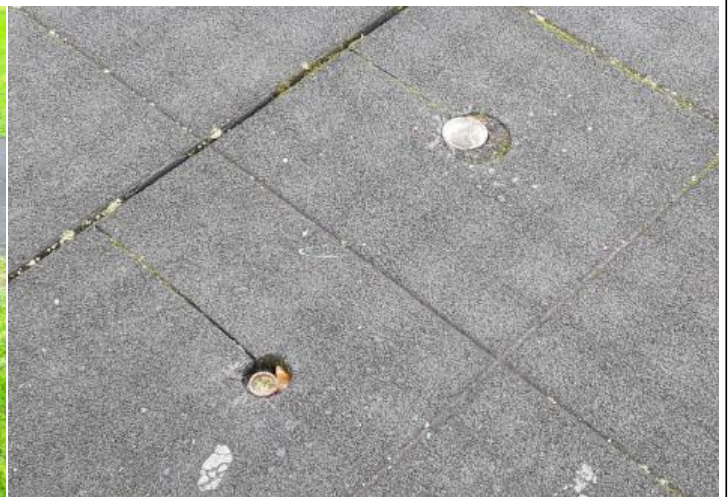
**Finding:** Cut off tubes are exposed in the tiles

**Action:** Reduce the tubes and repair the surfacing

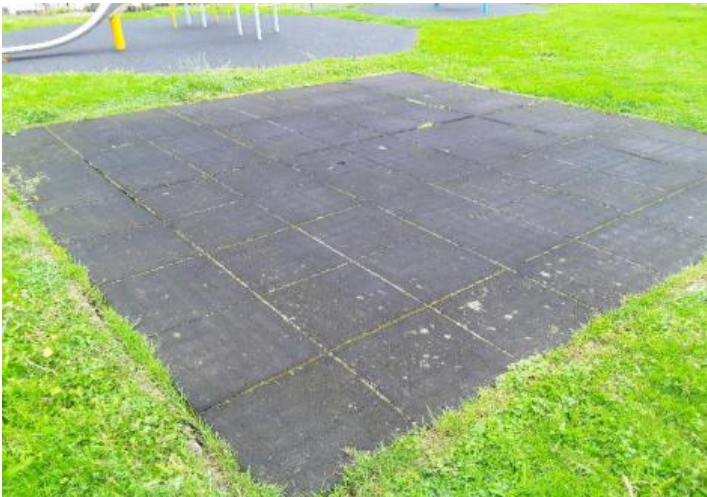
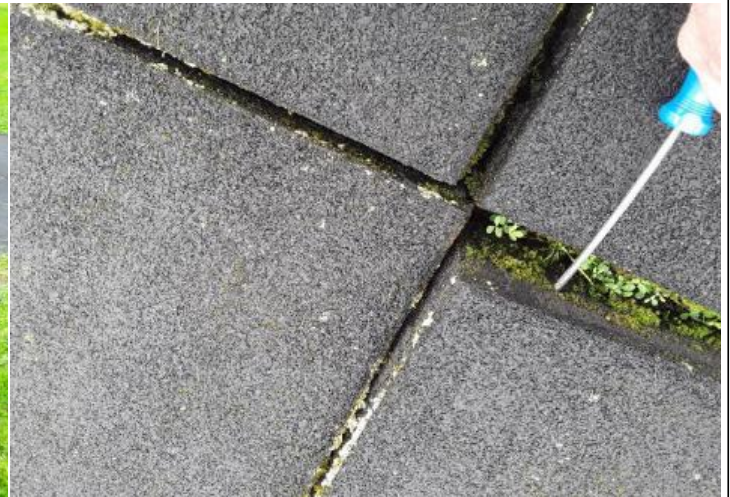
**Finding:** The tiles can easily be lifted or are lifting along the edges of the area  
**Action:** Lift and re-glue tiles to secure

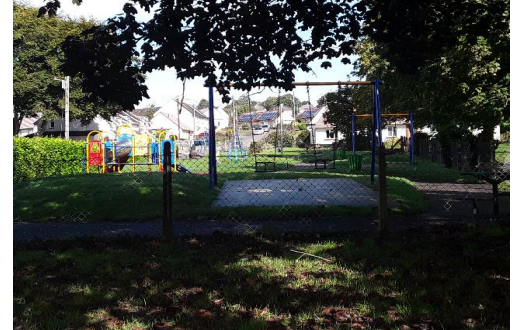
There is algae, silt or moss growth on the bonded rubber mulch surface resulting in slippery conditions - Clean and treat appropriately

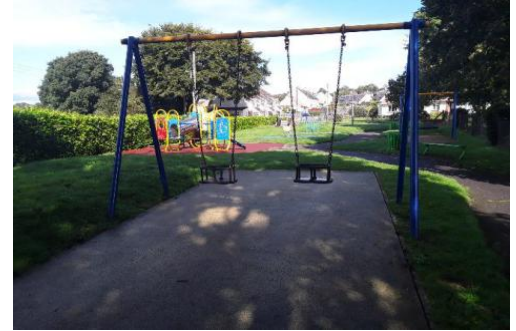
**Item:** 1 Bay 2 Seat (Cradle)  
**Manufacturer:** Wicksteed Playgrounds  
**Surface Type:** Wet Pour  
**Item Quantity:** 1  
**Equipment Compliance:** No  
**Surface Area Compliance:** Yes

The chain openings are in excess of the 8.6mm as recommended by BS EN 1176 - Monitor - No remedial work recommended

There is some notable evidence of chain wear - Monitor for any further deterioration and replace when 40% worn

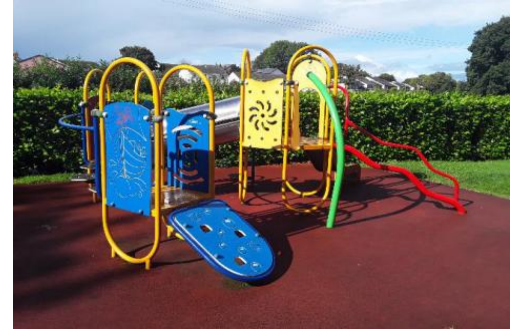
**Item:** Multi Play (Toddler)  
**Manufacturer:** Wicksteed Playgrounds  
**Surface Type:** Wet Pour  
**Item Quantity:** 1  
**Equipment Compliance:** Yes  
**Surface Area Compliance:** Yes

The paintwork on this item has been damaged or worn exposing the metal underneath which is rusting / corroding - Treat affected areas and repaint

There is evidence of fire damage to the surfacing - Monitor for any further deterioration and repair as required

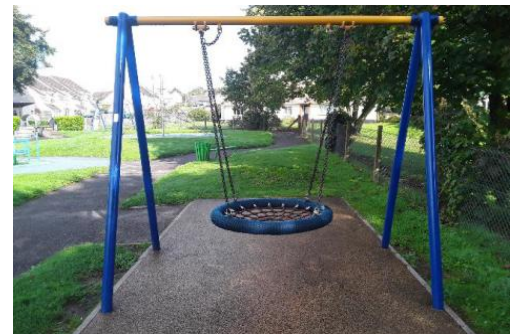
**Item:** Basket Swing - Type 1  
**Manufacturer:** Wicksteed Playgrounds  
**Surface Type:** Wet Pour  
**Item Quantity:** 1  
**Equipment Compliance:** No  
**Surface Area Compliance:** Yes

The chain links are worn in excess of 40% and require renewing - Replace worn chains

The bushes are worn or missing - Replace worn or missing bushes

The chain openings are in excess of the 8.6mm as recommended by BS EN 1176 - Monitor - No remedial work recommended

There is some wear to the shackles. - Monitor for any further deterioration and replace when 40% worn

The basket bushes are worn or missing - Replace worn or missing bushes

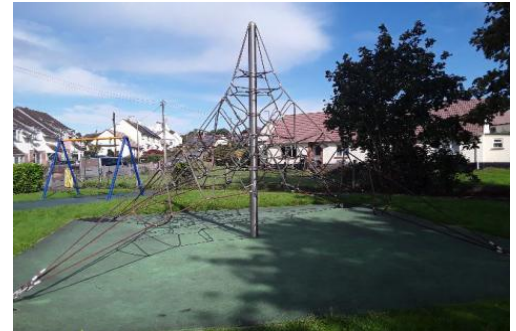
**Item:** Space Net  
**Manufacturer:** Tayplay Ltd  
**Surface Type:** Wet Pour  
**Item Quantity:** 1  
**Equipment Compliance:** No  
**Surface Area Compliance:** Yes

The surface is lifting around the anchor points creating trip hazards - Repair perimeter of surfacing to remove trip points

The ropes/nets are worn/damaged in places - Monitor for any further deterioration and repair or replace as required

The surface has subsided creating unforeseen changes in levels adjacent to one inspection chamber - Repair as required to provide a uniform surface

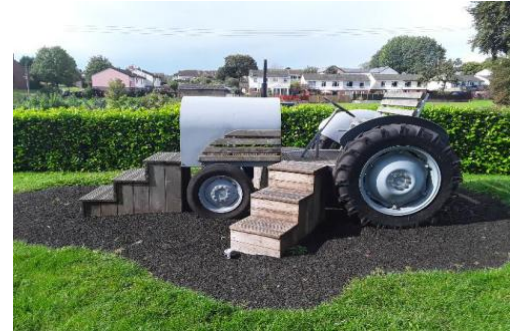
**Item:** Tractor  
**Manufacturer:** Image Playgrounds  
**Surface Type:** Wet Pour  
**Item Quantity:** 1  
**Equipment Compliance:** No  
**Surface Area Compliance:** Yes

The item has exposed edges and corners with a radius of less than 3mm and fails the requirements of BS EN 1176 - Provide a 3mm radius to all exposed edges and corners

A number of fixing(s) have worked loose on the steering wheel - Secure all loose fixings

The paintwork on this item has been damaged or worn exposing the metal underneath which is rusting / corroding - Treat affected areas and repaint

The unit is easily accessible and should have the appropriate barriers installed to meet the requirements of BS EN 1176 Part 1 as the height of the unit exceeds 600mm - Monitor - No remedial work recommended

The surface has subsided in some areas - Monitor for any further deterioration and repair as required

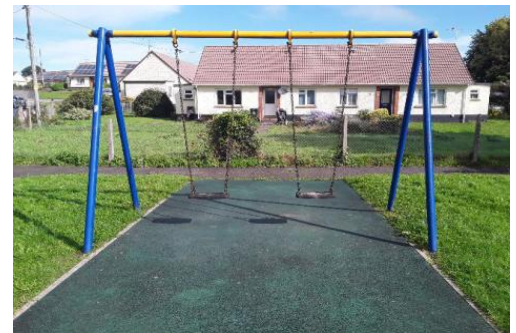
**Item:** 1 Bay 2 Seat (Flat)  
**Manufacturer:** Wicksteed Playgrounds  
**Surface Type:** Wet Pour  
**Item Quantity:** 1  
**Equipment Compliance:** No  
**Surface Area Compliance:** Yes

The chain openings are in excess of the 8.6mm as recommended by BS EN 1176 - Monitor - No remedial work recommended

There is some notable evidence of chain wear - Monitor for any further deterioration and replace when 40% worn

The bushes are showing signs of wear - Monitor for any further deterioration and replace as required

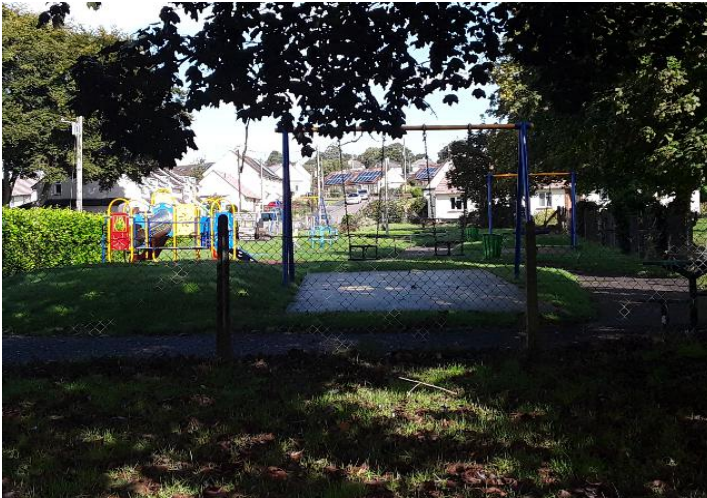
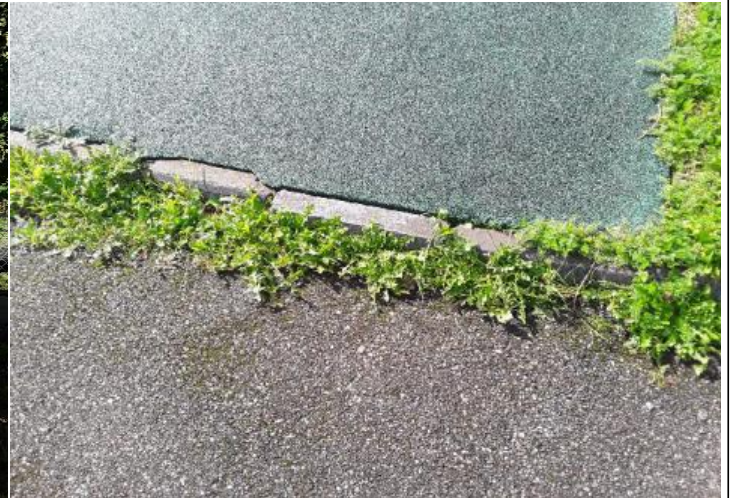
**Finding:** There is weed / vegetation growth on, between, or around the edges of the footpath surfacing  
**Action:** Remove weed / vegetation growth

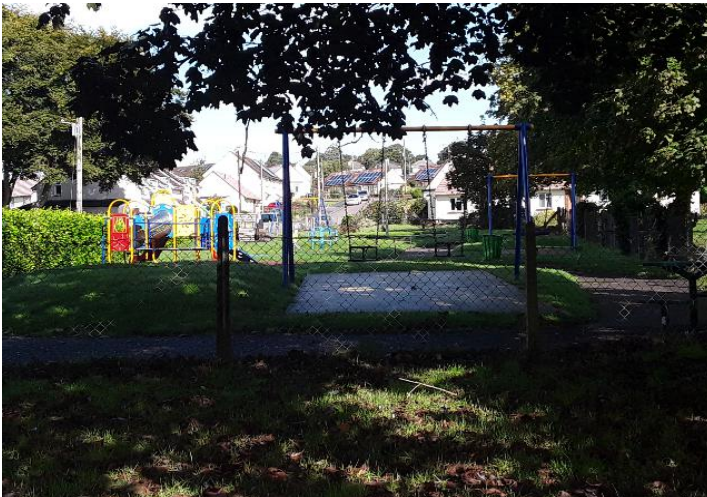
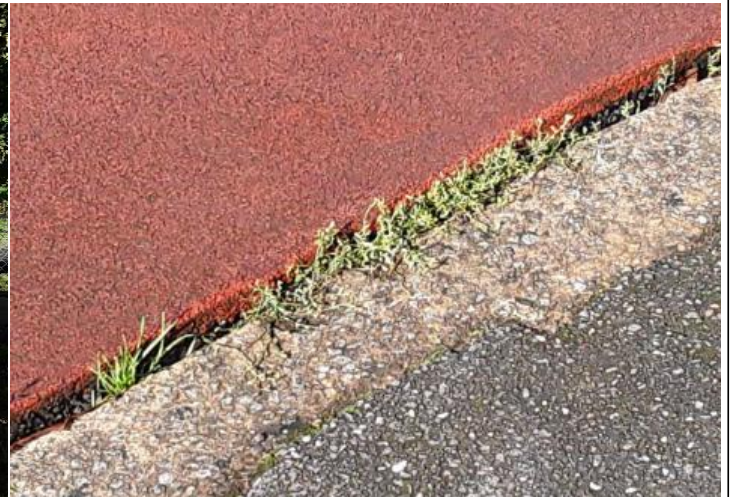
**Finding:** There is weed / vegetation growth on, between, or around the edges of the safety surfacing  
**Action:** Remove weed / vegetation growth

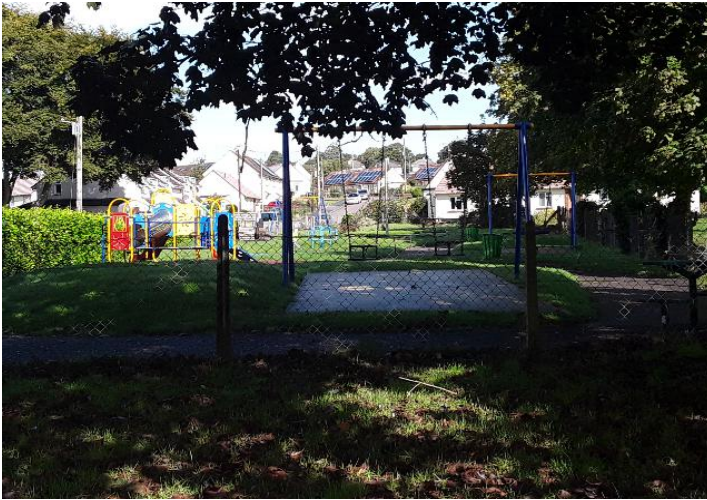
There are trip hazards present over the edgings - Reinststate surrounding surfaces to level to remove the trip points

**Finding:** There are trip hazards present over the edgings

**Action:** Reinstate surrounding surfaces to level to remove the trip points

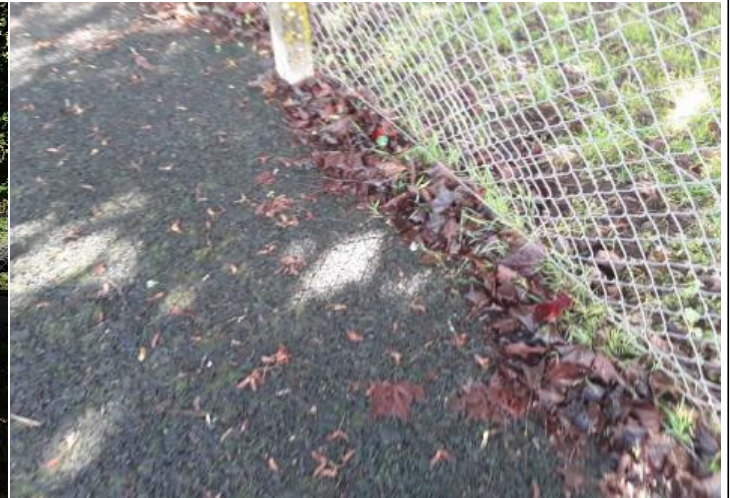
**Finding:** There is some tree debris on the surfacing

**Action:** Remove and maintain

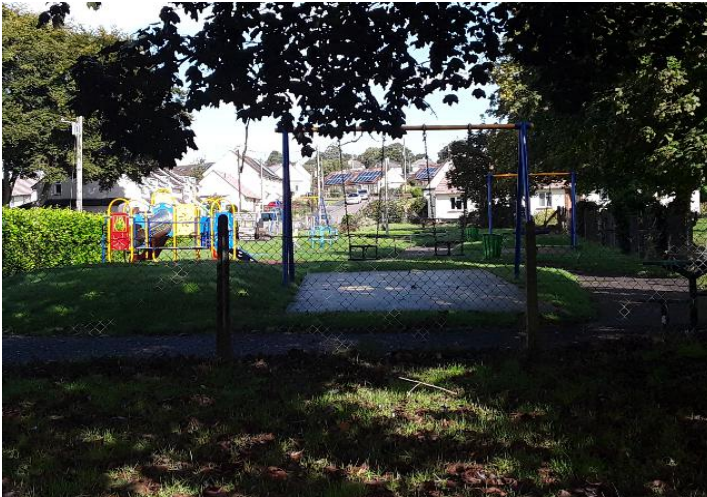
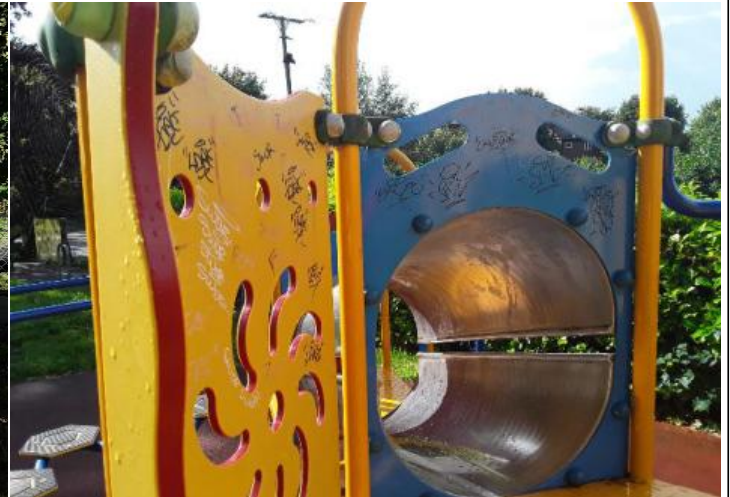
**Finding:** There is offensive graffiti present

**Action:** Remove as soon as practicable

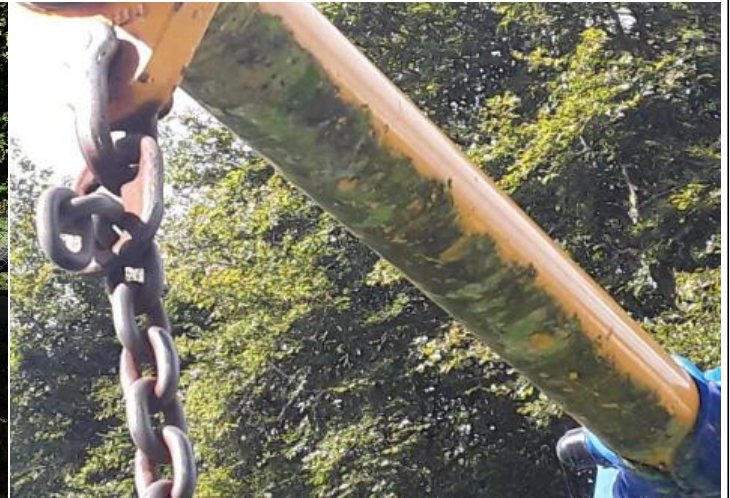
**Finding:** There is algae or moss on the surface of the equipment

**Action:** Clean and treat appropriately

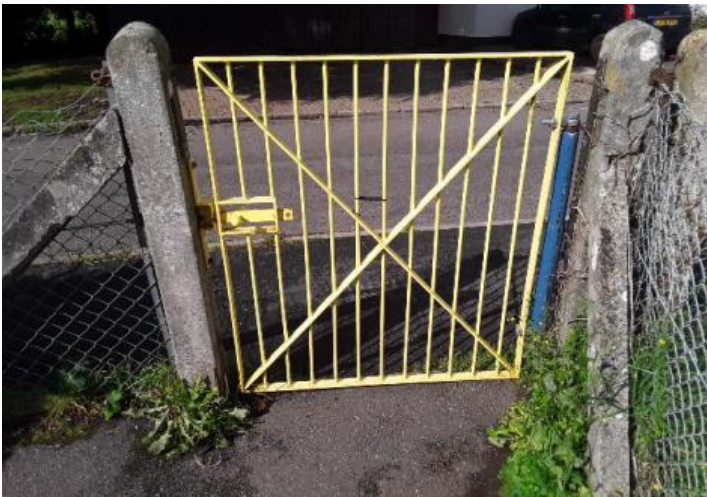
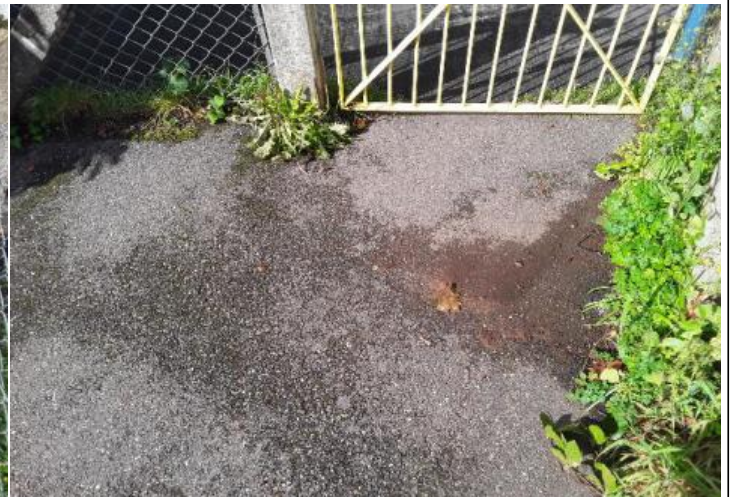
The surface has subsided in front of the gate - Monitor for any further deterioration and repair as required

**Finding:** The surface has subsided in front of the gate

**Action:** Monitor for any further deterioration and repair as required

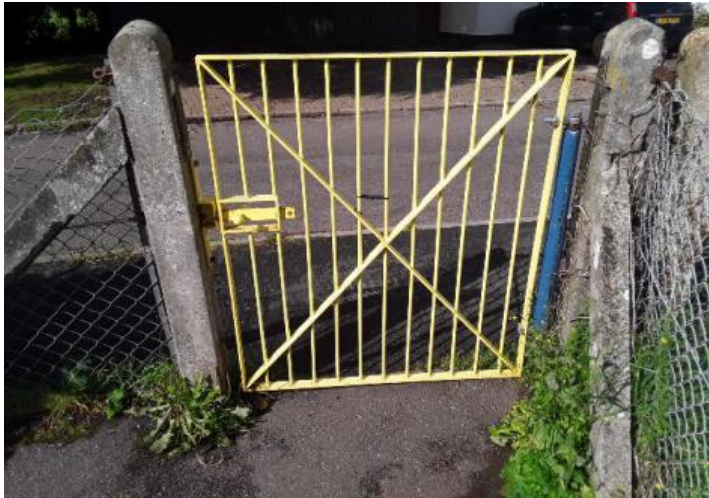
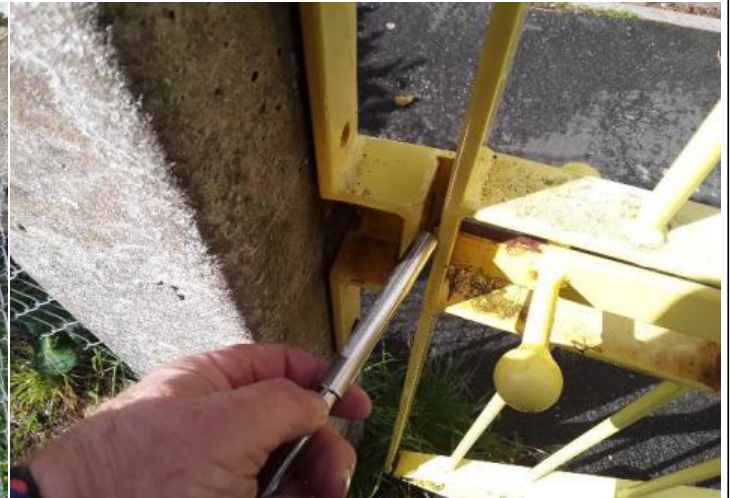
**Finding:** There are openings that are less than 12mm that could trap or crush fingers

**Action:** Provide a 12mm gap throughout full range of motion at both sides of gate

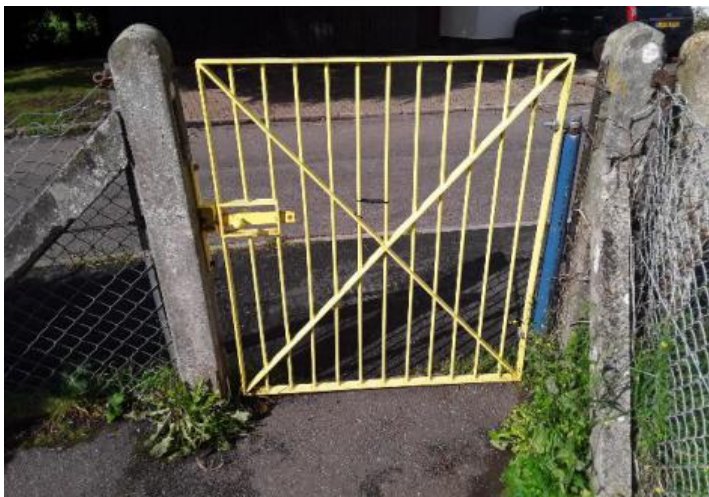
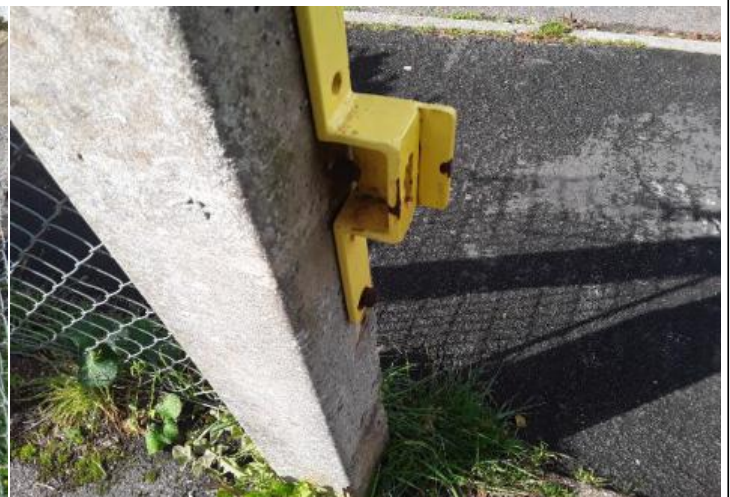
The rubber buffer is missing from the latch plate - Replace rubber buffer

**Finding:** The rubber buffer is missing from the latch plate

**Action:** Replace rubber buffer

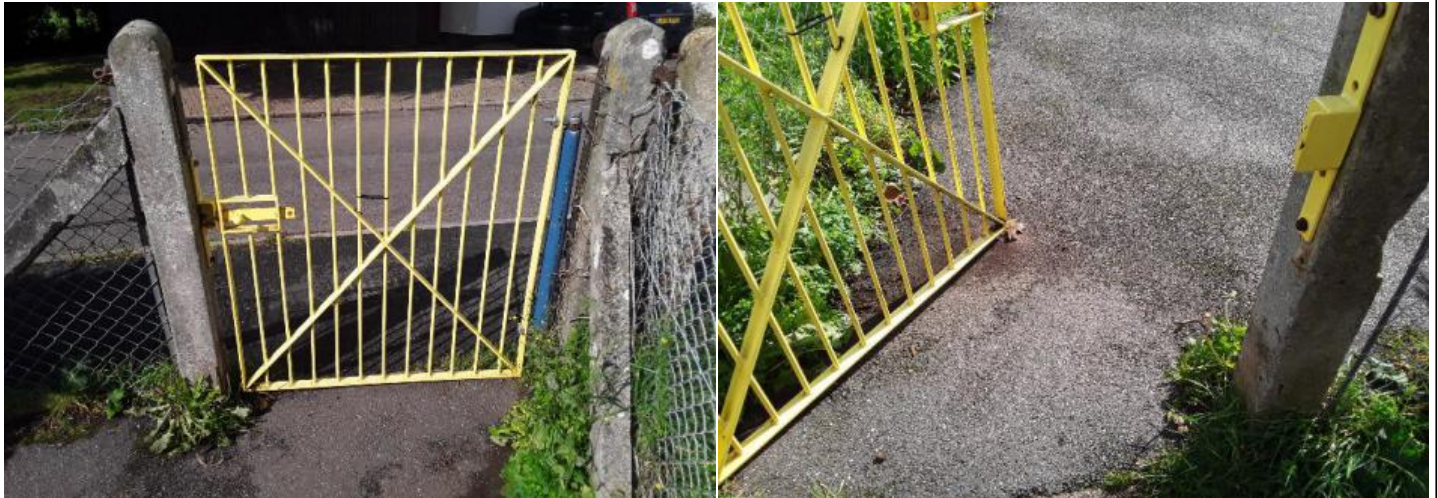
**Finding:** The gate is not operating correctly

**Action:** Take effective action to ensure the gate closes between 4 and 8 seconds

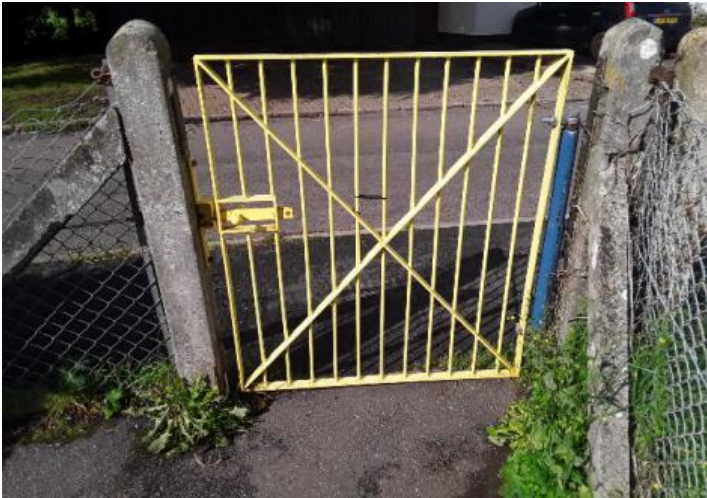
There are trip hazards present over the edgings under the gate - Reinstate surrounding surfaces to level to remove the trip points

**Finding:** There are trip hazards present over the edgings under the gate

**Action:** Reinstate surrounding surfaces to level to remove the trip points

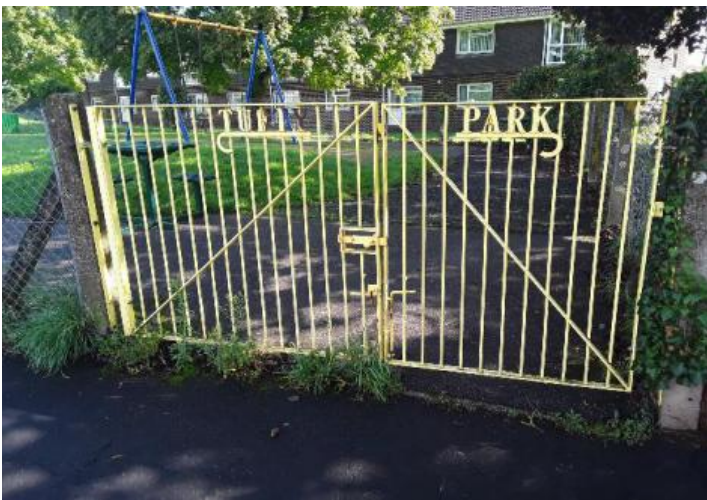
The paintwork on this item has been damaged or worn exposing the metal underneath which is rusting / corroding - Treat affected areas and repaint

**Finding:** The paintwork on this item has been damaged or worn exposing the metal underneath which is rusting / corroding

**Action:** Treat affected areas and repaint

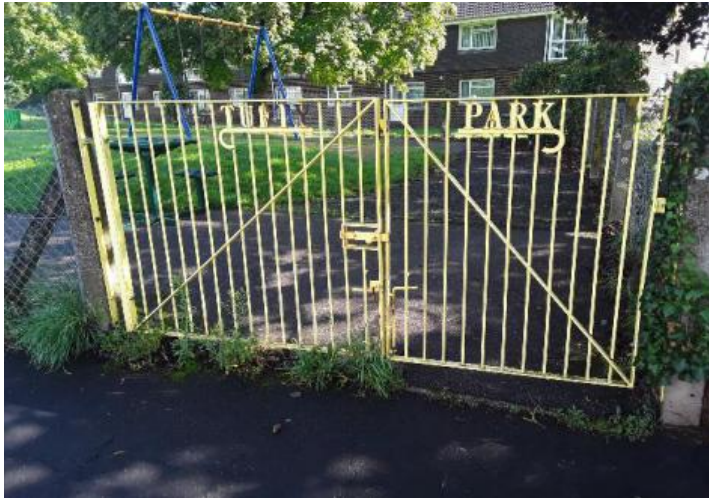
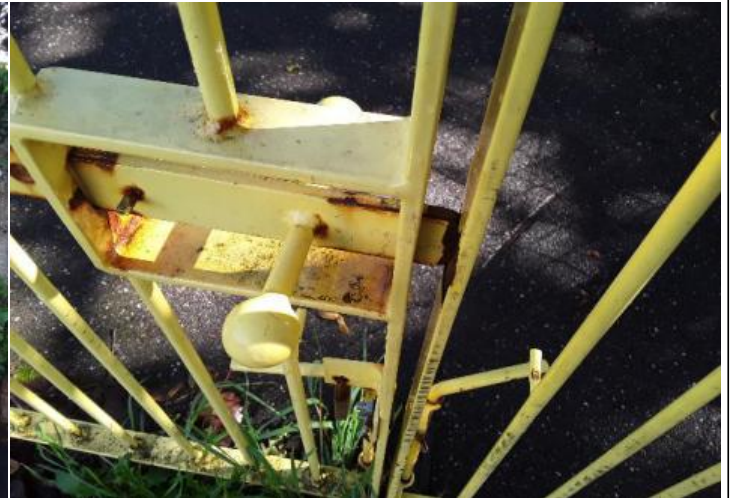
**Finding:** The gate latch doesn't align with the opening in the adjacent gate  
**Action:** Adjust the gate

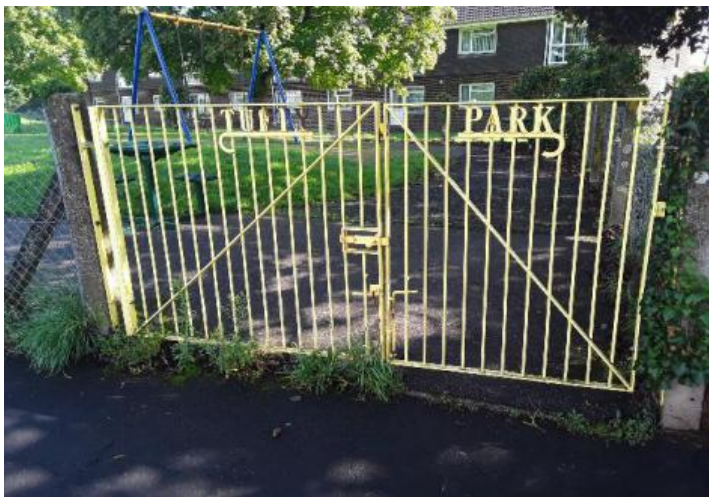
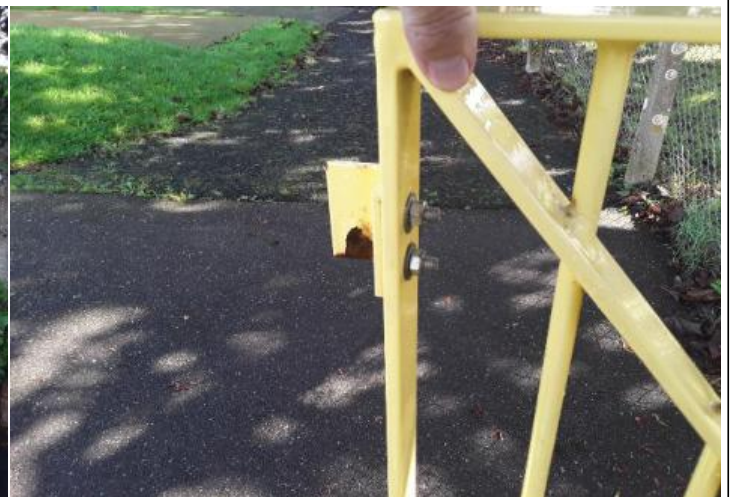
The rubber buffer is missing from the latch plate - Replace rubber buffer

**Finding:** The rubber buffer is missing from the latch plate  
**Action:** Replace rubber buffer

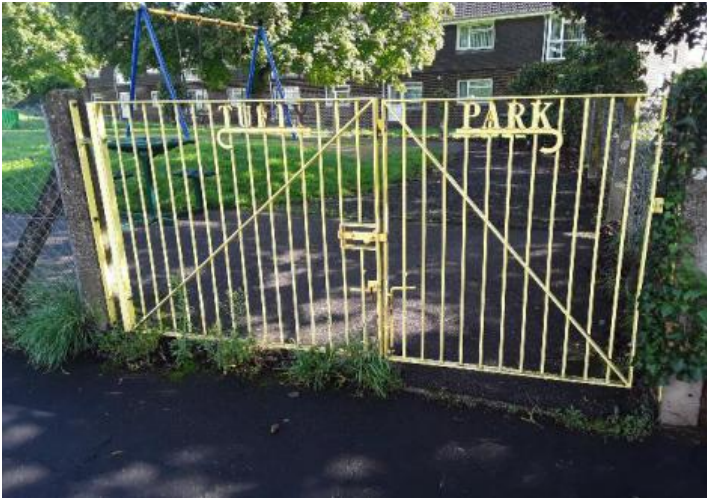
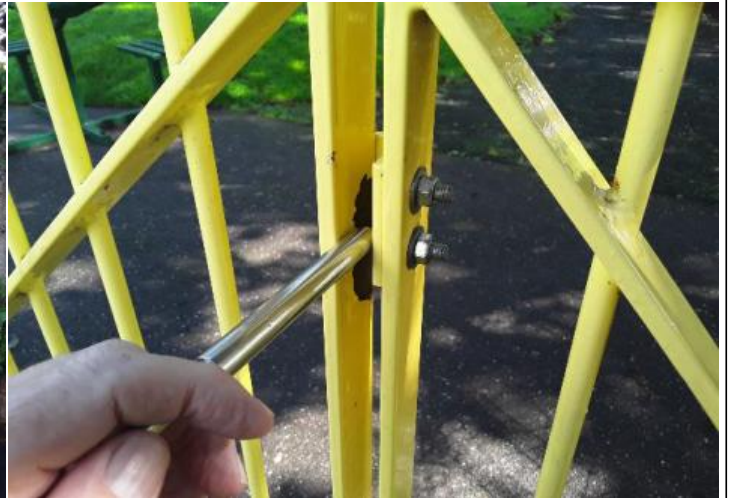
**Finding:** There are openings that are less than 12mm that could trap or crush fingers

**Action:** Provide a 12mm gap throughout full range of motion at both sides of gate

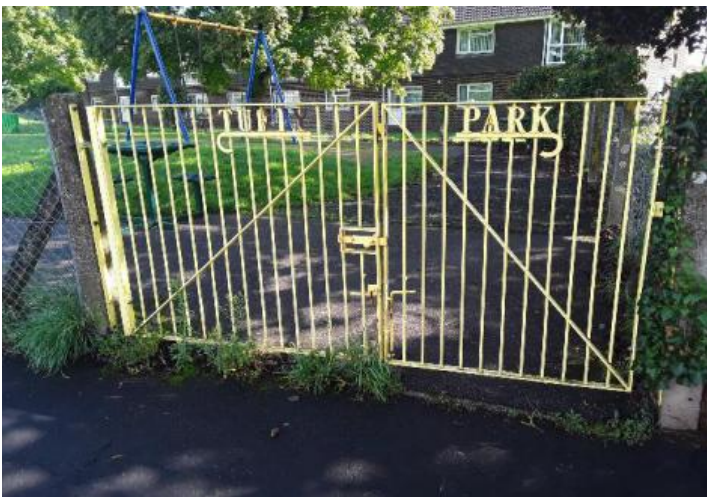
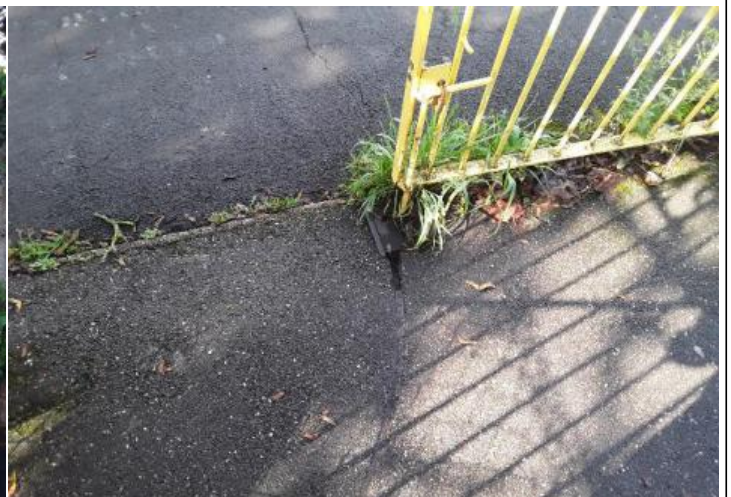
The drop bolt has damaged the tarmac under the gate - Monitor and repair if required

**Finding:** The drop bolt has damaged the tarmac under the gate

**Action:** Monitor and repair if required

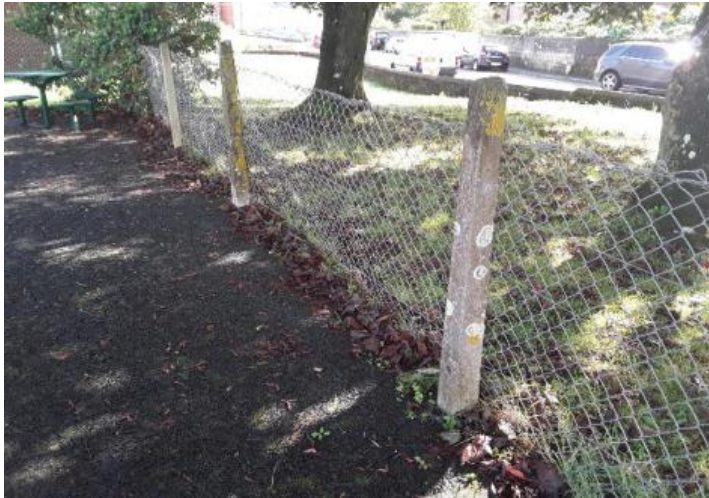
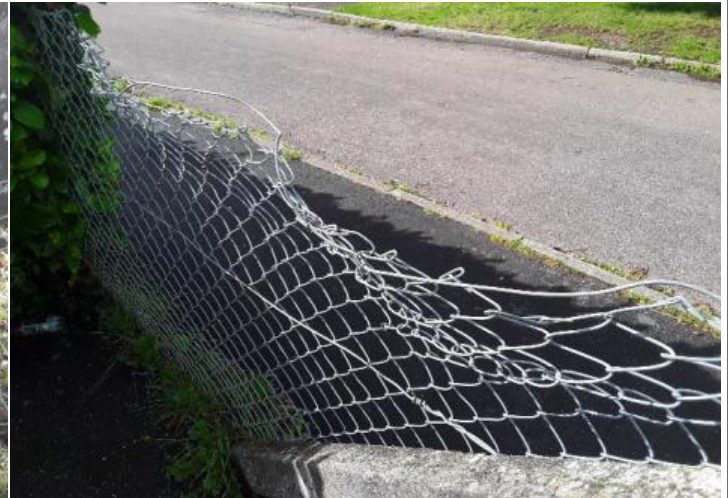
There is some damage to the fence sections - Monitor for any further deterioration and repair as required

<b>Finding:</b> There is some damage to the fence sections	<b>Action:</b> Monitor for any further deterioration and repair as required
--	---

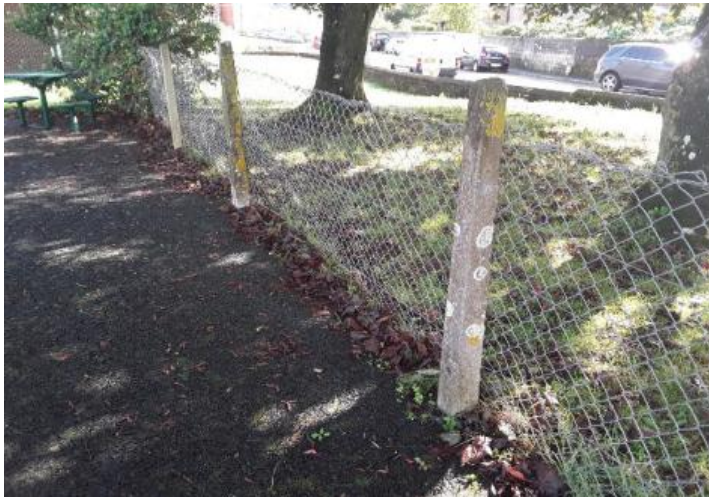
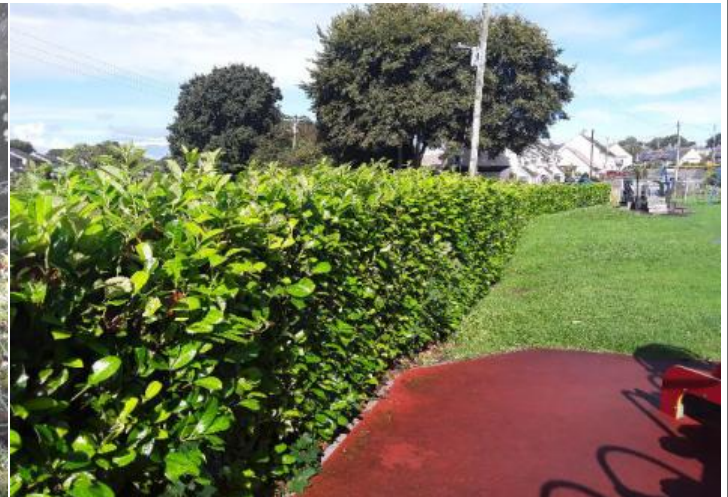
<b>Finding:</b> The laurel hedge has grown over and around a large section of the fence	<b>Action:</b> Monitor and maintain the hedge
---	---
