NOTICE IS GIVEN THAT A SERVICES, PROPERTY AND OUTDOOR SPACES COMMITTEE OF  
CULLOMPTON TOWN COUNCIL  
WILL BE HELD AT THE TOWN HALL, CULLOMPTON  
ON THURSDAY, 9<sup>th</sup> NOVEMBER 2023 AT 7PM

**MINUTES OF MEETING OF THE SERVICES, PROPERTY AND OUTDOOR SPACES COMMITTEE  
DATED TUESDAY 12 SEPTEMBER 2023 AT 7:00PM AT CULLOMPTON TOWN HALL**

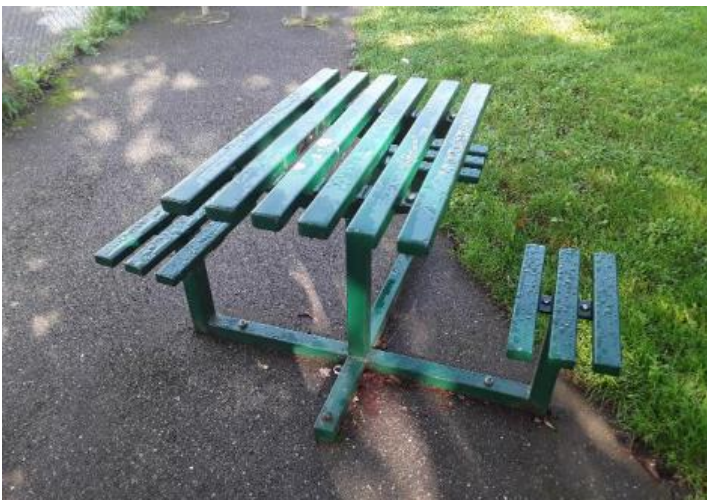
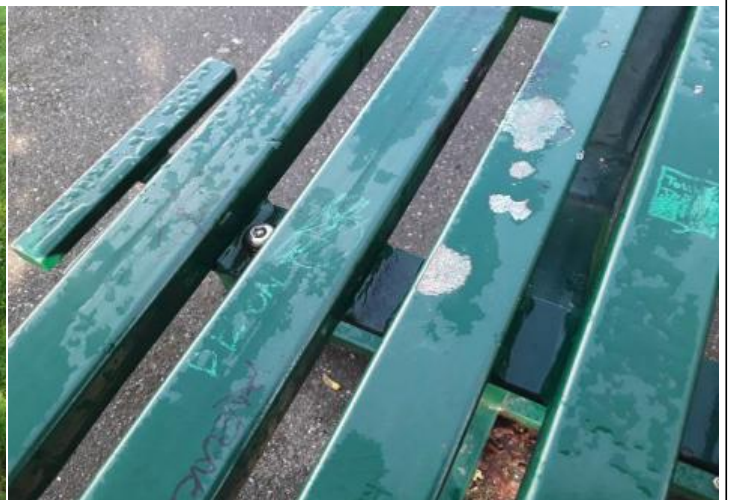
**Finding:** The paint is flaking off the metalwork

**Action:** Rub down and re-paint

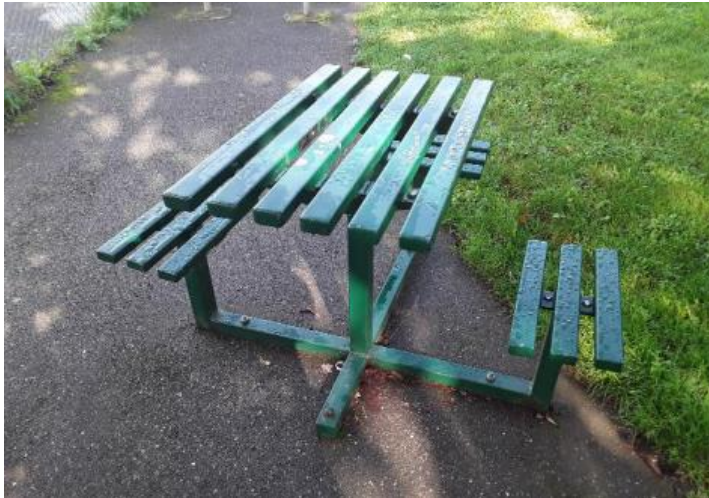
**Finding:** There is/are bolt cap covers missing or damaged on the item

**Action:** Replace missing or damaged bolt cap covers

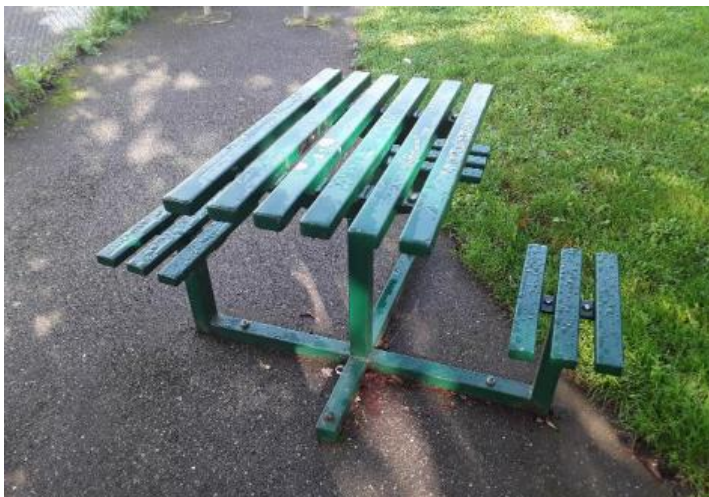
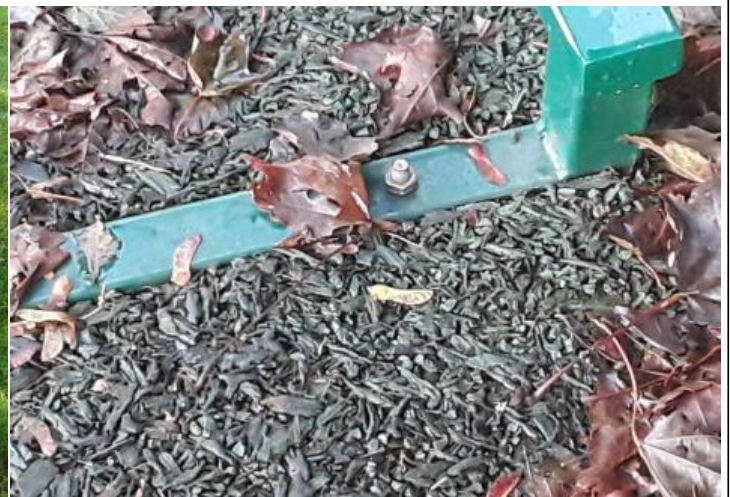
**Finding:** There are projecting bolt thread(s) present

**Action:** Remove excess thread length and deburr or provide cap

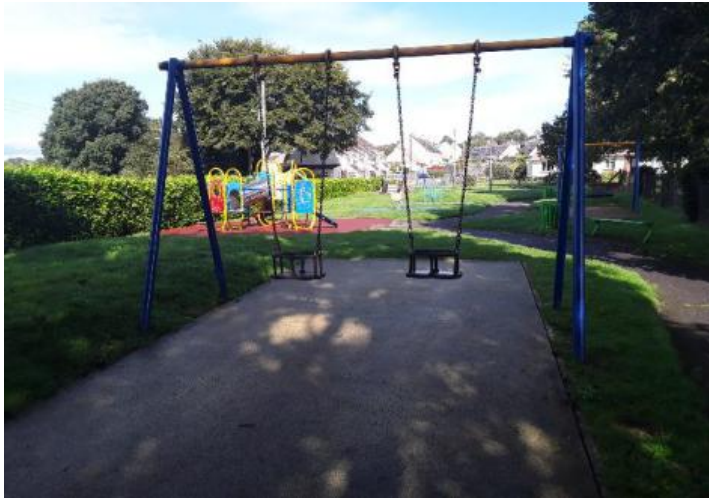
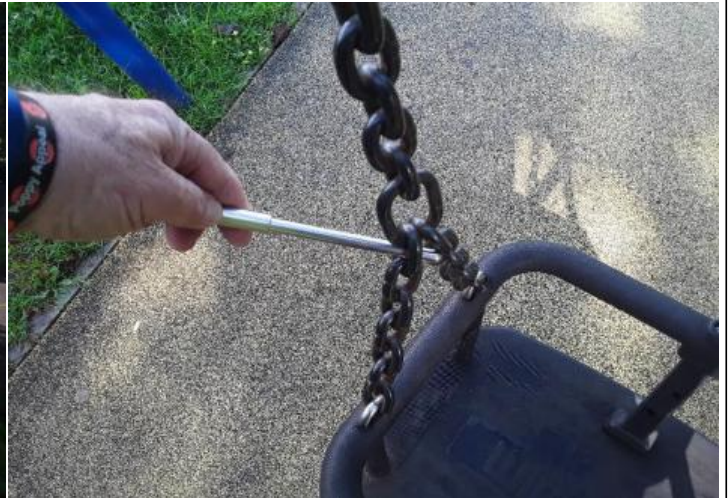
**Finding:** The chain openings are in excess of the 8.6mm as recommended by BS EN 1176 **Action:** Monitor - No remedial work recommended

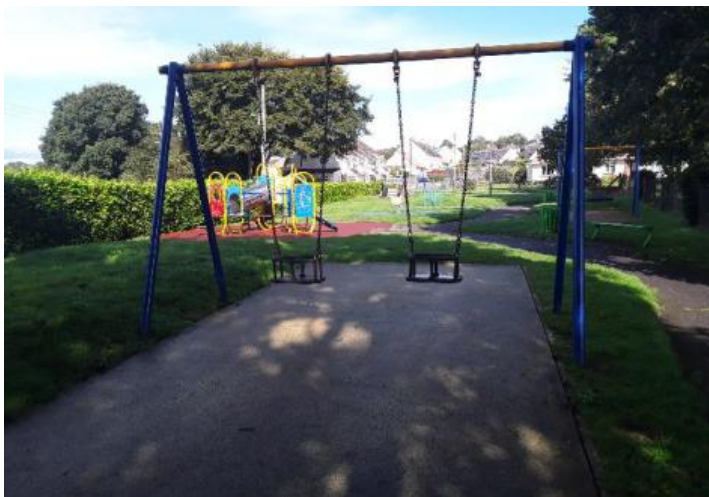
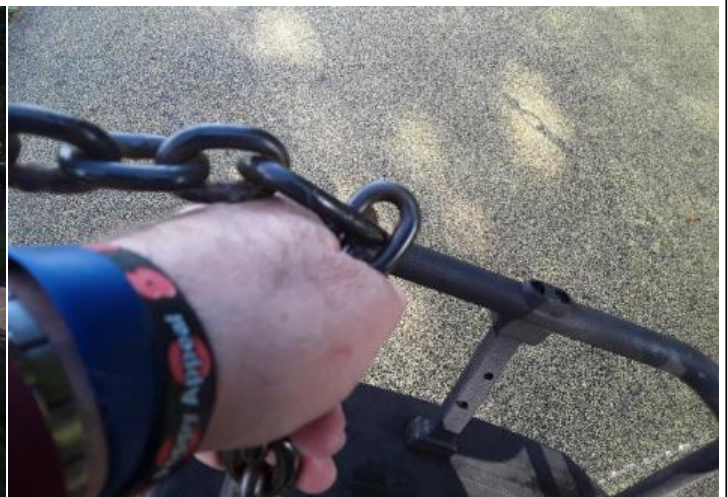
**Finding:** There is some notable evidence of chain wear **Action:** Monitor for any further deterioration and replace when 40% worn

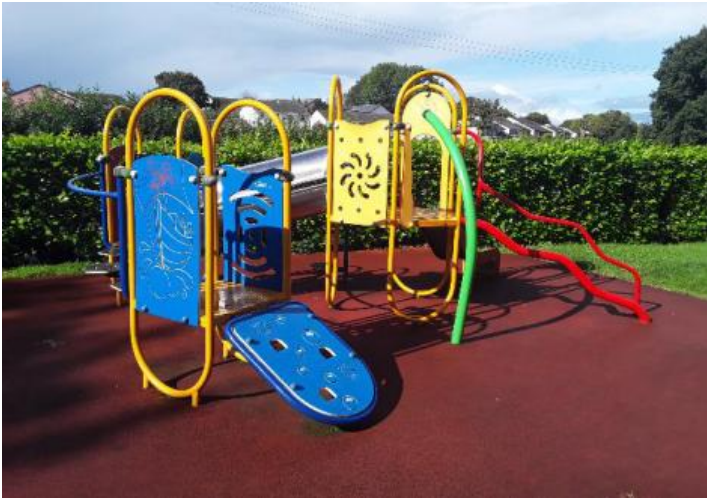
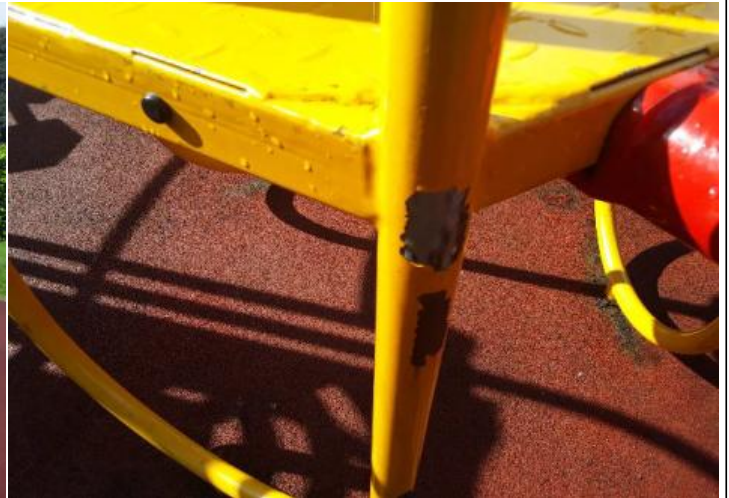
**Finding:** The paintwork on this item has been damaged or worn exposing the metal underneath which is rusting / corroding

**Action:** Treat affected areas and repaint

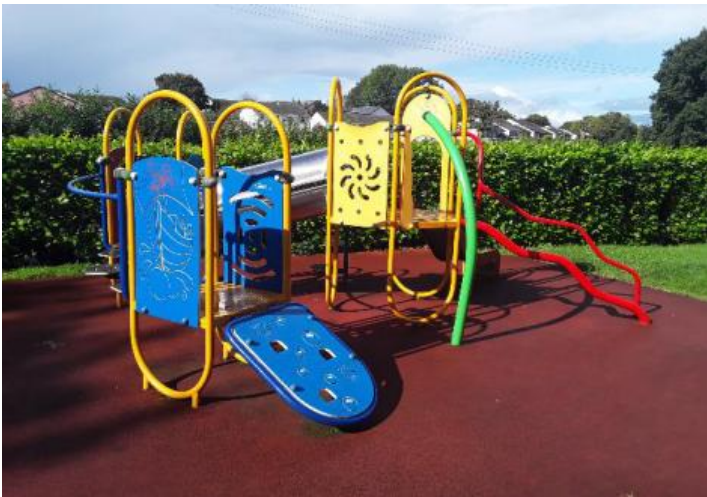
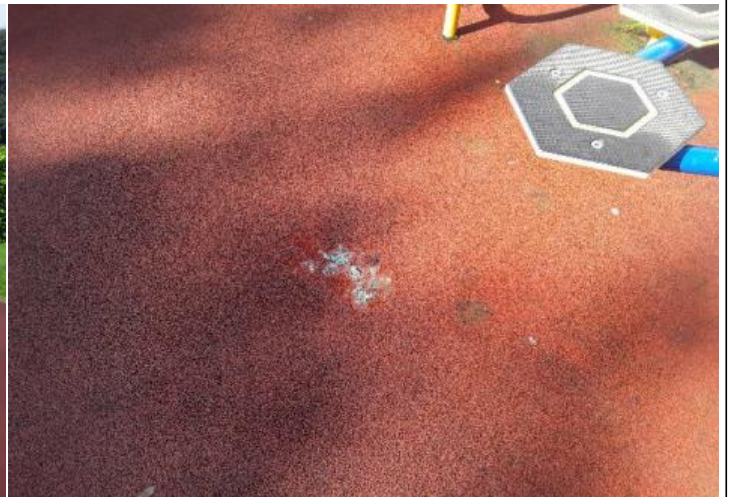
**Finding:** There is evidence of fire damage to the surfacing

**Action:** Monitor for any further deterioration and repair as required

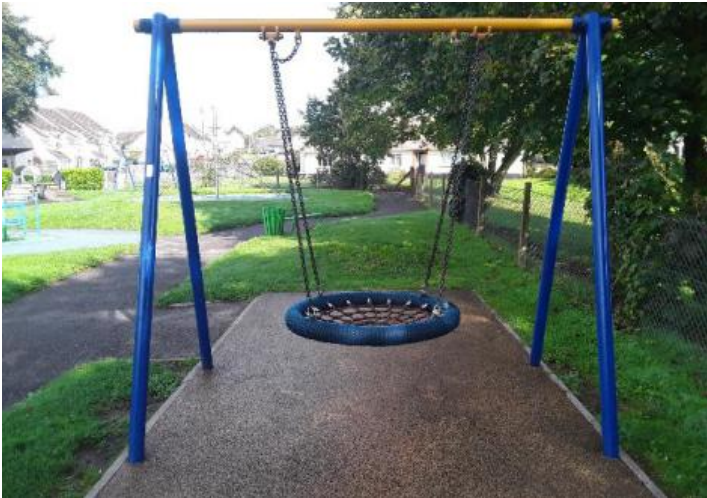
**Finding:** The chain links are worn in excess of 40% and require renewing

**Action:** Replace worn chains

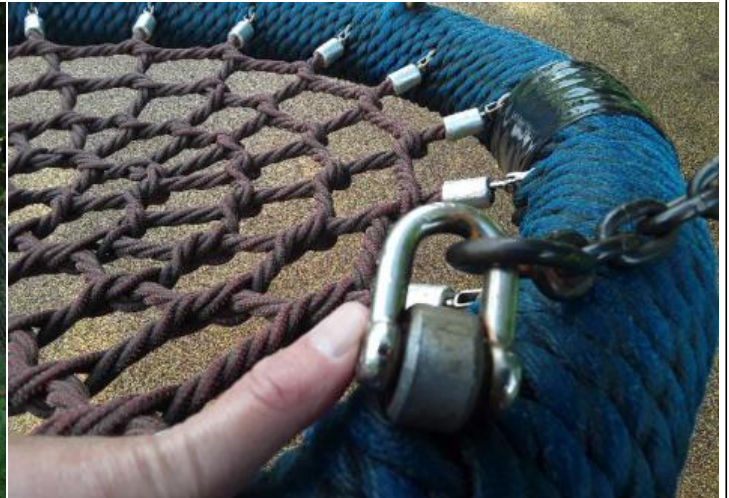
**Finding:** There is some wear to the shackles.

**Action:** Monitor for any further deterioration and replace when 40% worn

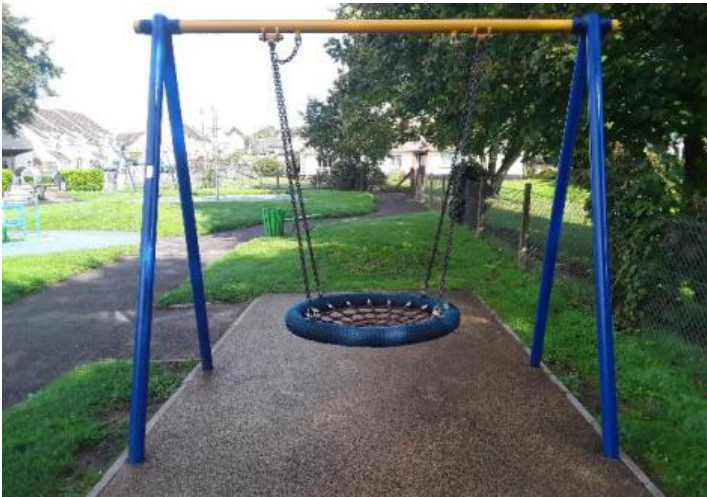
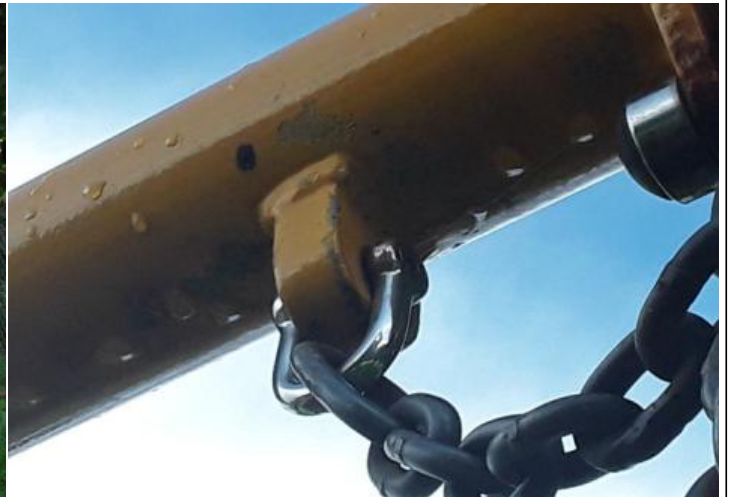
**Finding:** The bushes are worn or missing

**Action:** Replace worn or missing bushes

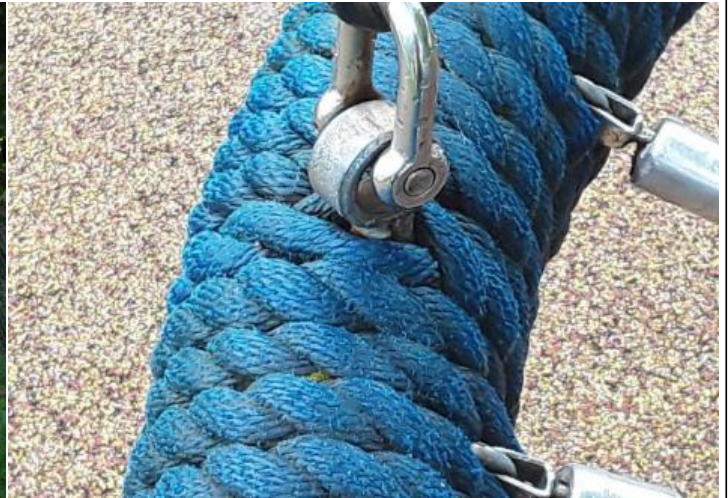
**Finding:** The basket bushes are worn or missing

**Action:** Replace worn or missing bushes

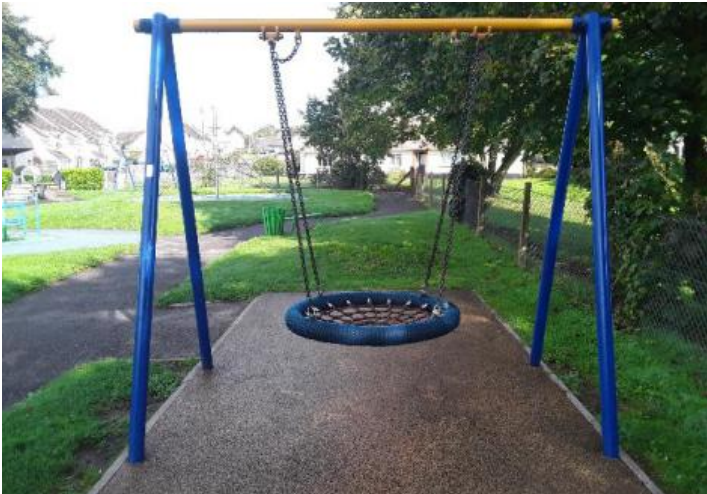
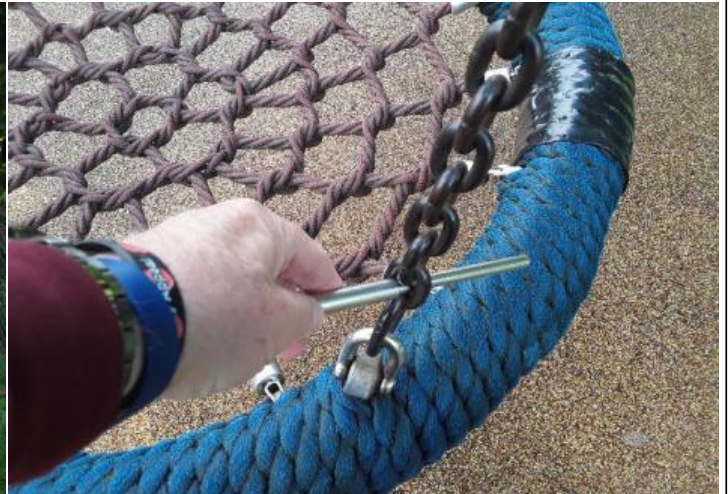
**Finding:** The chain openings are in excess of the 8.6mm as recommended by BS EN 1176

**Action:** Monitor - No remedial work recommended

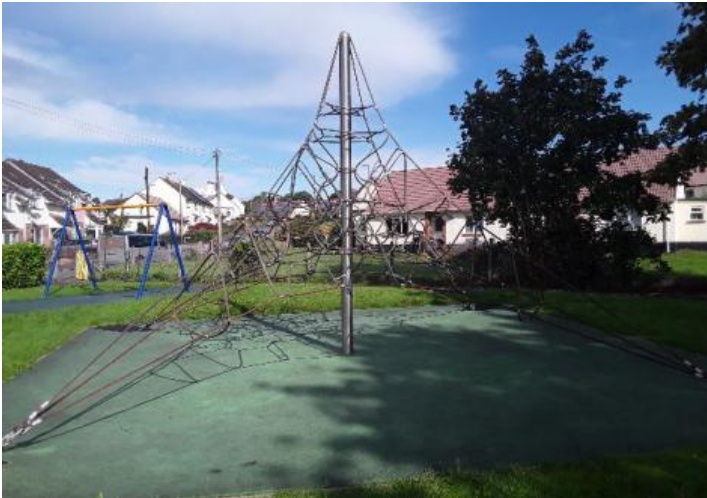
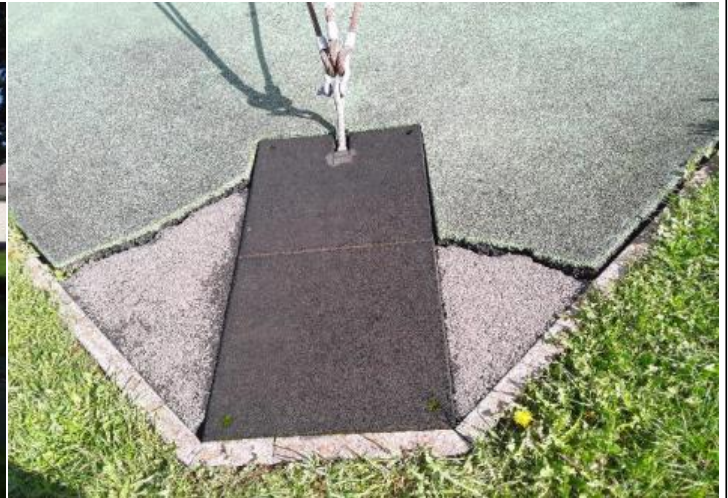
**Finding:** The surface is lifting around the anchor points creating trip hazards

**Action:** Repair perimeter of surfacing to remove trip points

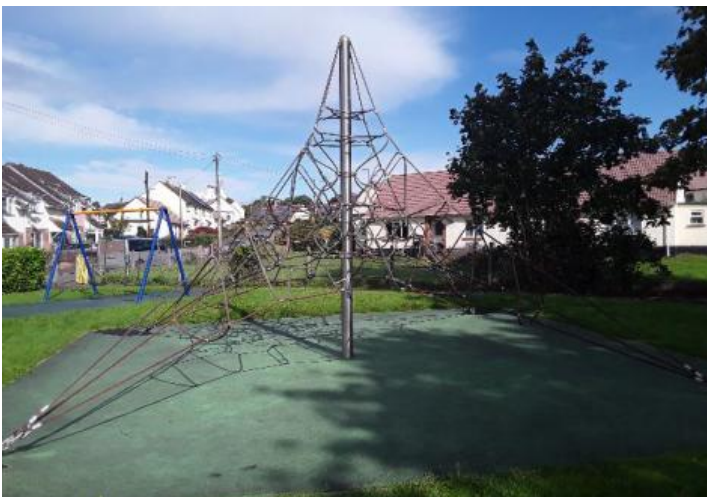
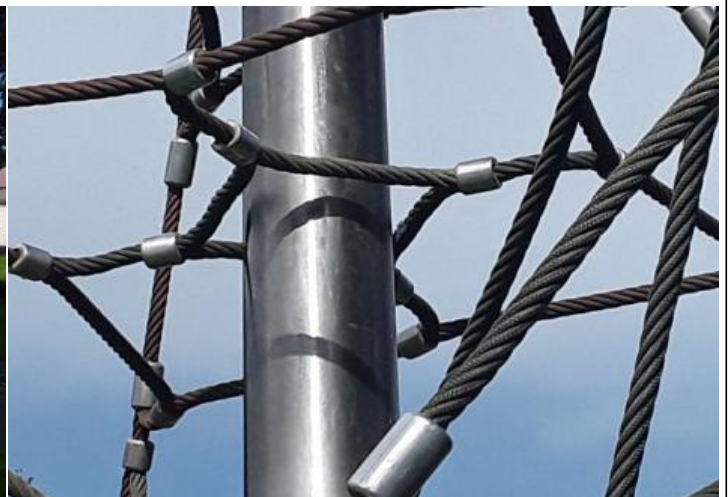
**Finding:** There is a potential crushing point between the rope and the central post in contravention of BS EN 1176 Part 1

**Action:** Re-tension ropes to ensure the rope is spaced evenly around the post

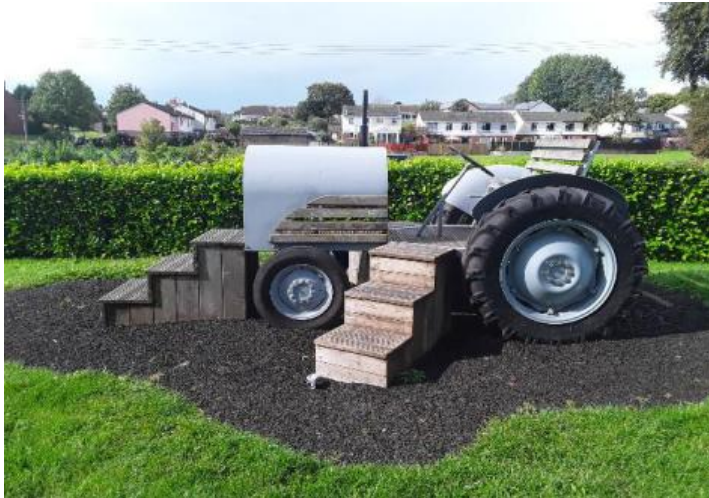
**Finding:** The item has exposed edges and corners with a radius of less than 3mm and fails the requirements of BS EN 1176  
**Action:** Provide a 3mm radius to all exposed edges and corners

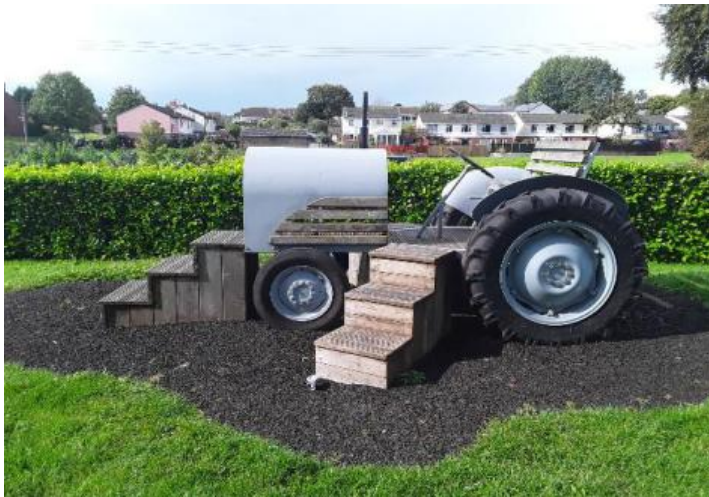
**Finding:** A number of fixing(s) have worked loose on the steering wheel  
**Action:** Secure all loose fixings

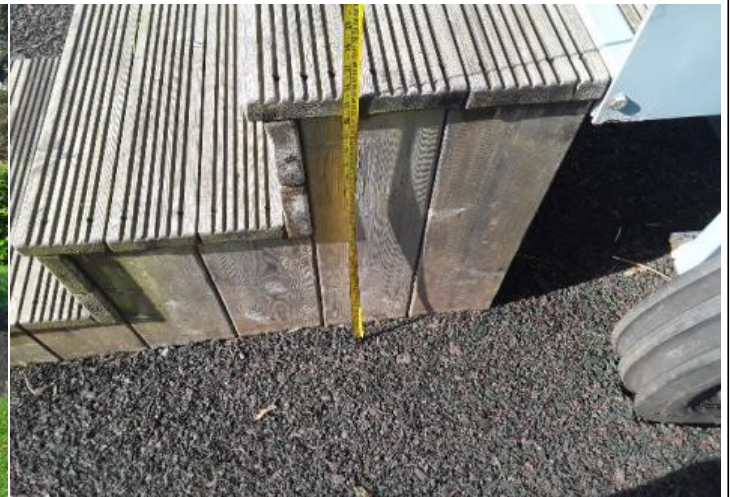
**Finding:** The unit is easily accessible and should have the appropriate barriers installed to meet the requirements of BS EN 1176 Part 1 as the height of the unit exceeds 600mm

**Action:** Monitor - No remedial work recommended

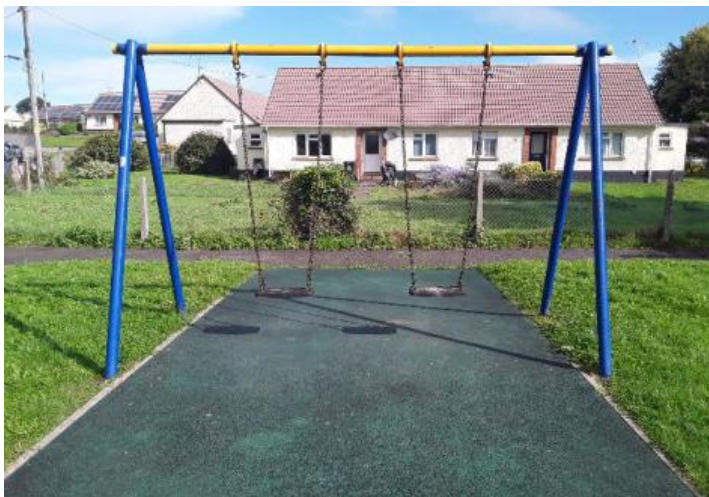
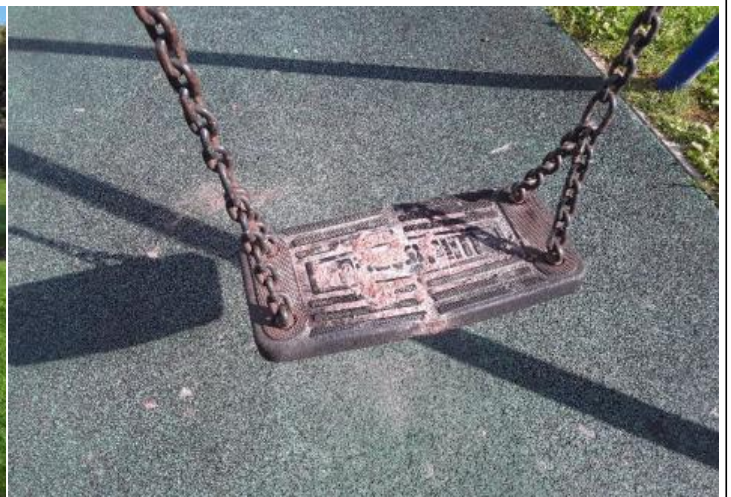
**Finding:** There is excrement on the seat

**Action:** Clean and maintain the seat

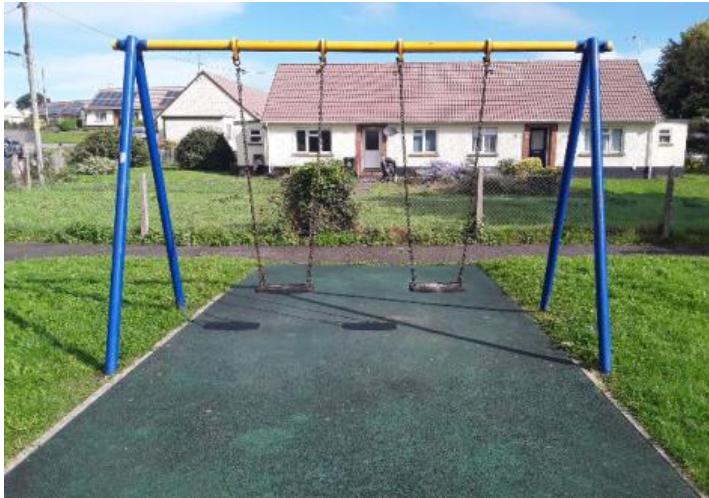
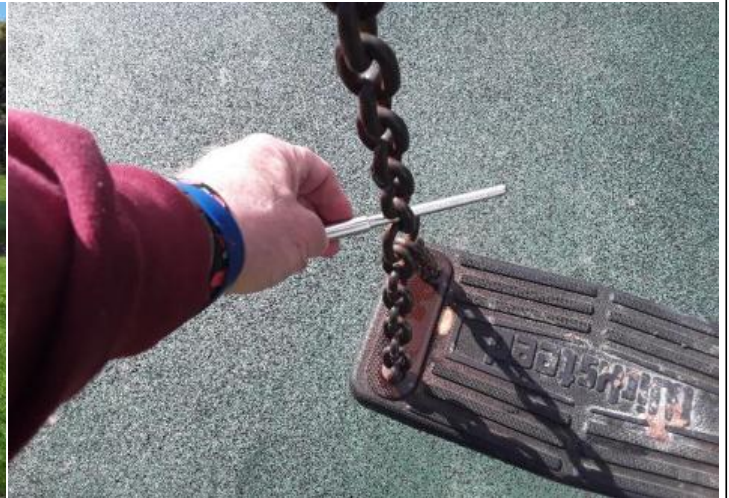
**Finding:** The chain openings are in excess of the 8.6mm as recommended by BS EN 1176 **Action:** Monitor - No remedial work recommended

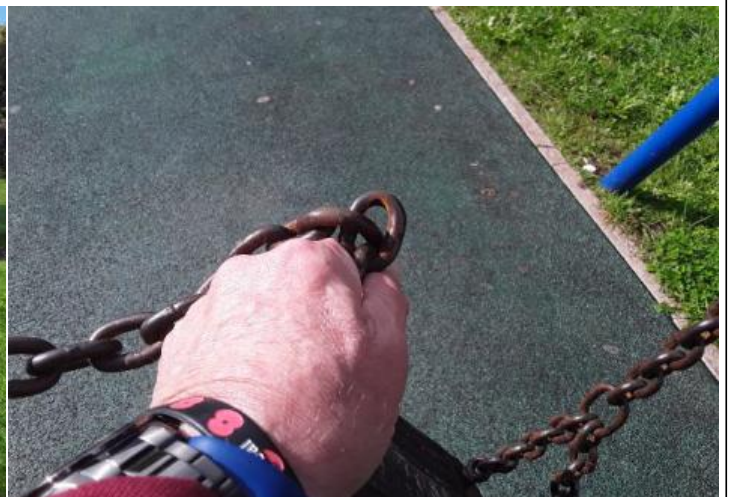
**Finding:** There is some notable evidence of chain wear **Action:** Monitor for any further deterioration and replace when 40% worn

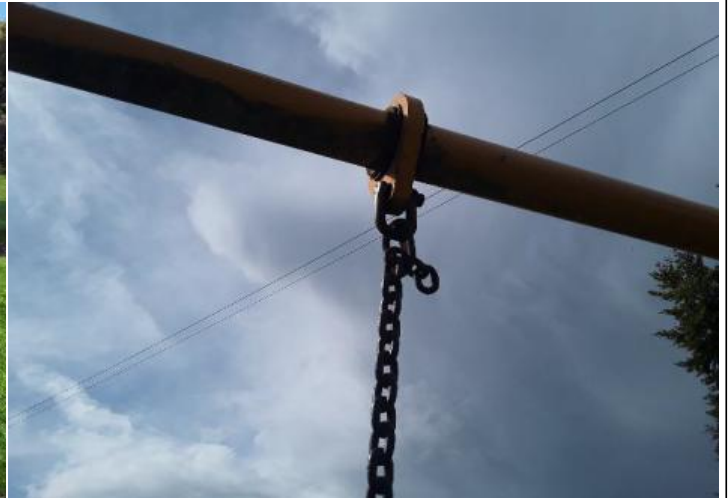
**Finding:** The bushes are showing signs of wear

**Action:** Monitor for any further deterioration and replace as required

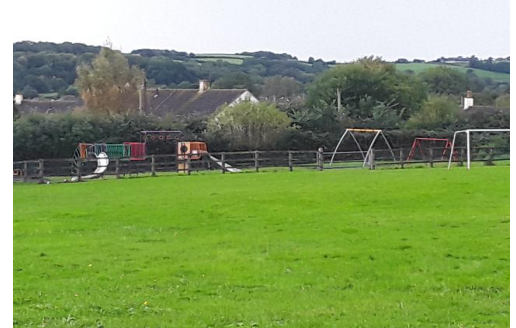
There are significant gaps (over 30mm) between the surface and the edging or between the joints in the surface; these are large enough for a small foot to enter - Repair surfacing

There is algae, silt or moss growth on the surface resulting in slippery conditions - Clean and treat appropriately

The grass is overgrown within the play area and may hide hazards - Reduce the length of grass to an acceptable height and maintain

The grass mats are silted up and the soil is compacted; this may have an effect on the impact absorbing properties of the surface - Consider HIC testing impact absorbing properties to ensure the correct surface qualities are maintained for the equipment and replace as required

There is a redundant wet pour base within the play area with a redundant springer base plate in situ - Replace the missing springer or remove the item completely

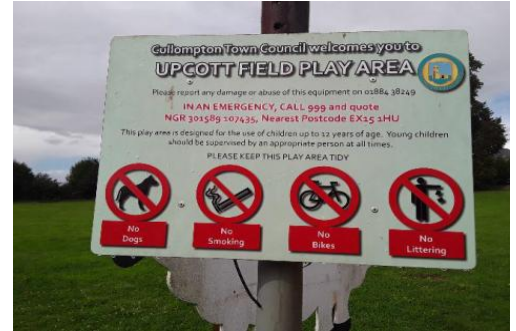
The paintwork on the extension sleeve has been damaged or worn exposing the metal underneath which is rusting / corroding - Treat affected areas and repaint

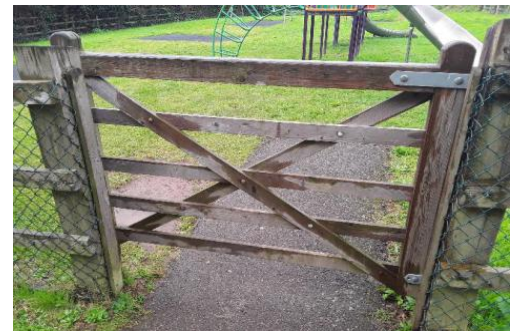
The timber has a number of splits/shakes or air cracks and this may affect the stability or allow water ingress which will accelerate the rotting process - Monitor to ensure the splits do not cross through fixing points of the structure and/or cause any instability

The surface has eroded adjacent to the gate creating trip hazards and may become slippery in wet conditions - Reinstate the surface

Holes have been drilled into the tube to release captured water. The metal has started to corrode - Treat the corroded metal

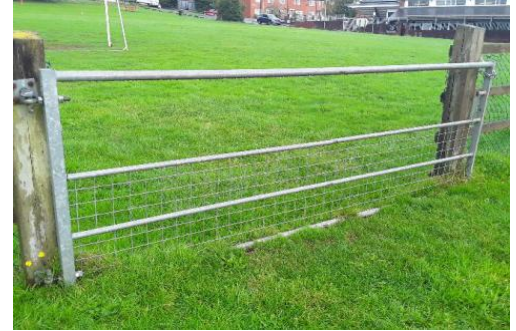
There are post / end caps missing from the item - Replace missing post caps

A number of fixing(s) have worked loose - Secure all loose fixings

There are parts of the timber hanging post that have rotted - Replace all affected timbers

There is or are fixings missing on the item - Replace all missing fixings

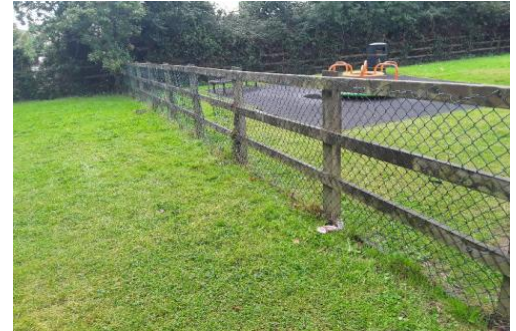
**Item:** Fence - Timber & Mesh Infill  
**Manufacturer:** Not Identified  
**Surface Type:** Grass  
**Item Quantity:** 1  
**Equipment Compliance:** N/A  
**Surface Area Compliance:** N/A

The fence mesh is severely damaged in places - Repair or replace all affected sections

There are loose rails along the fence line - Resecure the rails

An incorrect fixing or fixing method has been used - Replace with appropriate fixings to manufacturer specification

There is some strimmer / machinery damage apparent on the posts, this can penetrate the preservative applied to the timber and accelerate the rotting process - Monitor for any deterioration (rot) and replace as required

A number of posts have rotted at ground level and are unstable - Replace the affected posts

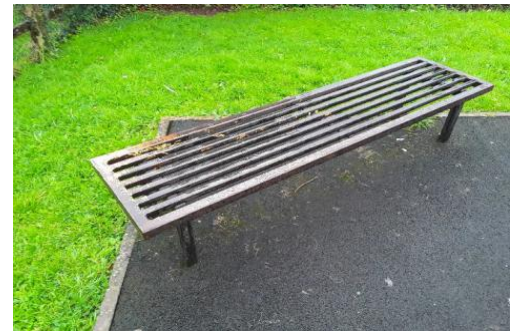
**Item:** Bench  
**Manufacturer:** Not Identified  
**Surface Type:** Wet Pour  
**Item Quantity:** 1  
**Equipment Compliance:** N/A  
**Surface Area Compliance:** N/A

There is surface corrosion / rust present on the item - Consider treating the item

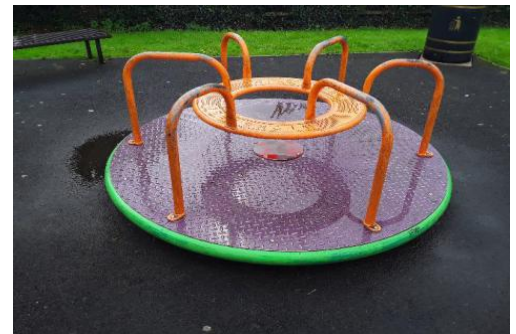
**Item:** Roundabout  
**Manufacturer:** Wicksteed Playgrounds  
**Surface Type:** Wet Pour  
**Item Quantity:** 1  
**Equipment Compliance:** No  
**Surface Area Compliance:** Yes

The distance between the underside of the roundabout platform and the playing surface is in excess of 110mm and contravenes the requirements of BS EN 1176 Part 5 which requires that the distance be maintained between 60mm-110mm - for the entire circumference of the roundabout - Monitor - No remedial work recommended

The bearing is showing signs of wear - Monitor for any further deterioration and replace as required

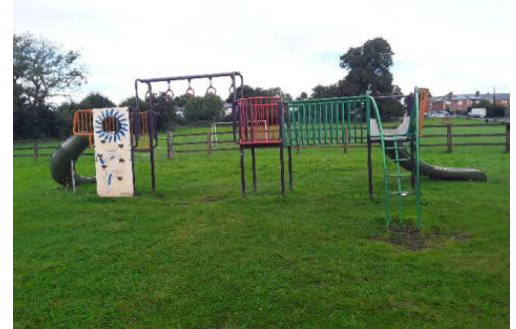
**Item:** Multi Play (Junior)  
**Manufacturer:** Wicksteed Playgrounds  
**Surface Type:** Grass Matrix Tiles  
**Item Quantity:** 1  
**Equipment Compliance:** Yes  
**Surface Area Compliance:** Yes

There is surface corrosion / rust present on the item - Consider treating the item

There is vandalism damage to the side panels - Remove the sharp protrusions

There is damage to the surface - Repair the damaged areas of surfacing

There is/are inserts missing - Replace missing inserts

There are a number of dents in the slide surface - Monitor for any further deterioration and repair as required

The bushes are worn or missing - Replace worn or missing bushes

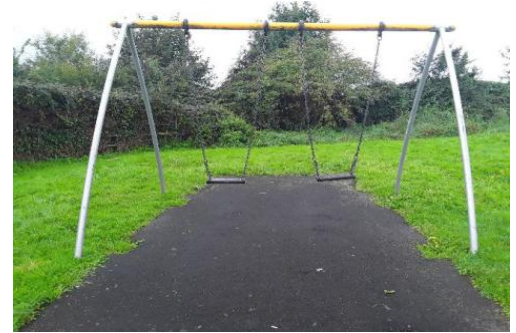
**Item:** 1 Bay 2 Seat (Flat)  
**Manufacturer:** SMP  
**Surface Type:** Wet Pour  
**Item Quantity:** 1  
**Equipment Compliance:** No  
**Surface Area Compliance:** Yes

There is damage to the surface - Repair the damaged areas of surfacing

The seat has minor damage or wear - Monitor for any further deterioration and replace as required

The chain openings are in excess of the 8.6mm as recommended by BS EN 1176 - Monitor - No remedial work recommended

There is some notable evidence of chain wear - Monitor for any further deterioration and replace when 40% worn

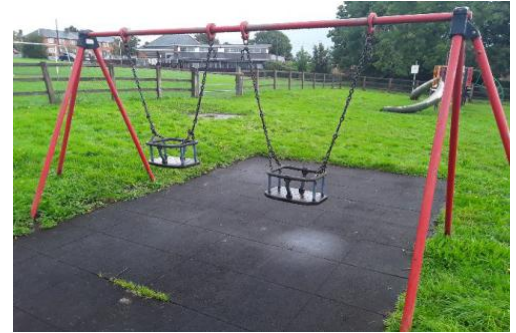
**Item:** 1 Bay 2 Seat (Cradle)  
**Manufacturer:** Wicksteed Playgrounds  
**Surface Type:** Rubber Tiles  
**Item Quantity:** 1  
**Equipment Compliance:** No  
**Surface Area Compliance:** Yes

There are gaps opening in between the tiles - Monitor for any further deterioration and repair as required

The chain openings are in excess of the 8.6mm as recommended by BS EN 1176 - Monitor - No remedial work recommended

There is some notable evidence of chain wear - Monitor for any further deterioration and replace when 40% worn

There is some wear to the shackles. - Monitor for any further deterioration and replace when 40% worn

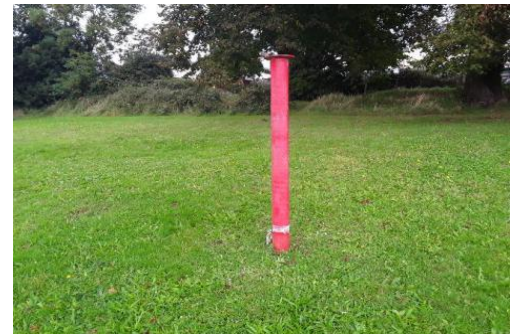
**Item:** Ball Shoot  
**Manufacturer:** Wicksteed Playgrounds  
**Surface Type:** Grass  
**Item Quantity:** 1  
**Equipment Compliance:** N/A  
**Surface Area Compliance:** N/A

The top section has been removed - Replace the missing components or remove the item completely

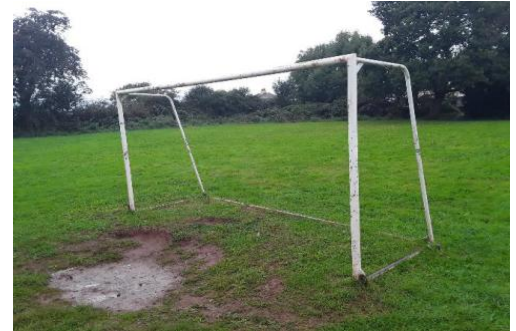
**Item:** 5 a side Goals  
**Manufacturer:** Not Identified  
**Surface Type:** Grass  
**Item Quantity:** 1  
**Equipment Compliance:** N/A  
**Surface Area Compliance:** N/A

There is surface corrosion / rust present on the item - Consider treating the item

The surface has eroded in some areas and may be slippery in wet conditions - Reinstate the surface

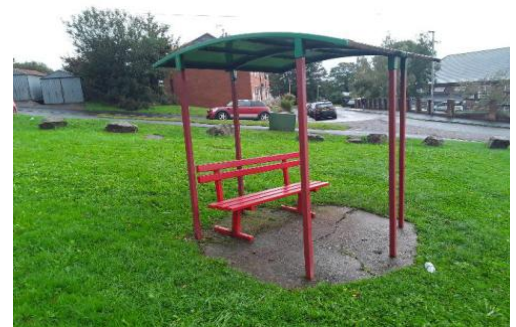
**Item:** Shelter  
**Manufacturer:** Record RSS  
**Surface Type:** Concrete  
**Item Quantity:** 1  
**Equipment Compliance:** N/A  
**Surface Area Compliance:** N/A

There is/are inserts missing - Replace missing inserts

The paintwork on this item has been damaged or worn exposing the metal underneath which is rusting / corroding - Treat affected areas and repaint

There are shear cracks in the concrete base - Monitor and repair if required

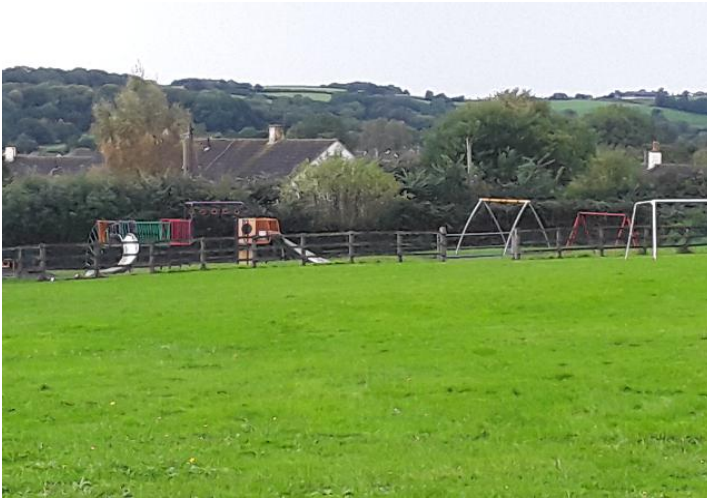
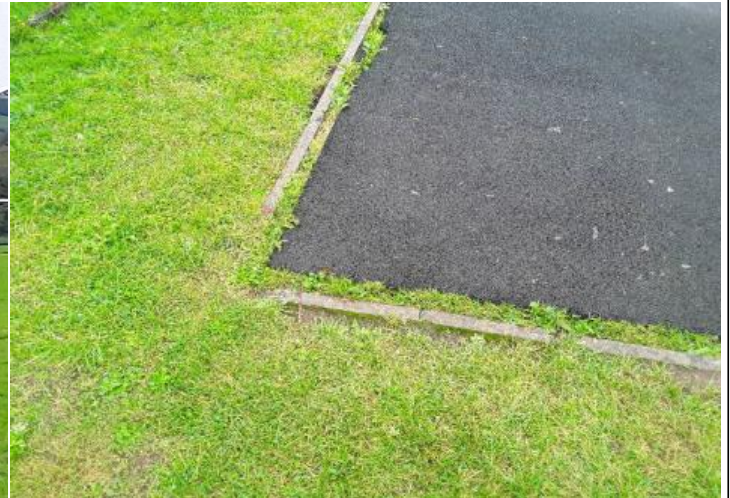
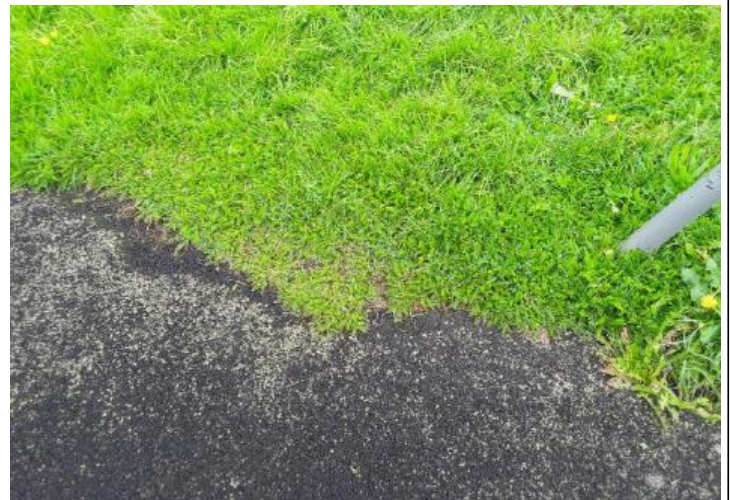
**Finding:** There is weed / vegetation growth on, between, or around the edges of the surfacing  
**Action:** Remove weed / vegetation growth

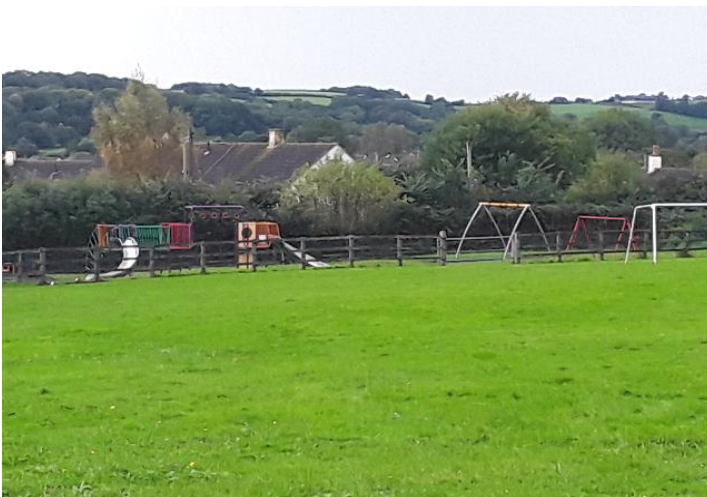
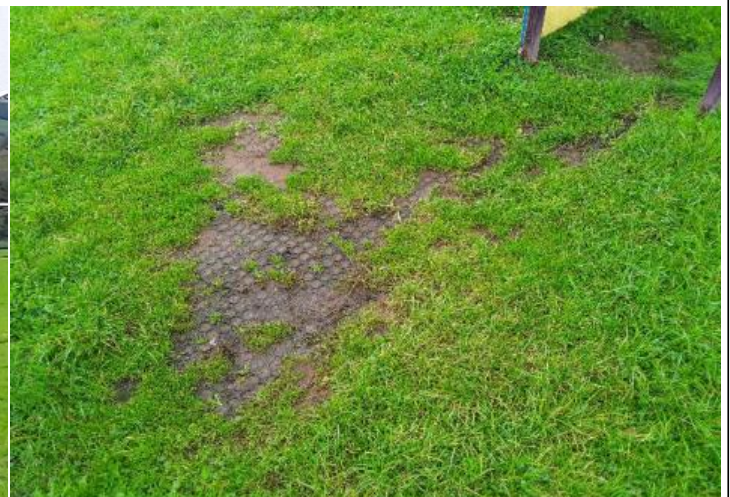
**Finding:** The grass mats are silted up and the soil is compacted; this may have an effect on the impact absorbing properties of the surface

**Action:** Consider HIC testing impact absorbing properties to ensure the correct surface qualities are maintained for the equipment and replace as required

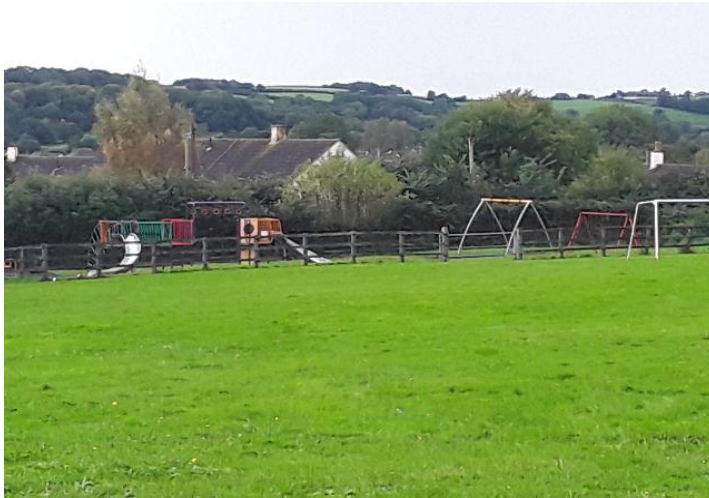
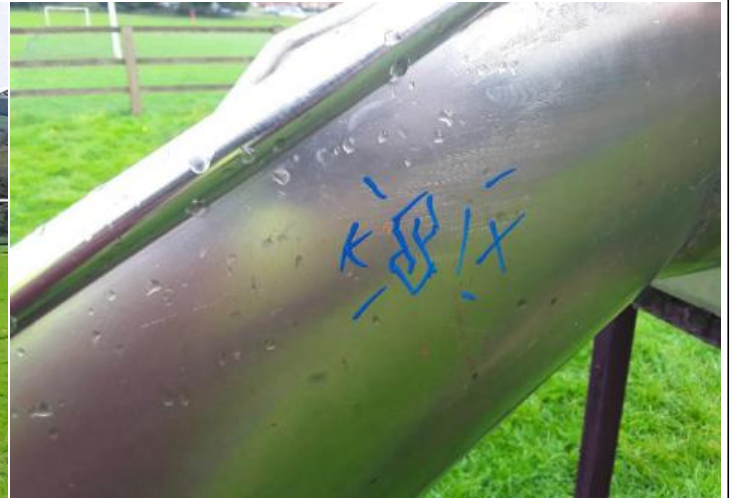
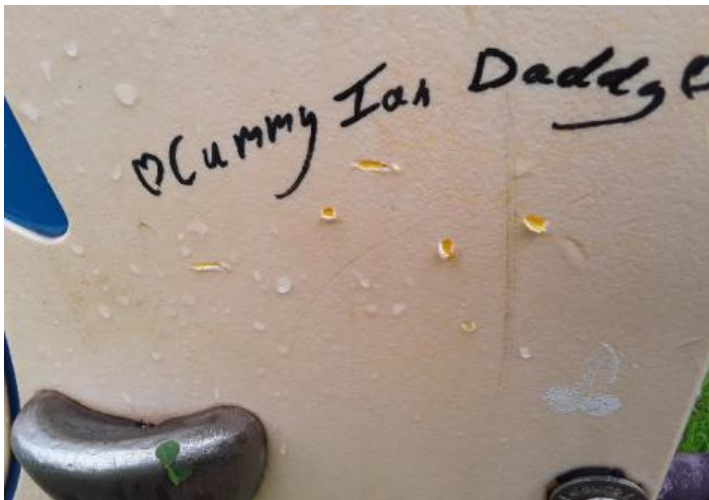
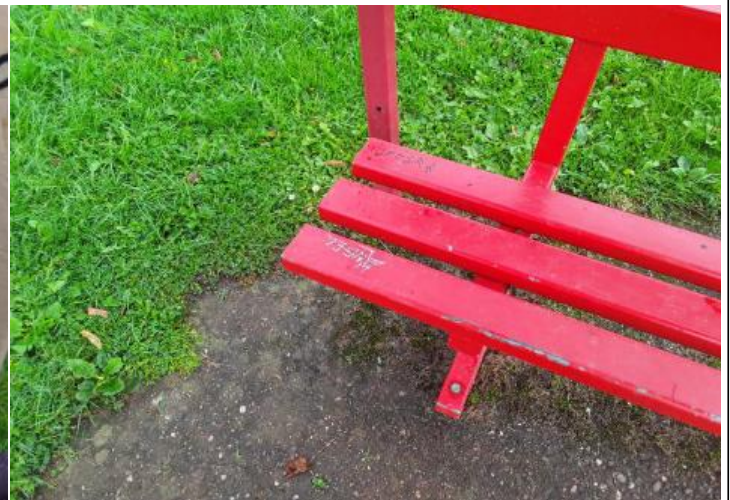
**Finding:** There is some graffiti present

**Action:** Remove the graffiti

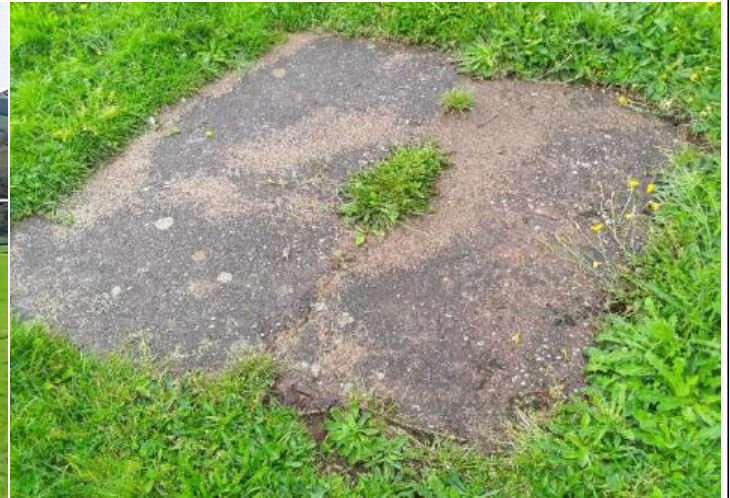
**Finding:** There is a redundant concrete base within the play area  
**Action:** Consider removing the concrete base

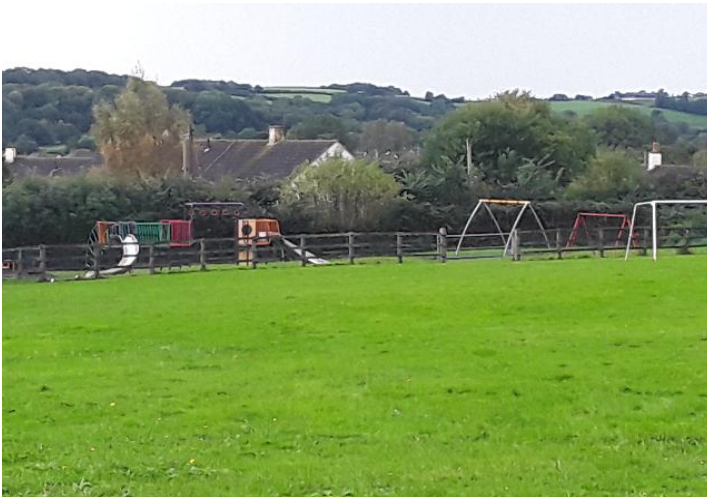
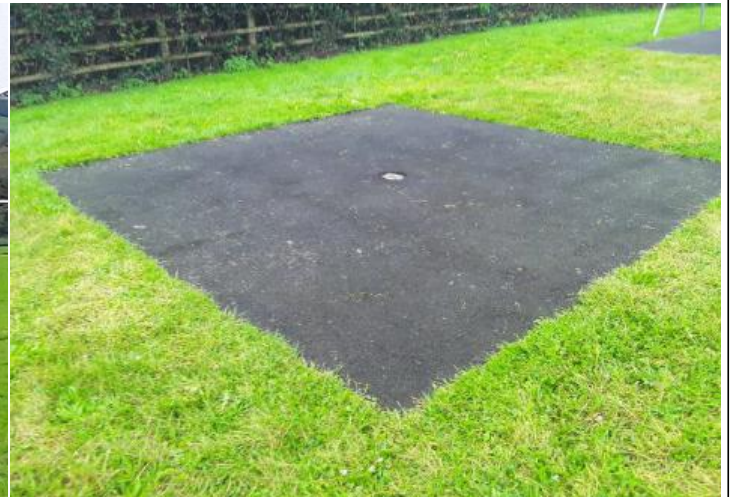
**Finding:** There is a redundant wet pour base within the play area with a redundant springer base plate in situ  
**Action:** Replace the missing springer or remove the item completely

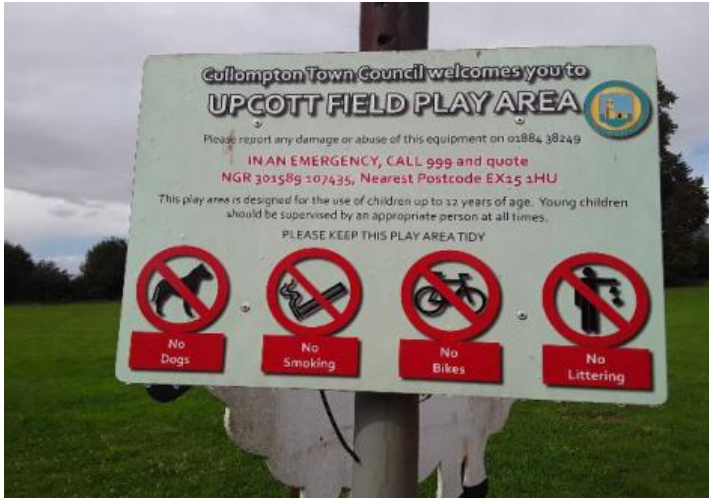
**Finding:** The paintwork on the extension sleeve has been damaged or worn exposing the metal underneath which is rusting / corroding

**Action:** Treat affected areas and repaint

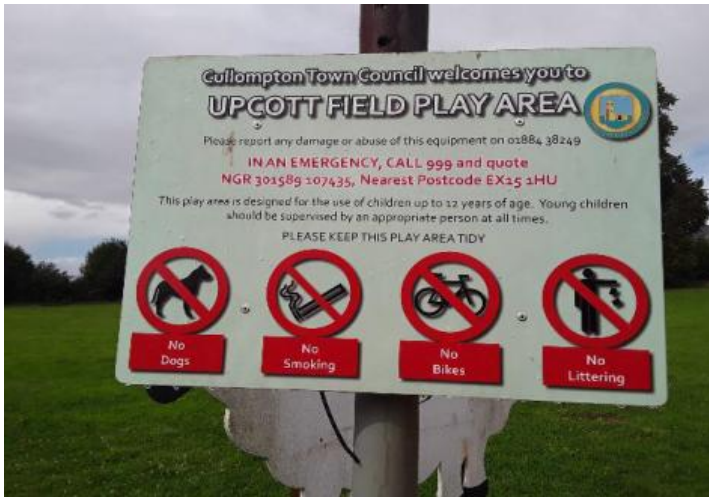
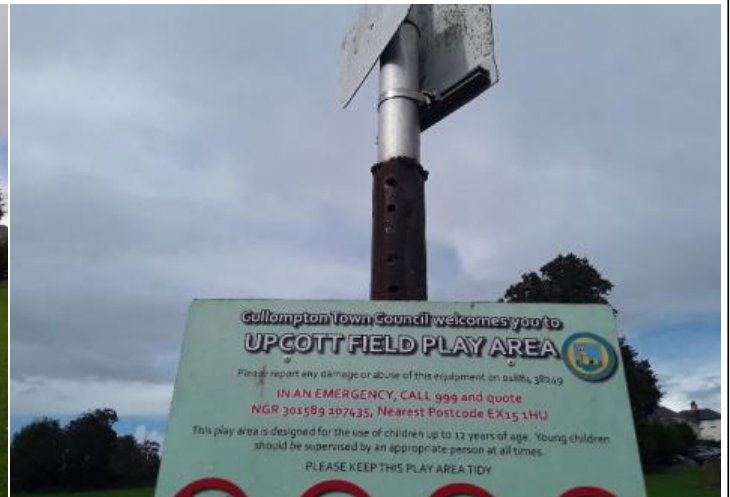
**Finding:** Holes have been drilled into the sleeve

**Action:** Consider providing inserts

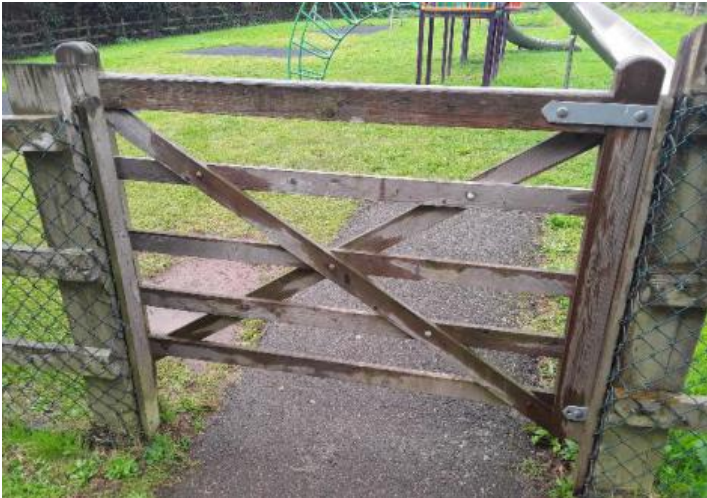
**Finding:** The timber has a number of splits/shakes or air cracks and this may affect the stability or allow water ingress which will accelerate the rotting process  
**Action:** Monitor to ensure the splits do not cross through fixing points of the structure and/or cause any instability
