NOTICE IS GIVEN THAT A SERVICES, PROPERTY AND OUTDOOR SPACES COMMITTEE OF  
CULLOMPTON TOWN COUNCIL  
WILL BE HELD AT THE TOWN HALL, CULLOMPTON  
ON THURSDAY, 9<sup>th</sup> NOVEMBER 2023 AT 7PM

**MINUTES OF MEETING OF THE SERVICES, PROPERTY AND OUTDOOR SPACES COMMITTEE  
DATED TUESDAY 12 SEPTEMBER 2023 AT 7:00PM AT CULLOMPTON TOWN HALL**

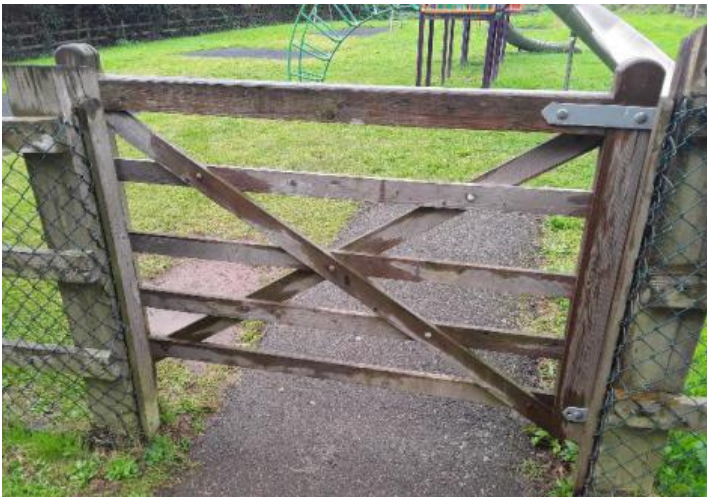
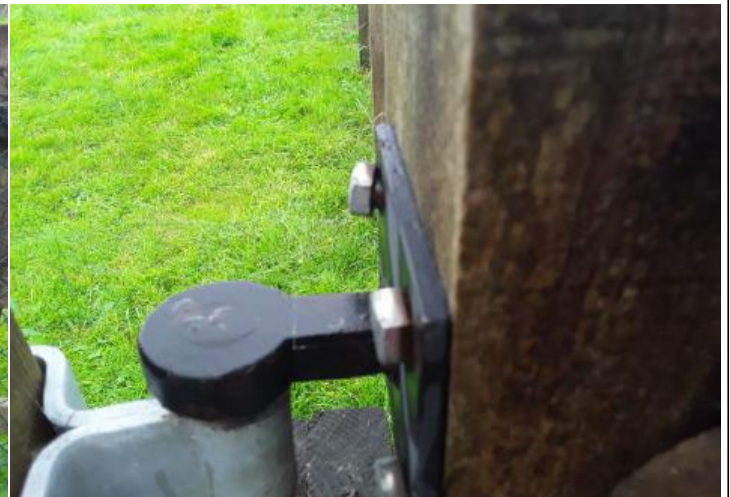
**Finding:** Fixings are misaligned  
**Action:** Monitor and reposition if required

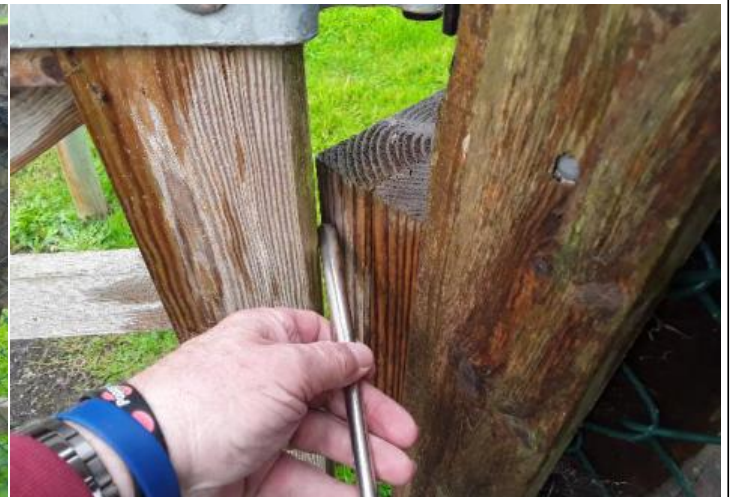
**Finding:** There are openings that are less than 12mm that could trap or crush fingers

**Action:** Provide a 12mm gap throughout full range of motion at both sides of gate

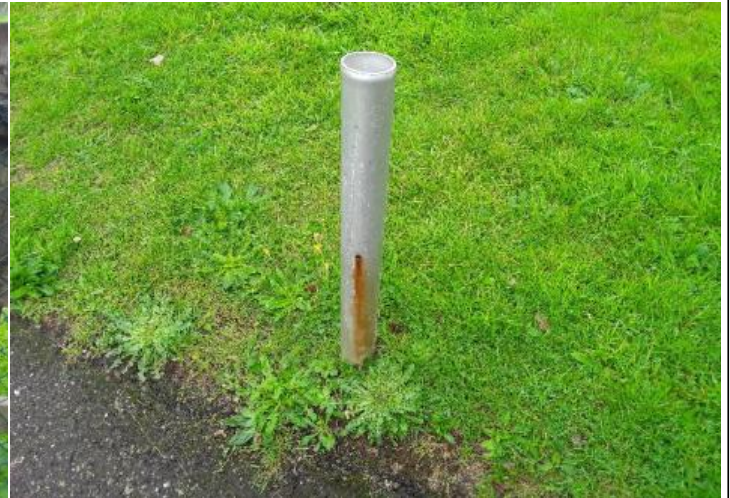
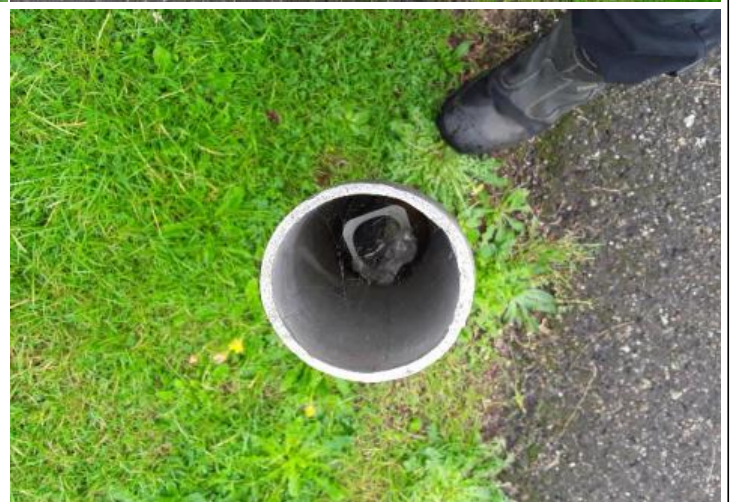
**Finding:** The gate stop has no post cap and has rubbish / debris pushed down the tube

**Action:** Remove the rubbish and provide a post cap

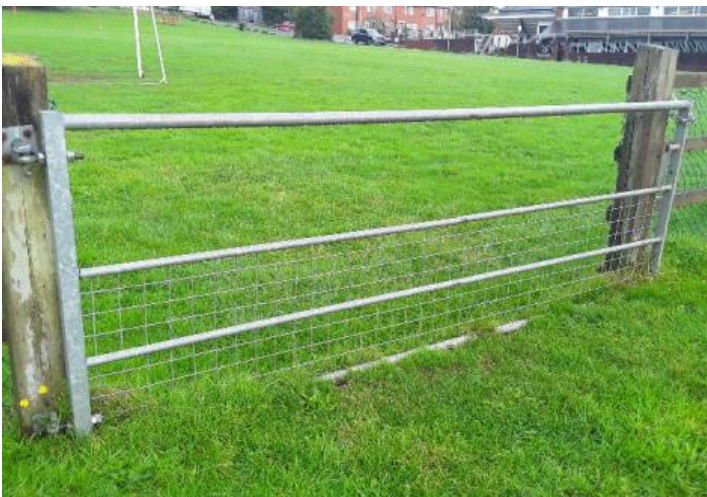
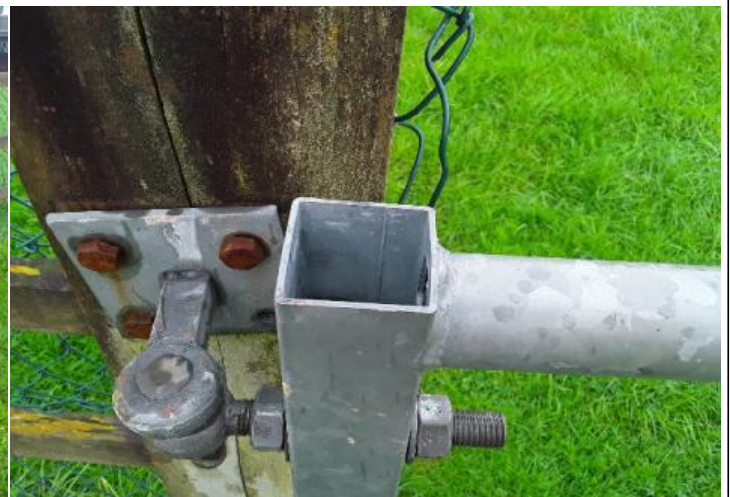
**Finding:** There are post / end caps missing from the item

**Action:** Replace missing post caps

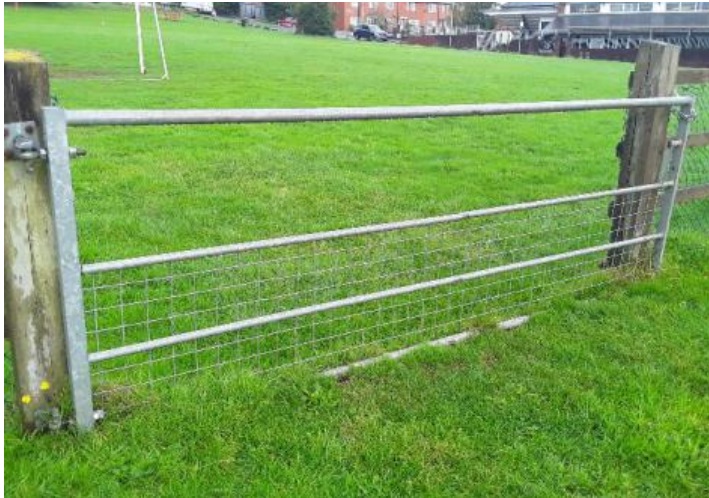
**Finding:** There is or are fixings missing on the item

**Action:** Replace all missing fixings

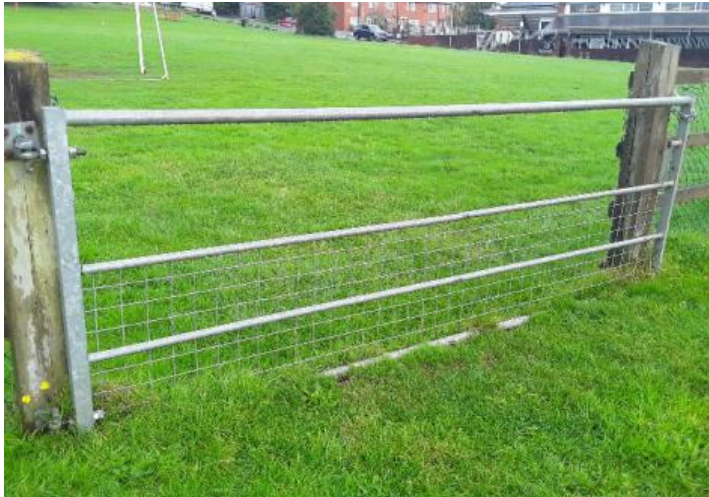
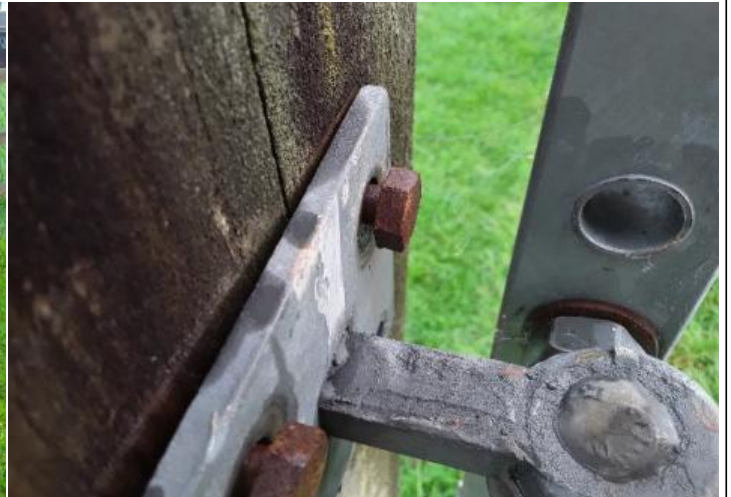
**Finding:** A number of fixing(s) have worked loose

**Action:** Secure all loose fixings

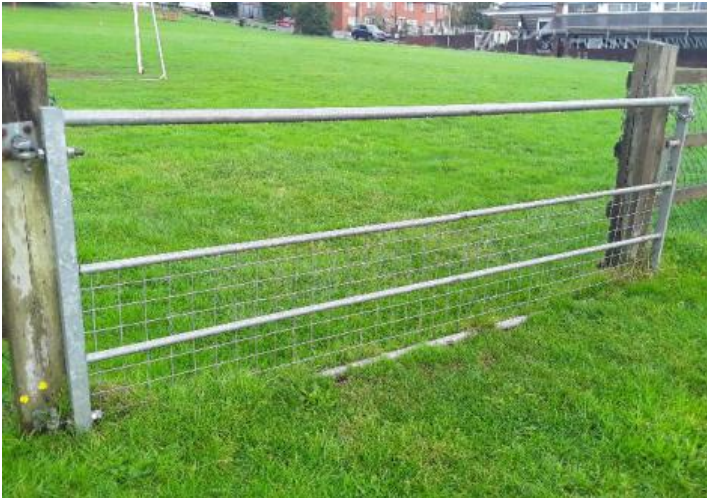
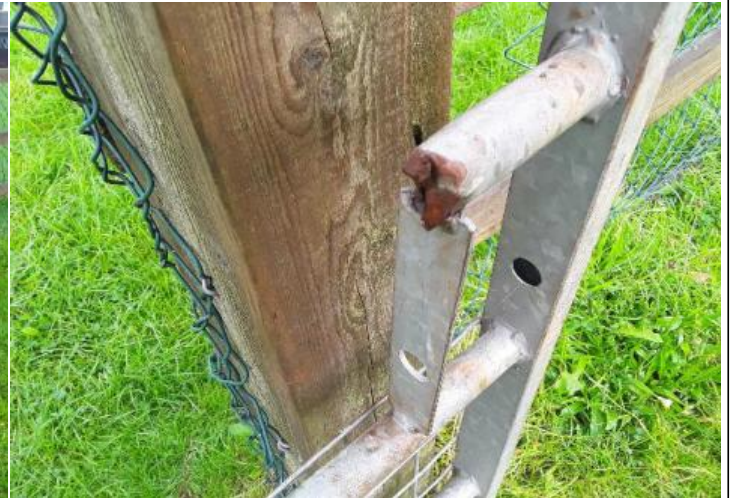
**Finding:** A section of the gate has been cut exposing sharp projections  
**Action:** Remove the sharp projections

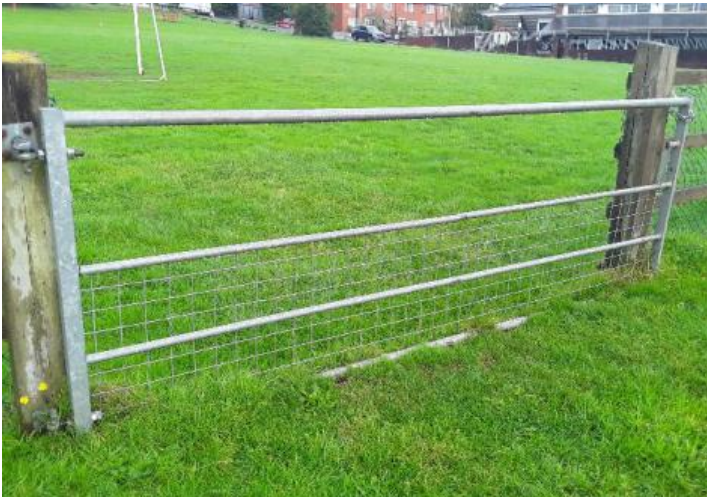
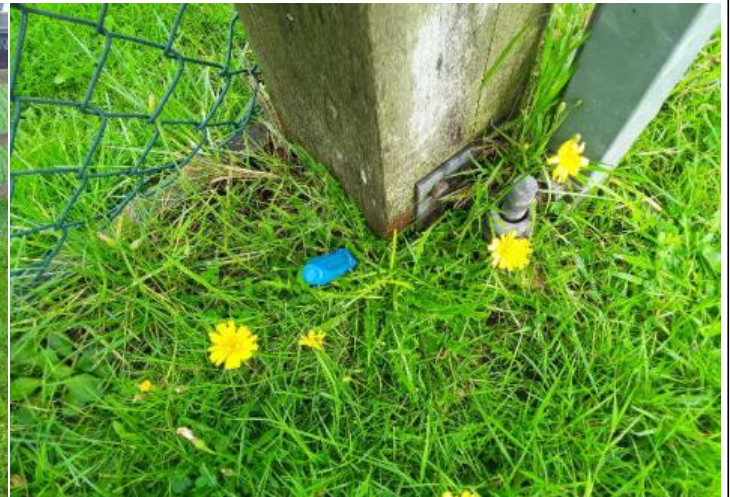
**Finding:** There are parts of the timber hanging post that have rotted  
**Action:** Replace all affected timbers

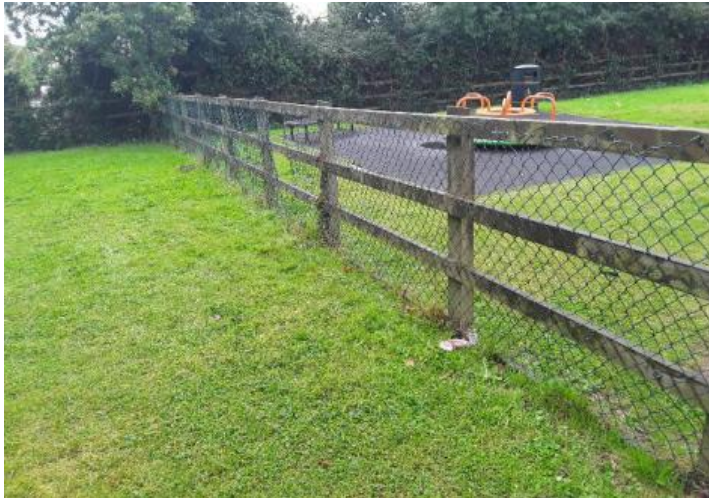
The fence mesh is severely damaged in places - Repair or replace all affected sections

**Finding:** The fence mesh is severely damaged in places

**Action:** Repair or replace all affected sections

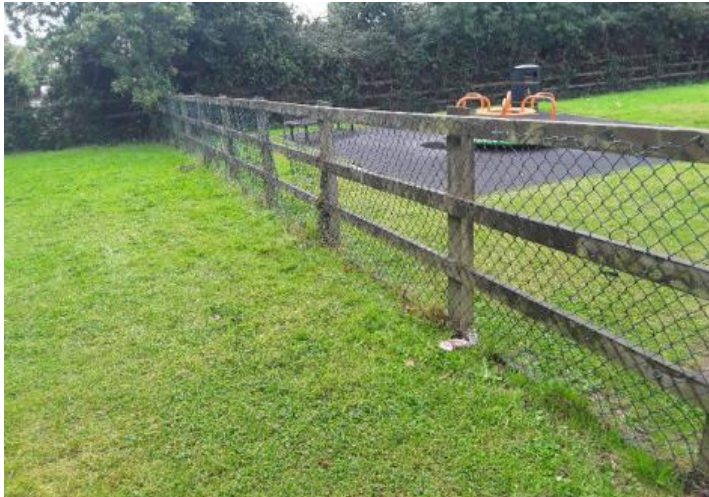
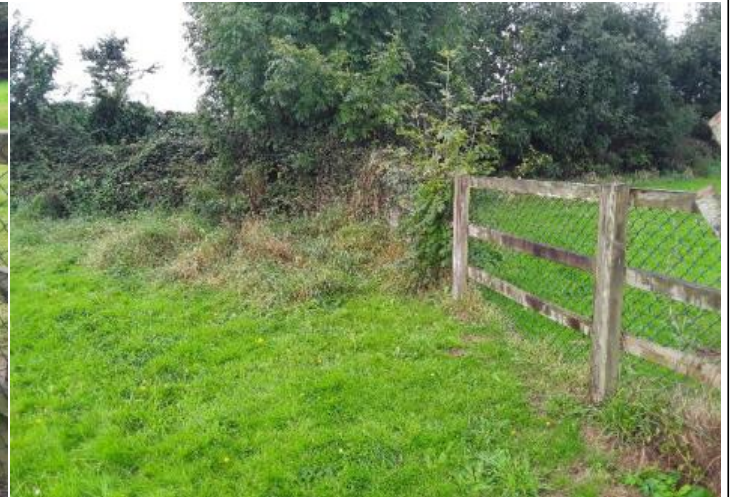
**Finding:** The adjacent foliage is overhanging or growing through the fence

**Action:** Cut back and maintain

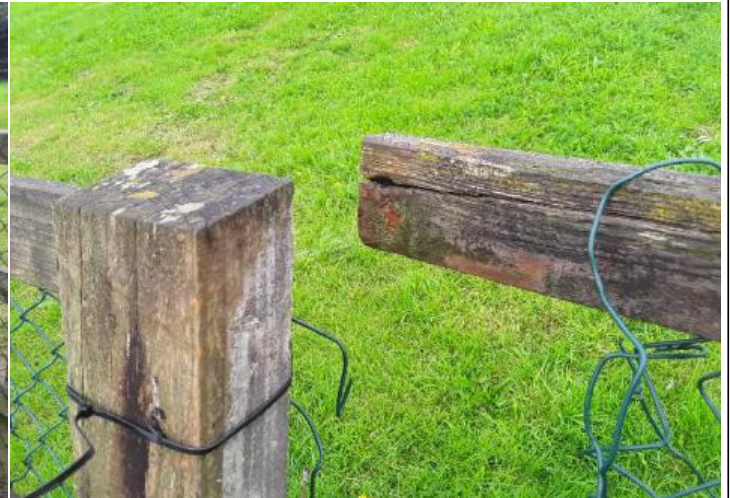
There are loose rails along the fence line - Resecure the rails

**Finding:** There are loose rails along the fence line

**Action:** Resecure the rails

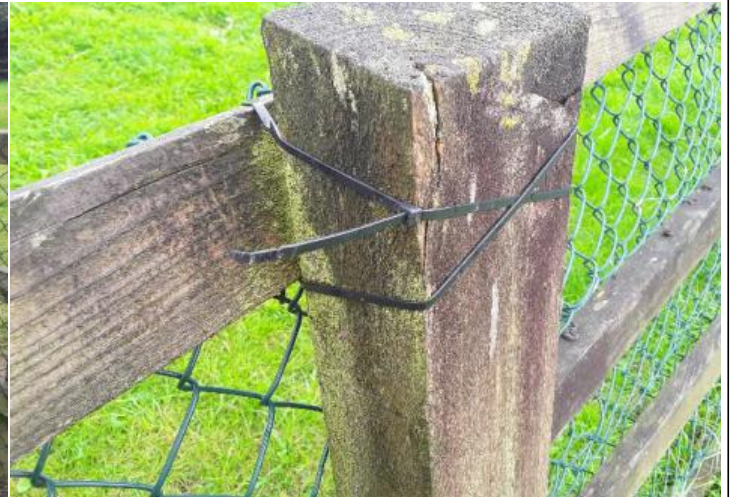
An incorrect fixing or fixing method has been used - Replace with appropriate fixings to manufacturer specification

**Finding:** An incorrect fixing or fixing method has been used

**Action:** Replace with appropriate fixings to manufacturer specification

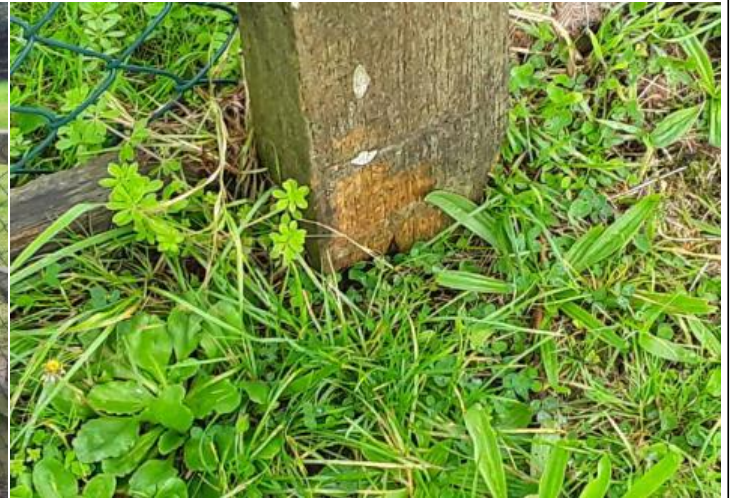
There is some strimmer / machinery damage apparent on the posts, this can penetrate the preservative applied to the timber and accelerate the rotting process - Monitor for any deterioration (rot) and replace as required

**Finding:** There is some strimmer / machinery damage apparent on the posts, this can penetrate the preservative applied to the timber and accelerate the rotting process

**Action:** Monitor for any deterioration (rot) and replace as required

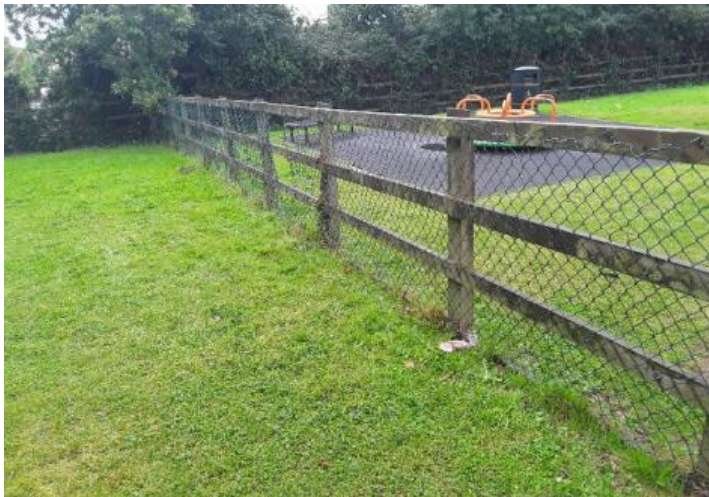
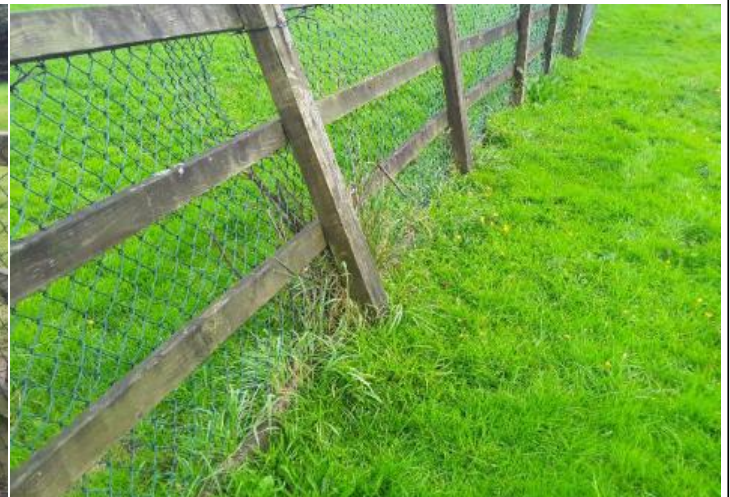
A number of posts have rotted at ground level and are unstable - Replace the affected posts

**Finding:** A number of posts have rotted at ground level and are unstable

**Action:** Replace the affected posts

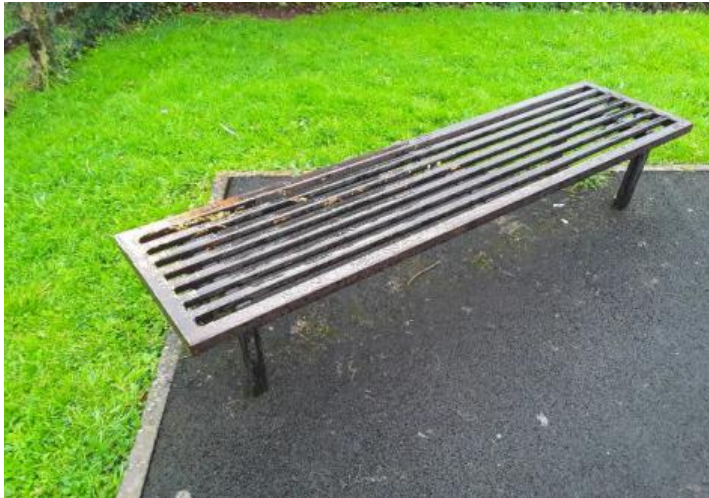
**Finding:** There is surface corrosion / rust present on the item

**Action:** Consider treating the item

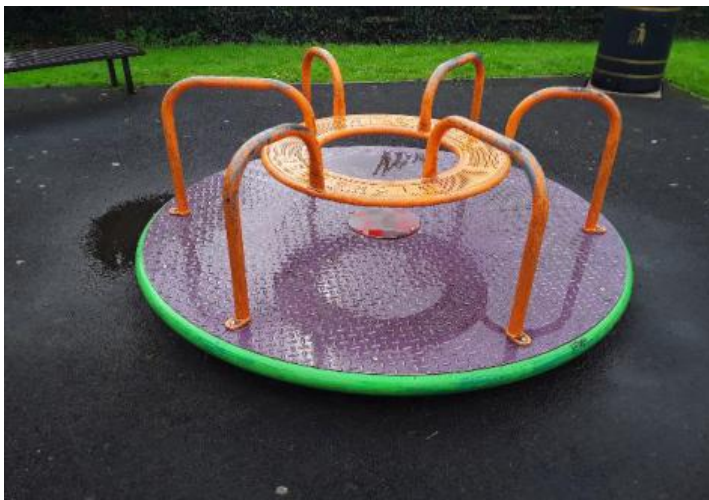
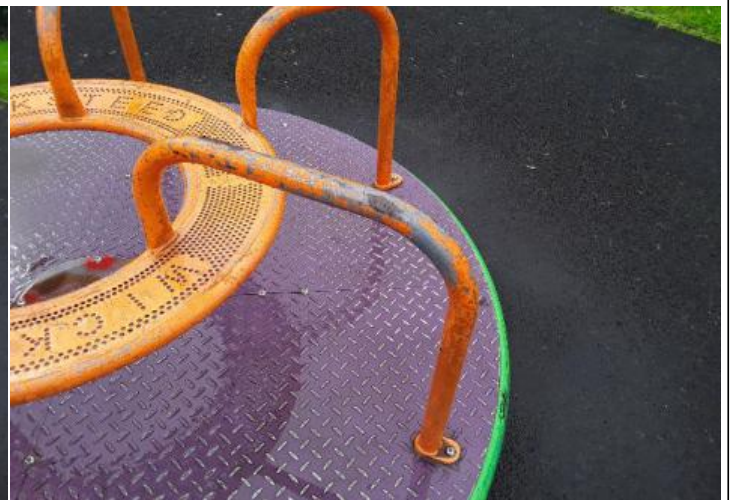
**Finding:** The paint is flaking off the metalwork

**Action:** Rub down and re-paint

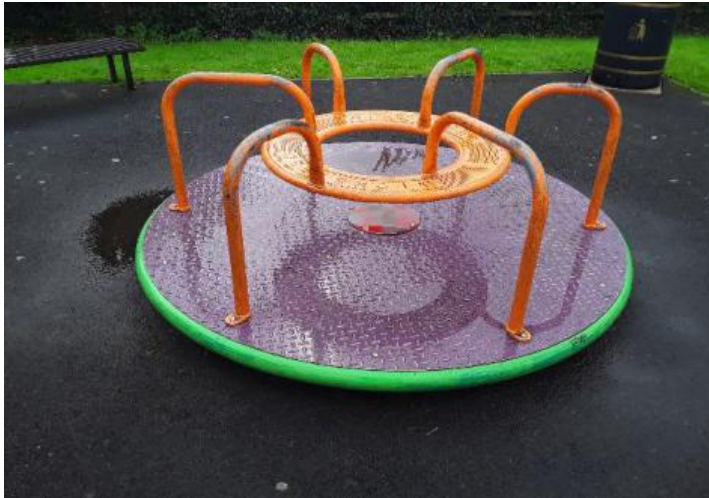
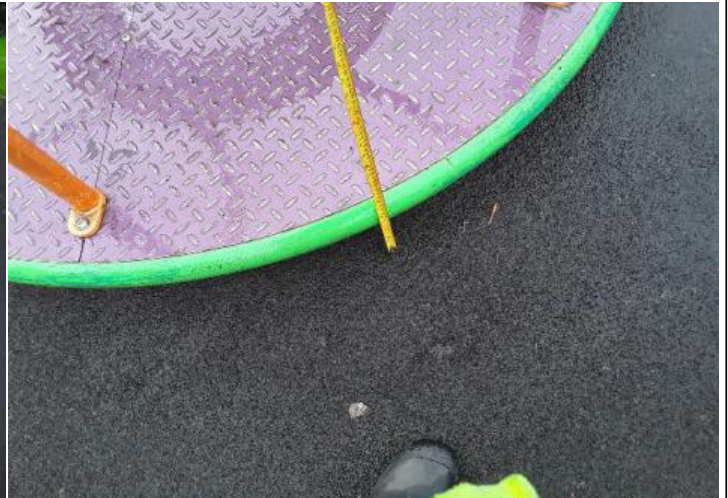
The distance between the underside of the roundabout platform and the playing surface is in excess of 110mm and contravenes the requirements of BS EN 1176 Part 5 which requires that the distance be maintained between 60mm-110mm - for the entire circumference of the roundabout - Monitor - No remedial work recommended

**Finding:** The distance between the underside of the roundabout platform and the playing surface is in excess of 110mm and contravenes the requirements of BS EN 1176 Part 5 which requires that the distance be maintained between 60mm-110mm - for the entire circumference of the roundabout

**Action:** Monitor - No remedial work recommended

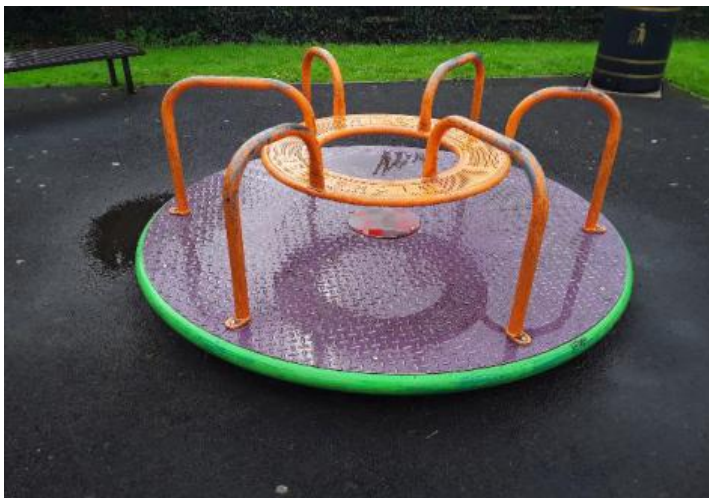
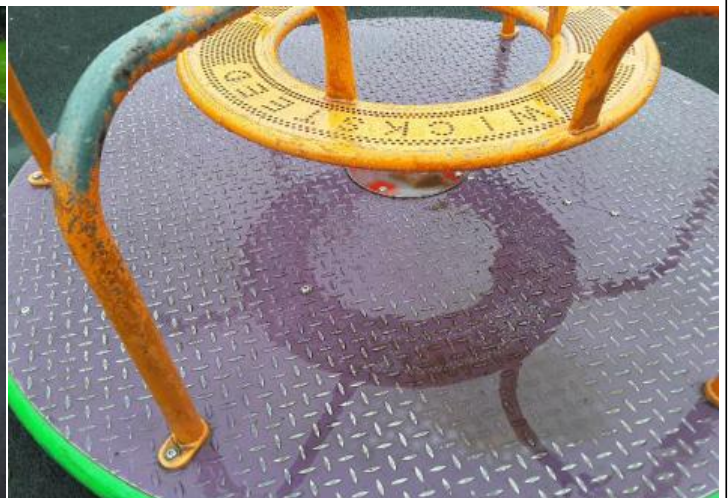
The bearing is showing signs of wear - Monitor for any further deterioration and replace as required

**Finding:** The bearing is showing signs of wear

**Action:** Monitor for any further deterioration and replace as required

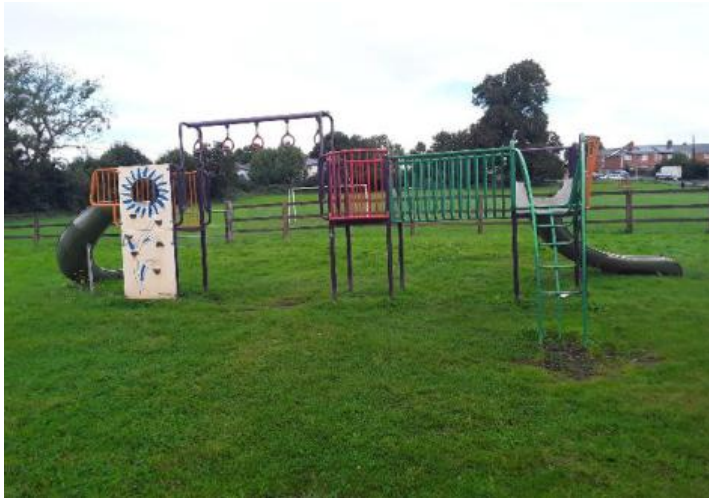
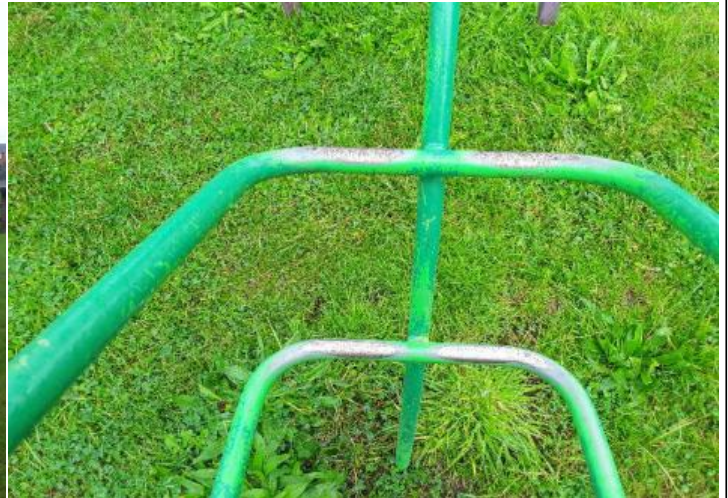
**Finding:** There is surface corrosion / rust present on the item

**Action:** Consider treating the item

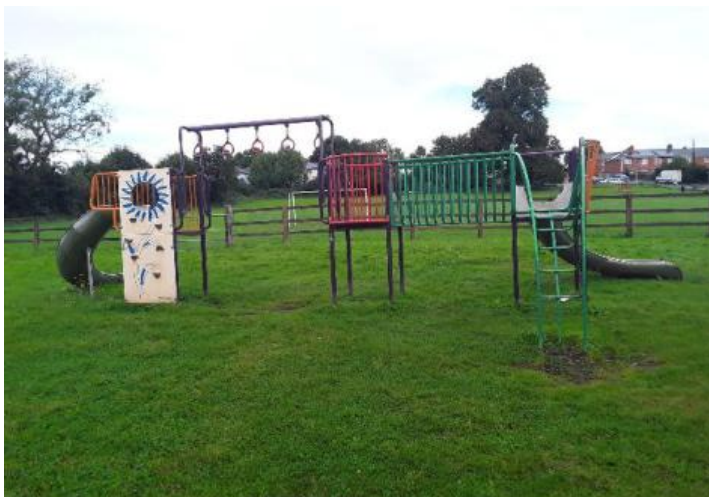
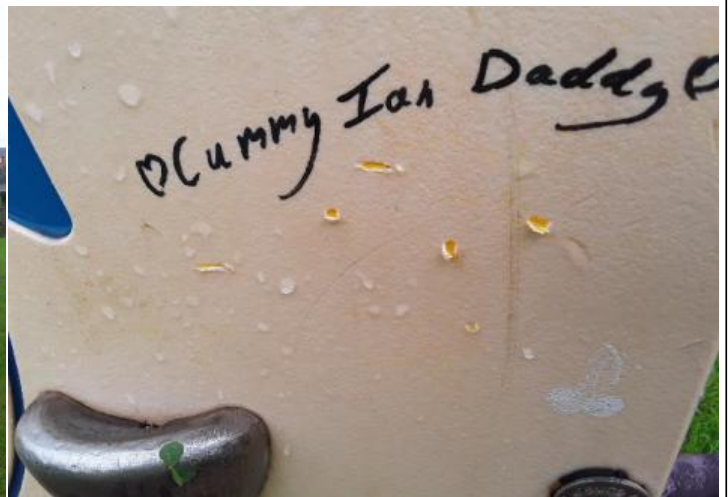
There is vandalism damage to the side panels - Remove the sharp protrusions

**Finding:** There is vandalism damage to the side panels

**Action:** Remove the sharp protrusions

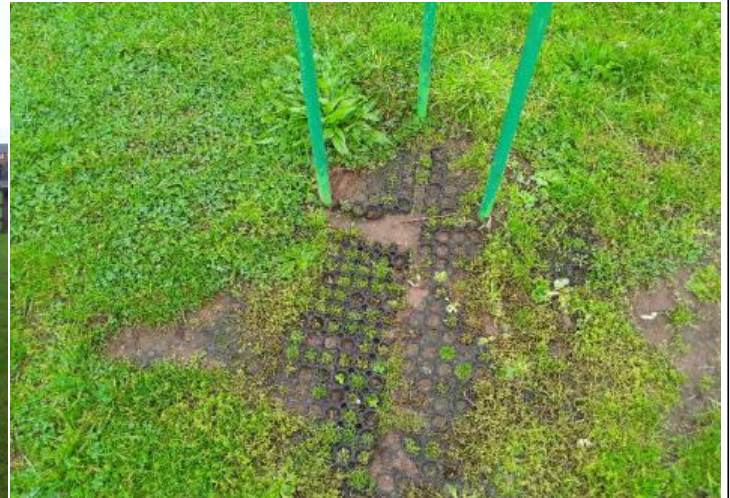
**Finding:** There is damage to the surface

**Action:** Repair the damaged areas of surfacing

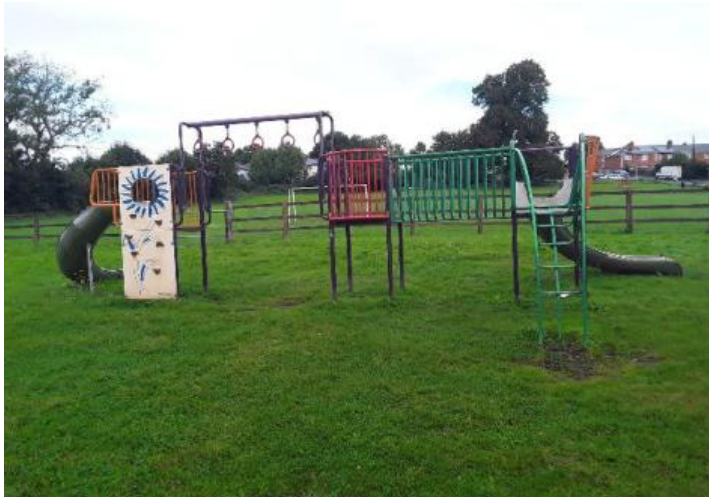
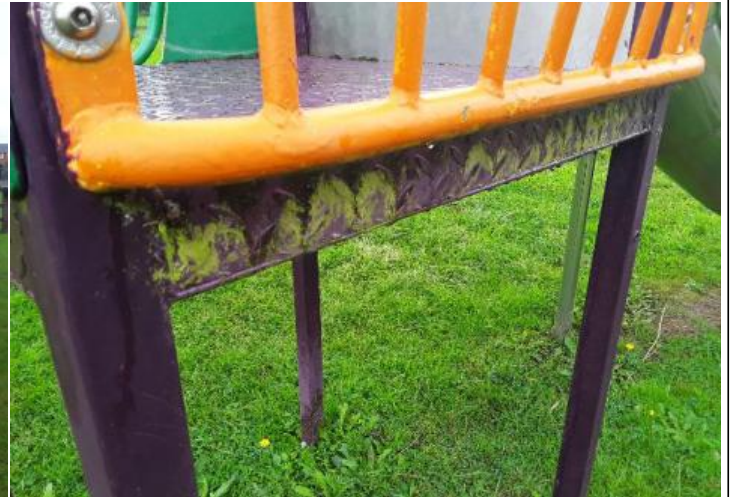
**Finding:** There is algae or moss on the surface of the equipment

**Action:** Clean and treat appropriately

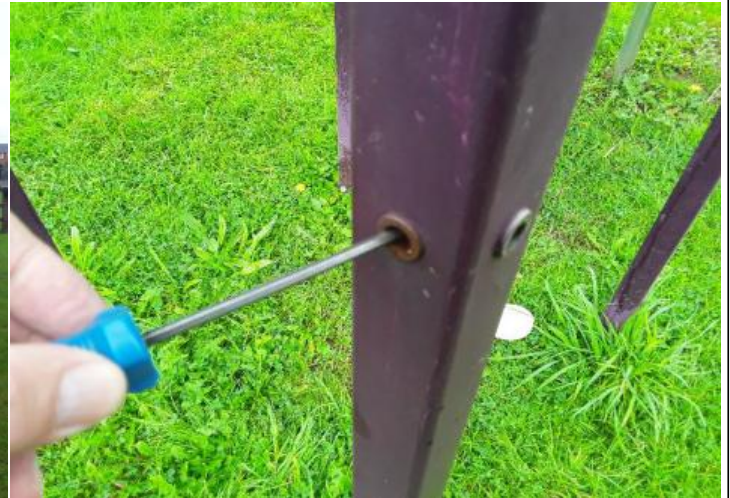
**Finding:** There is/are inserts missing

**Action:** Replace missing inserts

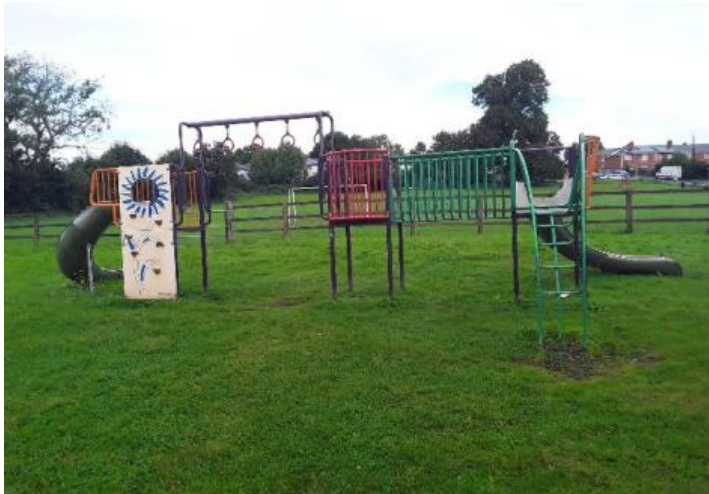
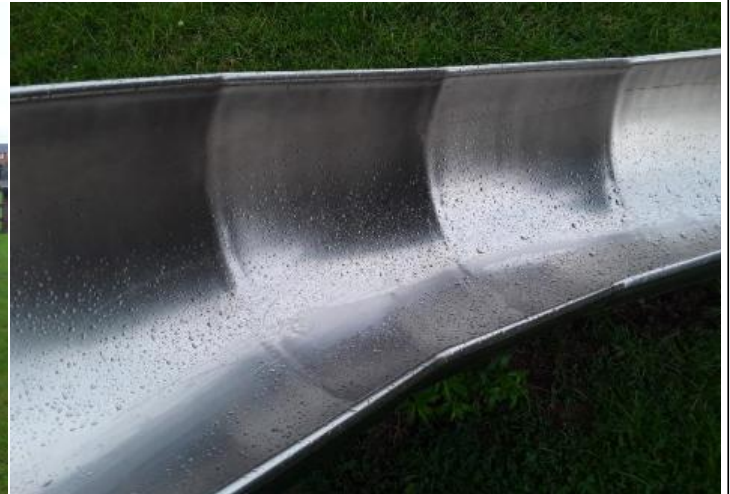
There are a number of dents in the slide surface - Monitor for any further deterioration and repair as required

**Finding:** There are a number of dents in the slide surface

**Action:** Monitor for any further deterioration and repair as required

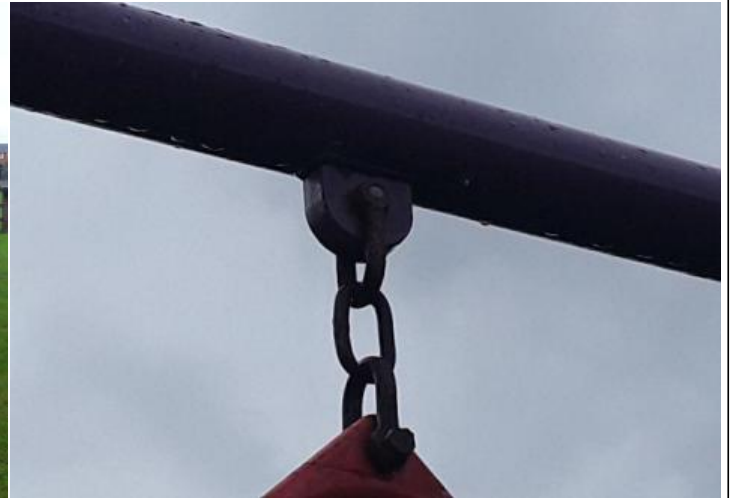
The bushes are worn or missing - Replace worn or missing bushes

**Finding:** The bushes are worn or missing

**Action:** Replace worn or missing bushes

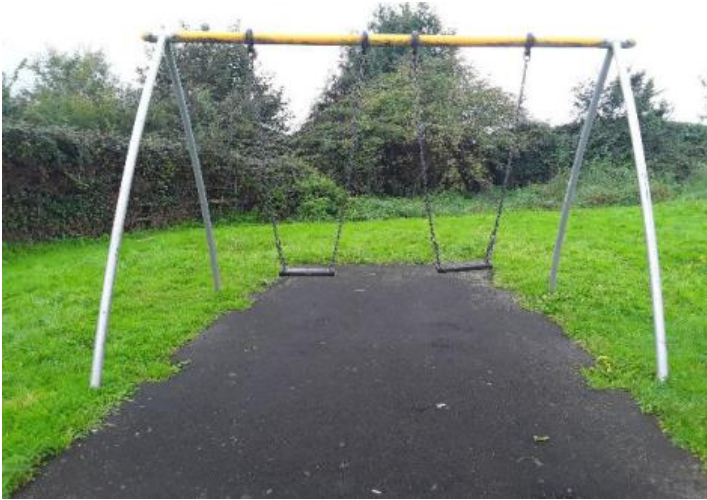
**Finding:** There is damage to the surface

**Action:** Repair the damaged areas of surfacing

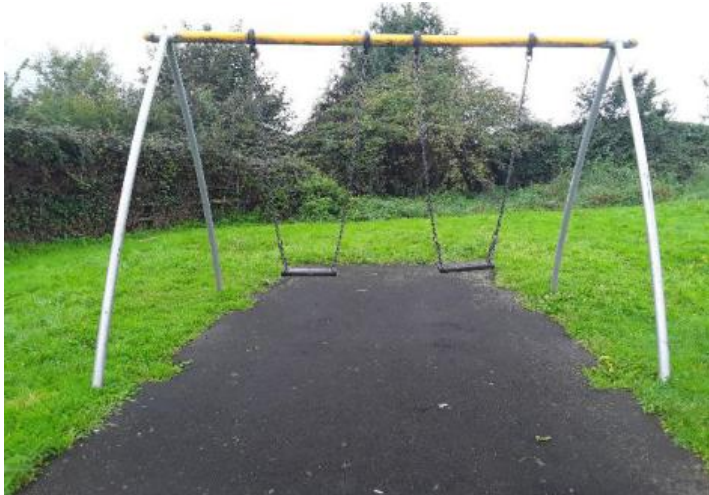
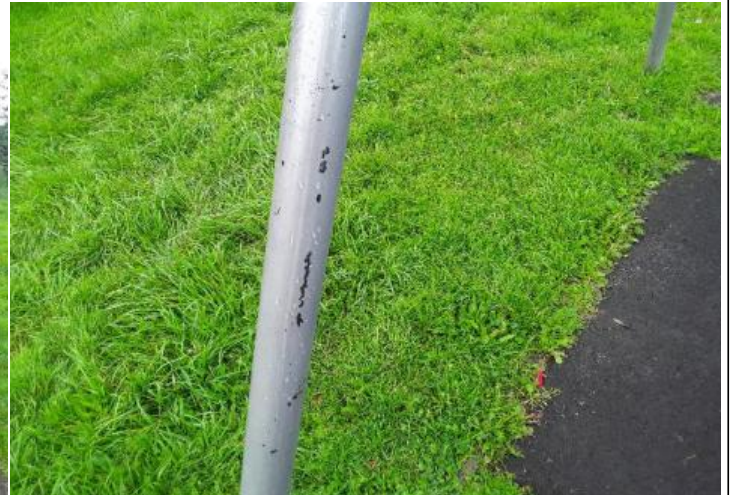
**Finding:** The paint is flaking off the metalwork

**Action:** Rub down and re-paint

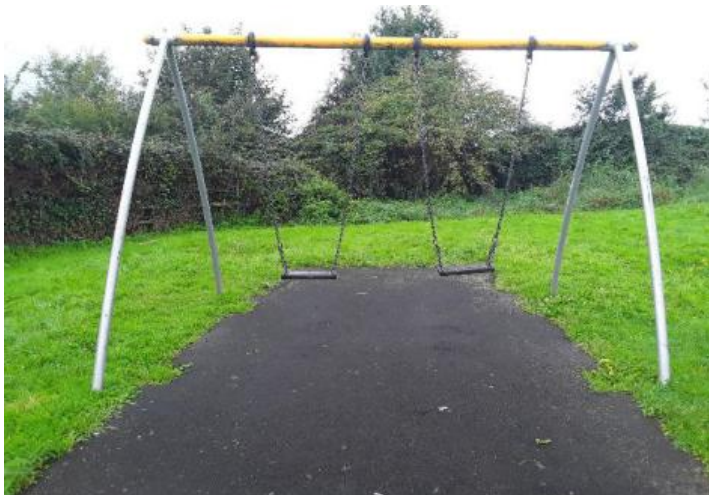
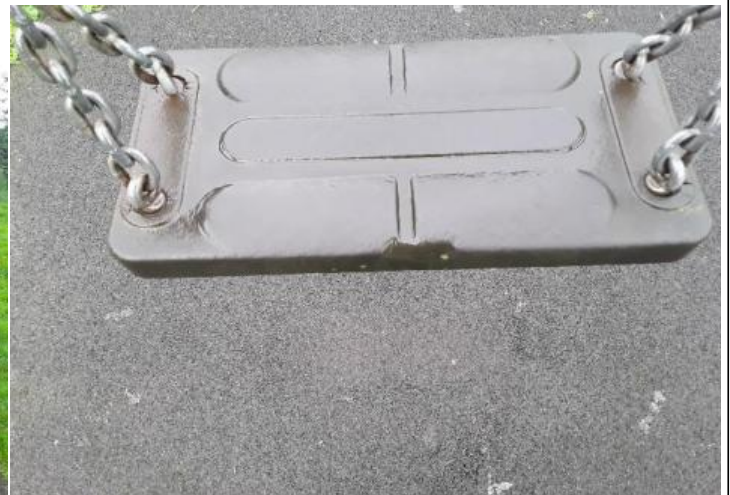
The seat has minor damage or wear - Monitor for any further deterioration and replace as required

**Finding:** The seat has minor damage or wear

**Action:** Monitor for any further deterioration and replace as required

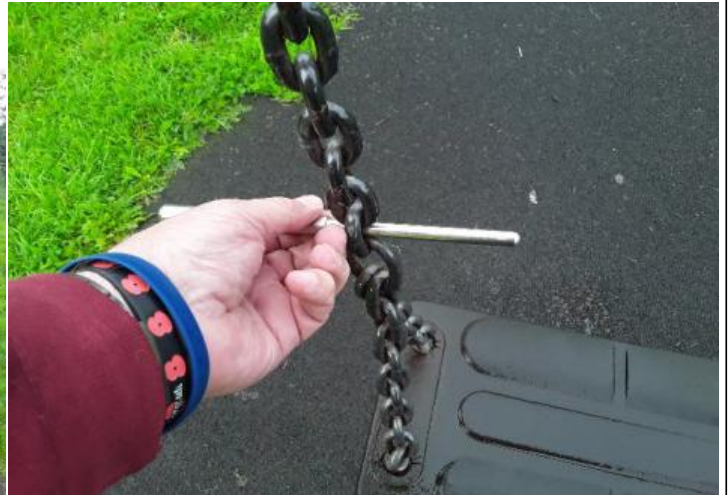
**Finding:** The chain openings are in excess of the 8.6mm as recommended by BS EN 1176  
**Action:** Monitor - No remedial work recommended

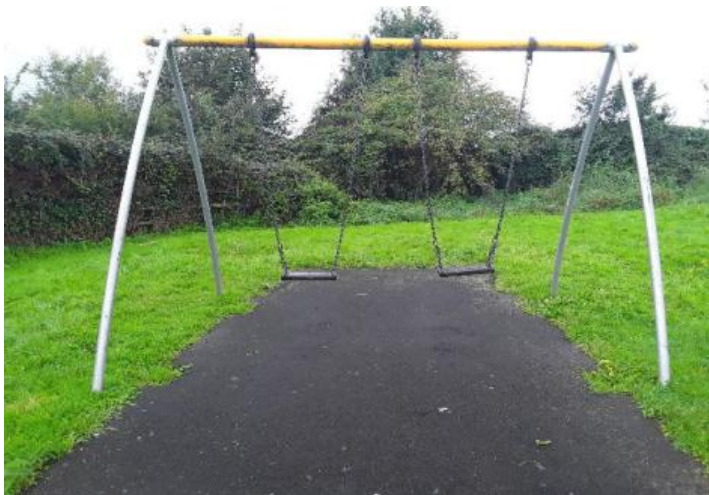
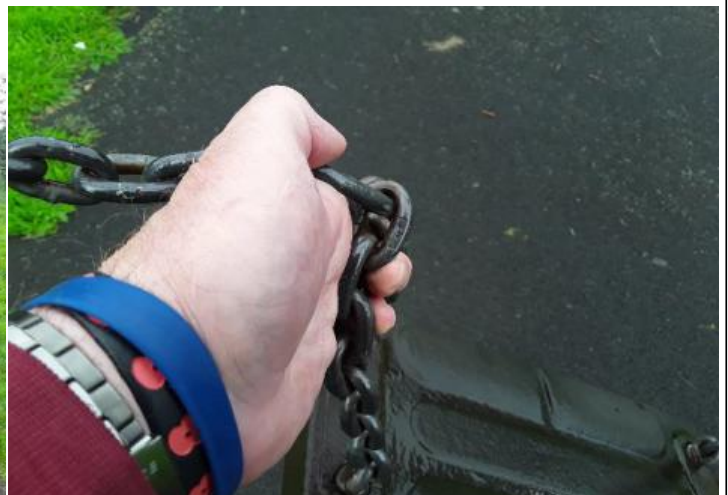
**Finding:** There is some notable evidence of chain wear  
**Action:** Monitor for any further deterioration and replace when 40% worn

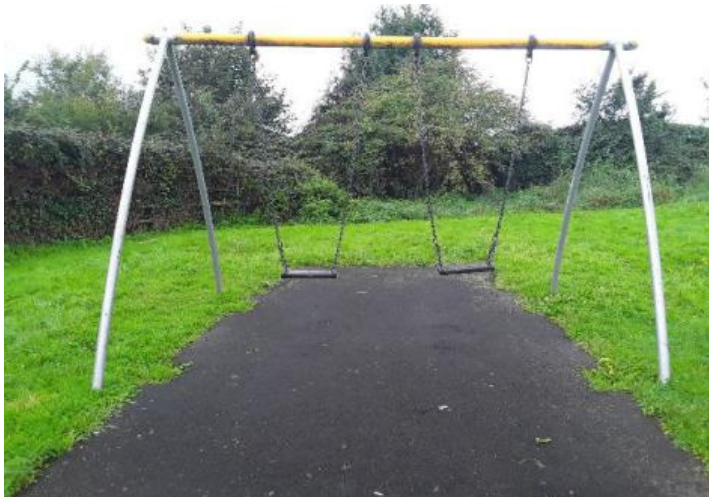
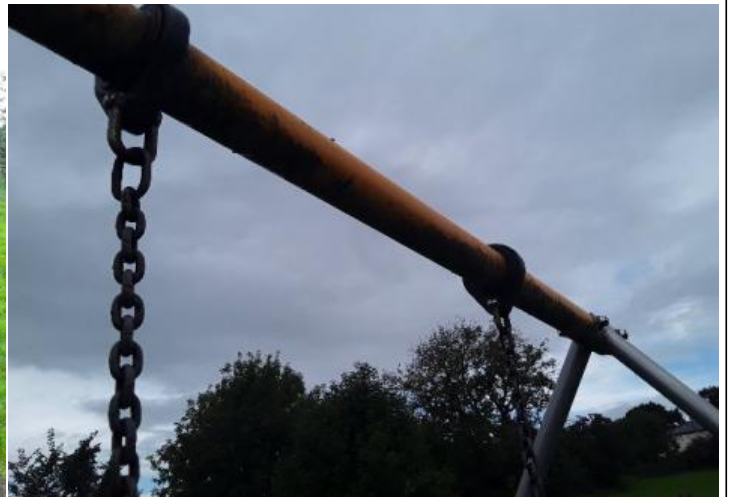
**Finding:** There is algae or moss on the surface of the equipment

**Action:** Clean and treat appropriately

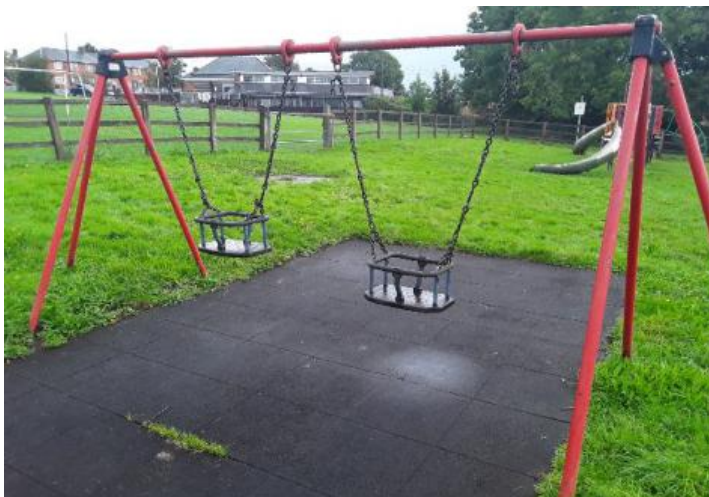
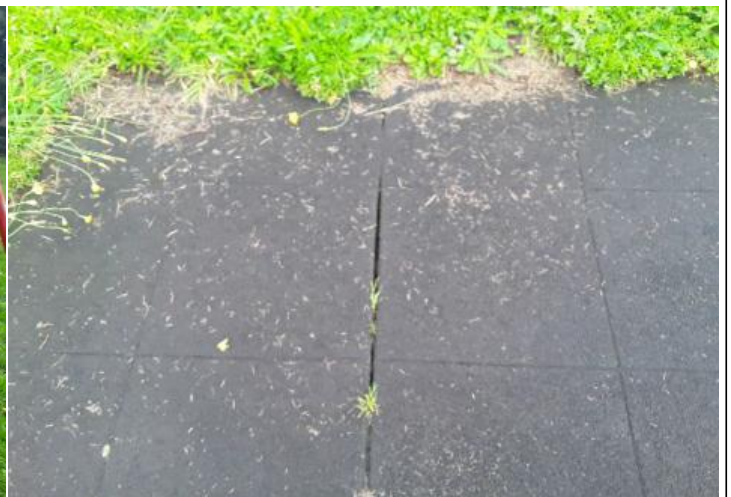
There are gaps opening in between the tiles - Monitor for any further deterioration and repair as required

**Finding:** There are gaps opening in between the tiles

**Action:** Monitor for any further deterioration and repair as required

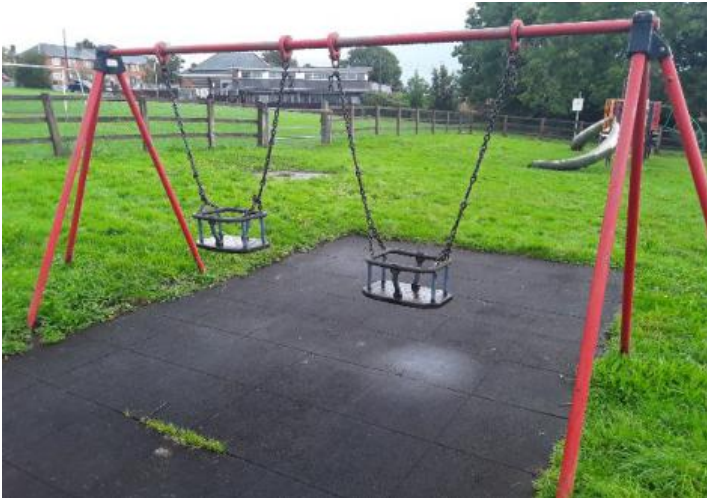
**Finding:** The chain openings are in excess of the 8.6mm as recommended by BS EN 1176 **Action:** Monitor - No remedial work recommended

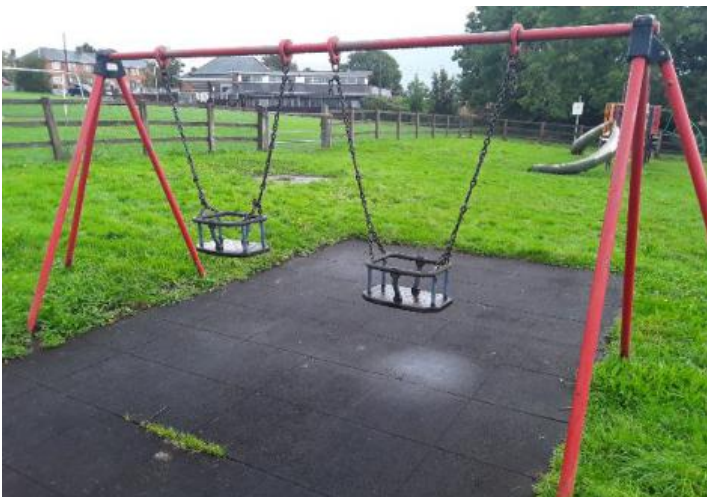
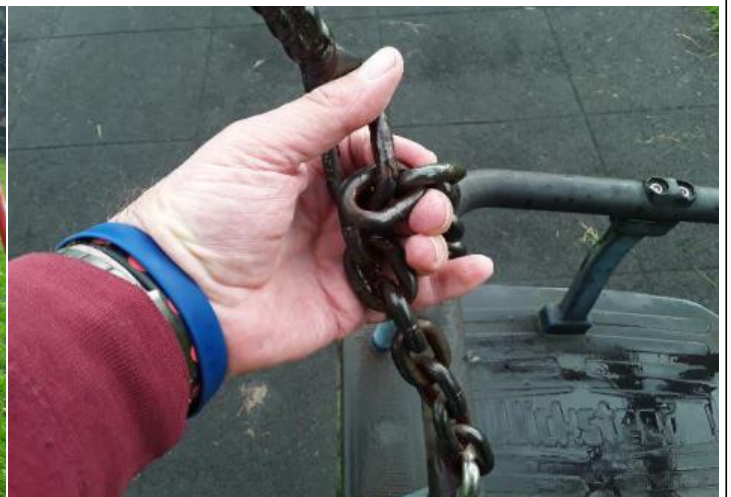
**Finding:** There is some notable evidence of chain wear **Action:** Monitor for any further deterioration and replace when 40% worn

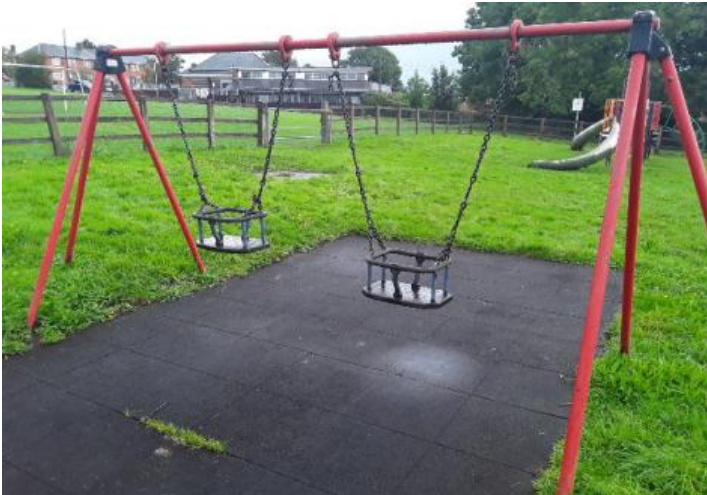
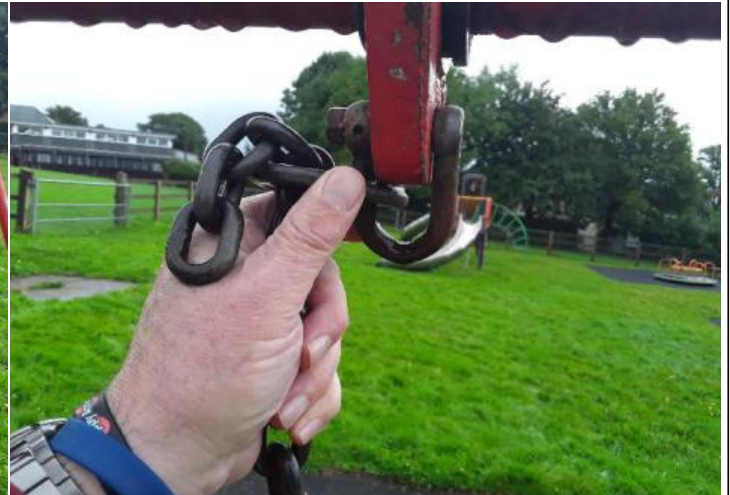
**Finding:** There is some wear to the shackles.

**Action:** Monitor for any further deterioration and replace when 40% worn

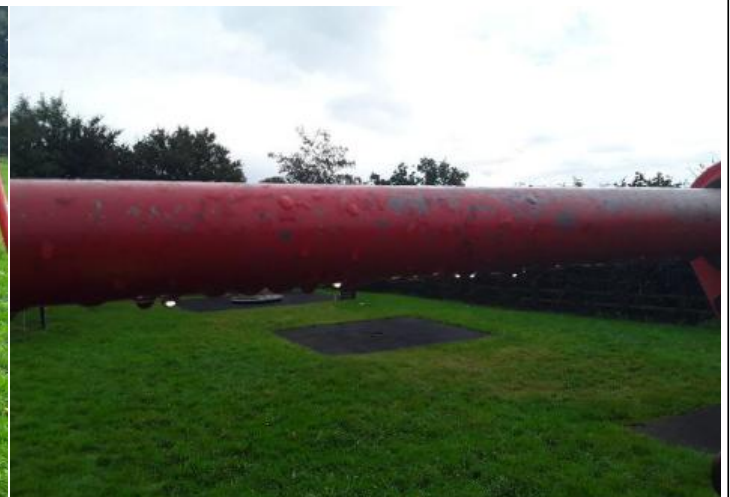
**Finding:** The paint is flaking off the metalwork

**Action:** Rub down and re-paint

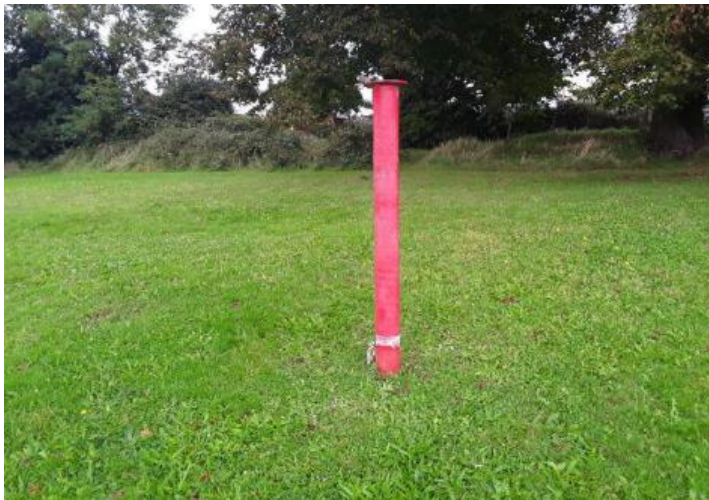
**Finding:** The top section has been removed  
**Action:** Replace the missing components or remove the item completely
