NOTICE IS GIVEN THAT A SERVICES, PROPERTY AND OUTDOOR SPACES COMMITTEE OF  
CULLOMPTON TOWN COUNCIL  
WILL BE HELD AT THE TOWN HALL, CULLOMPTON  
ON THURSDAY, 9<sup>th</sup> NOVEMBER 2023 AT 7PM

**MINUTES OF MEETING OF THE SERVICES, PROPERTY AND OUTDOOR SPACES COMMITTEE  
DATED TUESDAY 12 SEPTEMBER 2023 AT 7:00PM AT CULLOMPTON TOWN HALL**

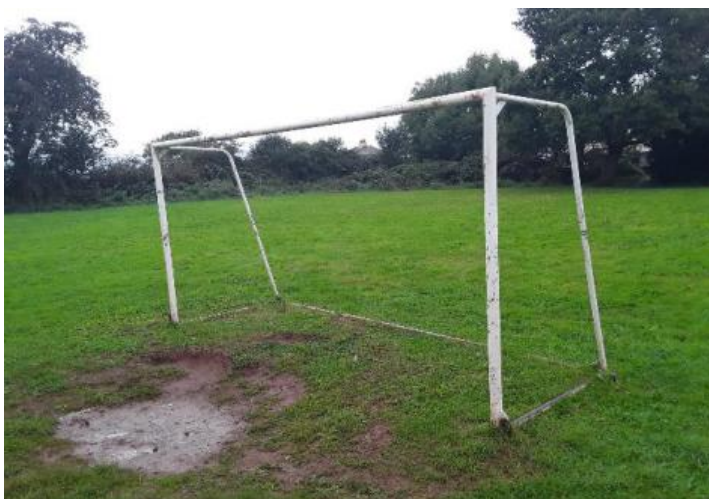
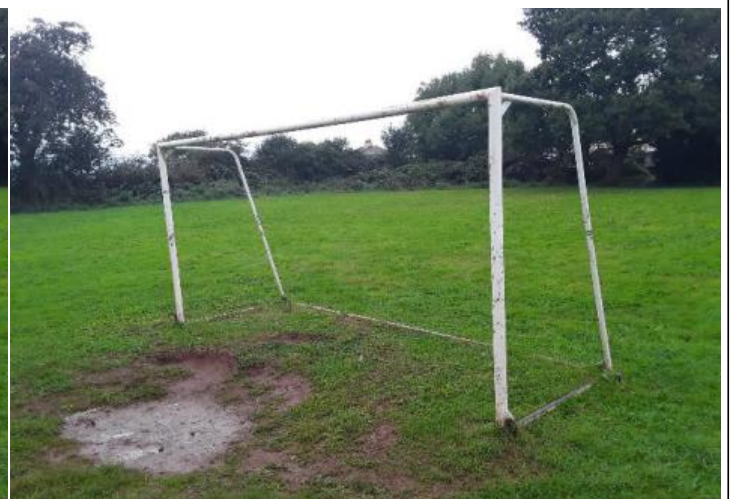
**Finding:** NB: We have undertaken a maintenance inspection only of the football goal(s); full load testing falls outside the scope of our inspection.  
**Action:** Implement load testing as required

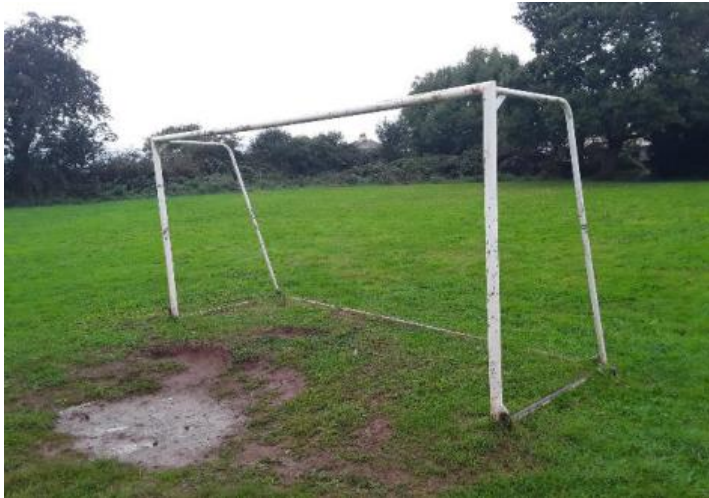
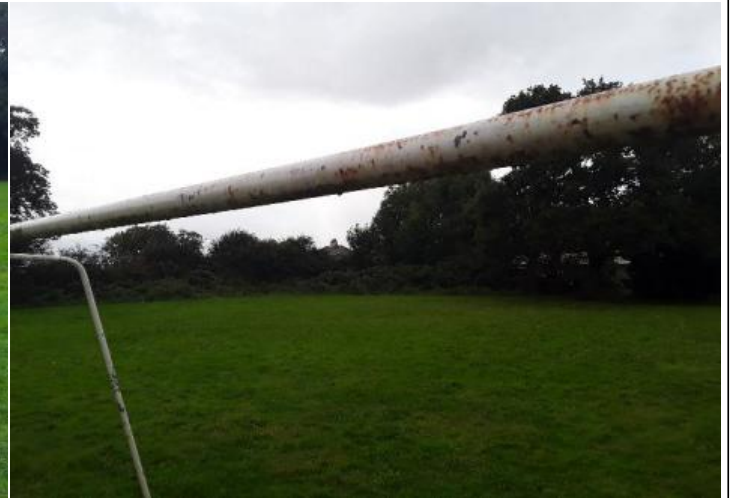
**Finding:** There is surface corrosion / rust present on the item

**Action:** Consider treating the item

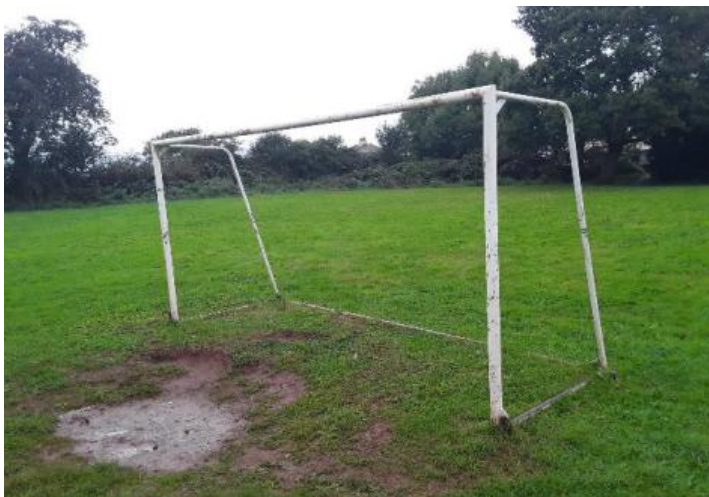
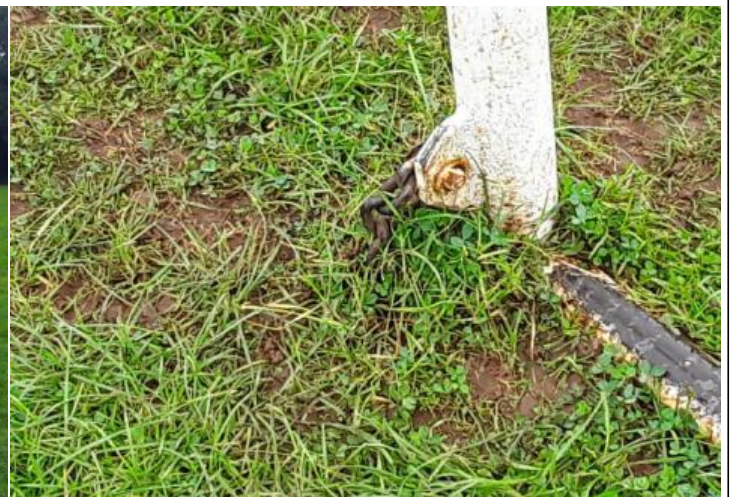
**Finding:** The goal has been secured in position using chain concreted into the grassed area

**Action:** Monitor for movement and stabilise if required

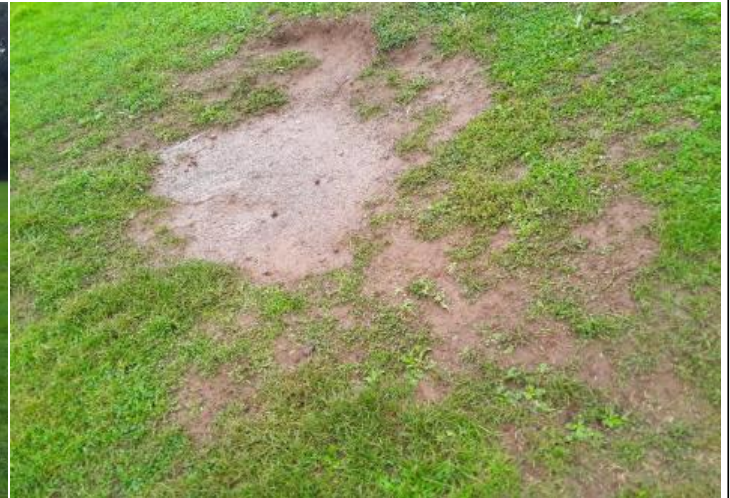
**Finding:** The surface has eroded in some areas and may be slippery in wet conditions  
**Action:** Reinstate the surface

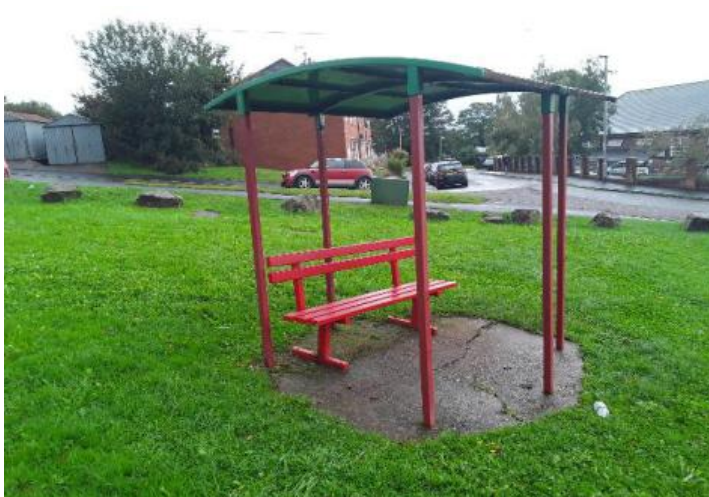
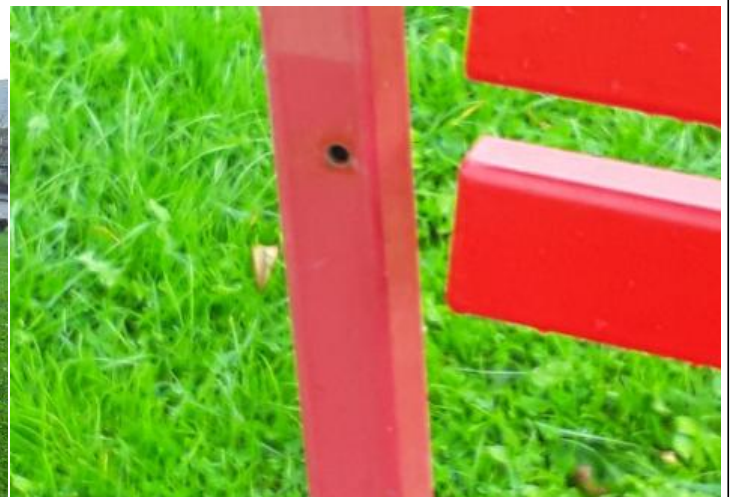
**Finding:** There is/are inserts missing  
**Action:** Replace missing inserts

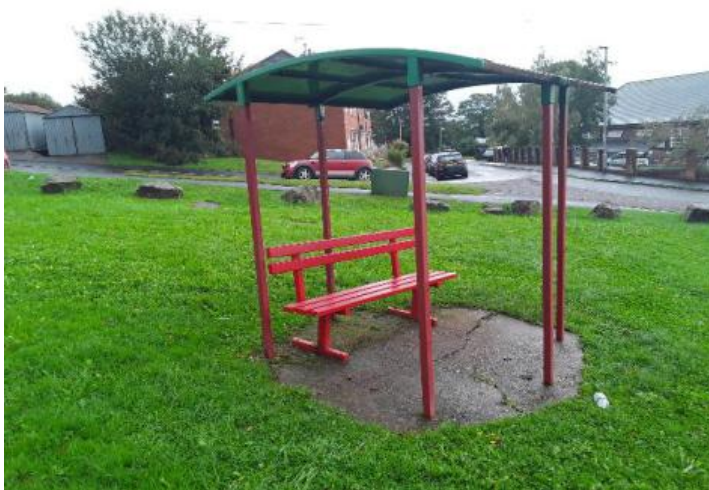
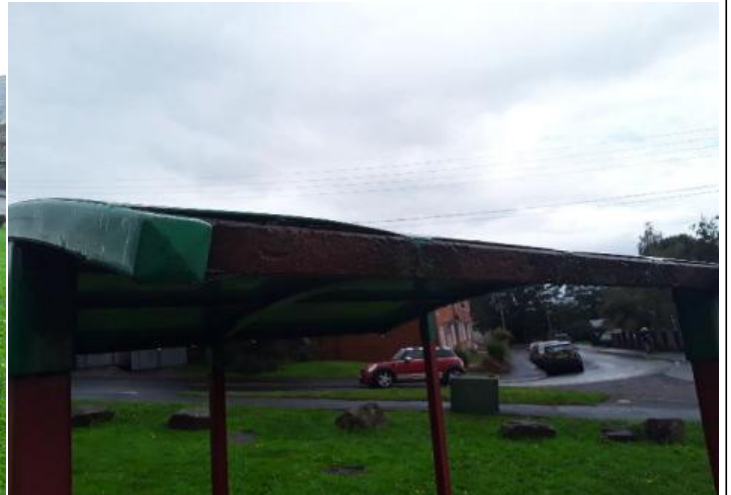
**Finding:** The paintwork on this item has been damaged or worn exposing the metal underneath which is rusting / corroding

**Action:** Treat affected areas and repaint

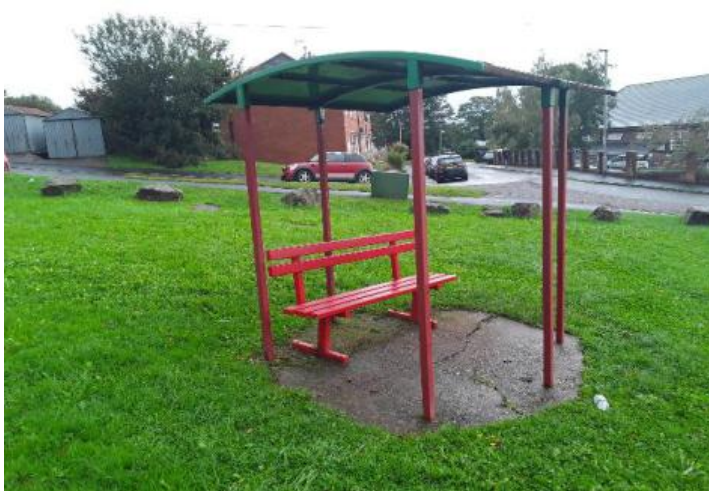
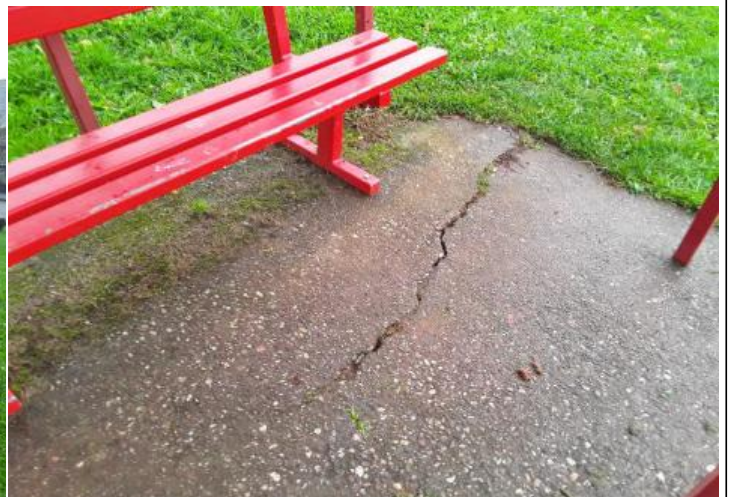
**Finding:** There are shear cracks in the concrete base

**Action:** Monitor and repair if required
